MARYLAND STATE DEPARTMENT OF HEALTH*

HOWARD COUNTY

Call Mus. Ferrarain order to gain access into house
4.014.7
FILE Well & Septic Inspection DATE REPORTED 6/29/78
PROPERTY OWNER Raymond Mills
P.O. ADDRESS 1310 Route 94 TELEPHONE
DIRECTIONS TO PROPERTY Liston, md.
INFORMANT Martla Ferrara 465-6400- home-465-0800
Scenpler Real Est.
4296 Montgomery Rd.
Elliott City, md. 21043
CONDITION FOUND Boxt. P769 10:40 Am 7/5/78 (88)
Dry well full level is up in stand sine wet less
Dry well full. Ievel is up in stand pipe at less than 2 feet below ground. Has been almost to top.
Hel 2 de e 1 cas 1.1 2 de
Had 2 days of rain July 2 and 3 td.
- MICHAIO WALL CAMBAIN
Letter 7-6-78 Needs, septir Repair (MS)
1 1 1 0 7 1 1 1 1 1 1 1 1 1 1
ACTION TAKEN
M
Mus 19:11s 489-4233
* FINAL DISPOSITION
) ————————————————————————————————————

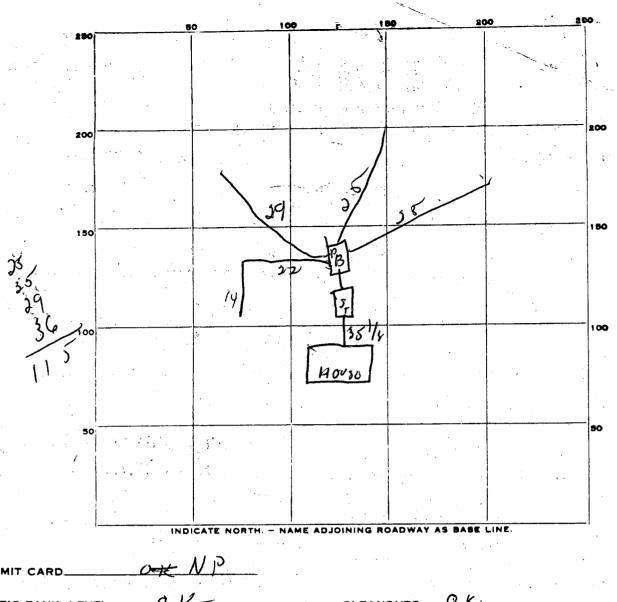
INDICATE NORTH NAME ADJOINING ROADWAY AS BASE LINE.	.l
PERMIT CARD OF NP	
SEPTIC TANK, LEVEL 0 12 CLEANOUTS OK	· · · · · · · · · · · · · · · · · · ·
DISTRIBUTION BOX, LEVEL OL	
TILE FIELD, DEPTH 4 FT. TRENCH WIDTH 3 FT.	* max
GRAVEL DEPTH 18 IN. TOTAL LENGTH 115 FT.	
NUMBER OF TRENCHES 4 TOTAL BOTTOM AREA 345	
SEEPAGE PITS, INSIDE DIAMETERFT. DEPTH BELOW INLETFT.	
ABSORBENT AREASQ. FT.	
REMARKS	
in the second of	
	·
DATE SYSTEM APPROVED 9/18/78 INSPECTOR DW Monagh	4
