**ON-SITE SEWAGE DISPOSAL SYSTEM  
HOWARD COUNTY HEALTH DEPARTMENT  
BUREAU OF ENVIRONMENTAL HEALTH**

ADDRESS: 11926 Queen Street PHONE NUMBER: 301-688-5275

SUBDIVISION: Kings Manor LOT NUMBER: 15

| PURPOSE: | In support of Building Permit #B00149518 with one bedroom addition. <del>Re-perc to determine repair area.</del> |

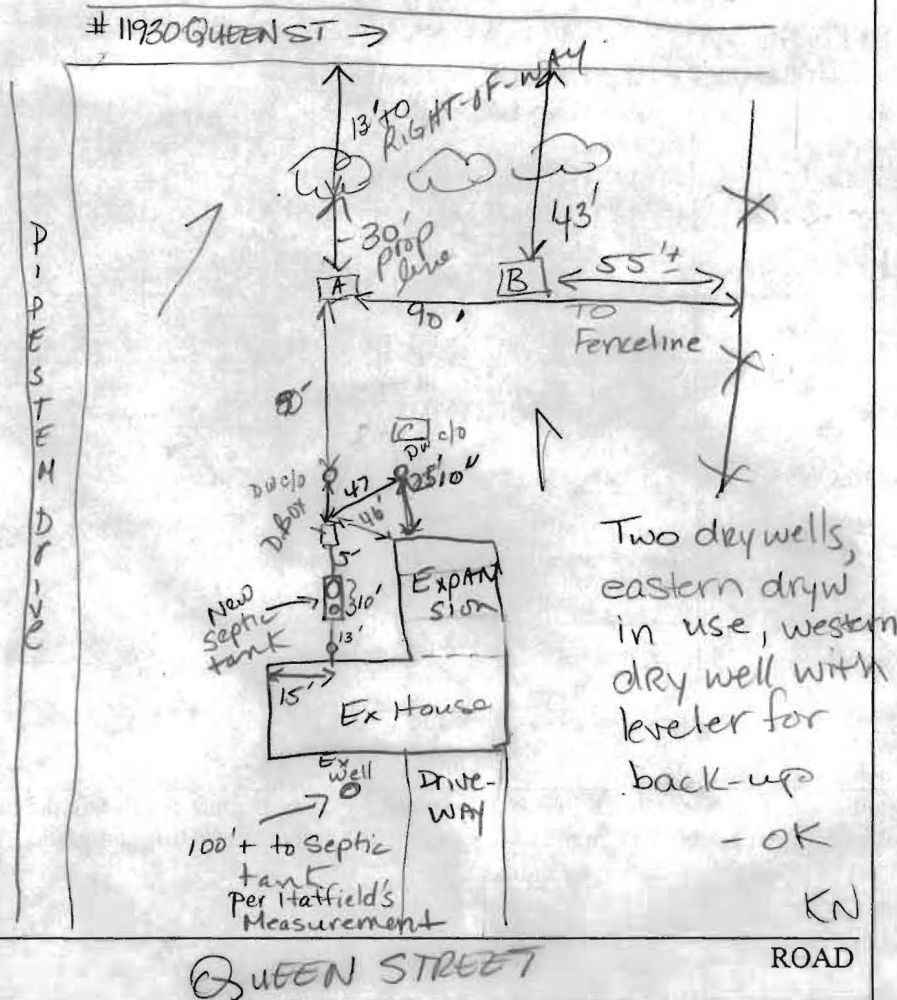
INSTALLATION 12-1-04 CONNECTION UNDER FOOTER. DIGGING PERC HOLES FOR SOILS DESCRIPTION  
 & identify future repair area. No ↑ in bedrooms now. Ex tank was 750; need to upgrade to minimum 1,000 gallon. 1500 gallon compartmented installed. Existing Drywell functioning properly - surrounded by loam @ 6'1/2-15' deep w/ sil. @ 5'. CLAY L ABOVE THAT. Future repair should stay higher in back yard - no trench installations below perc holes (A) and (B), which are approx 120' from house. KN
