STATE OF MARYLAND
WELL COMPLETION REPORT
FILL IN THIS FORM COMPLETELY
PLEASE PRINT OR TYPE

SITE INSPECTION SHEET

Site Inspection (6/13/16)
6535 River Clyde Drive
Highland, MD 20777

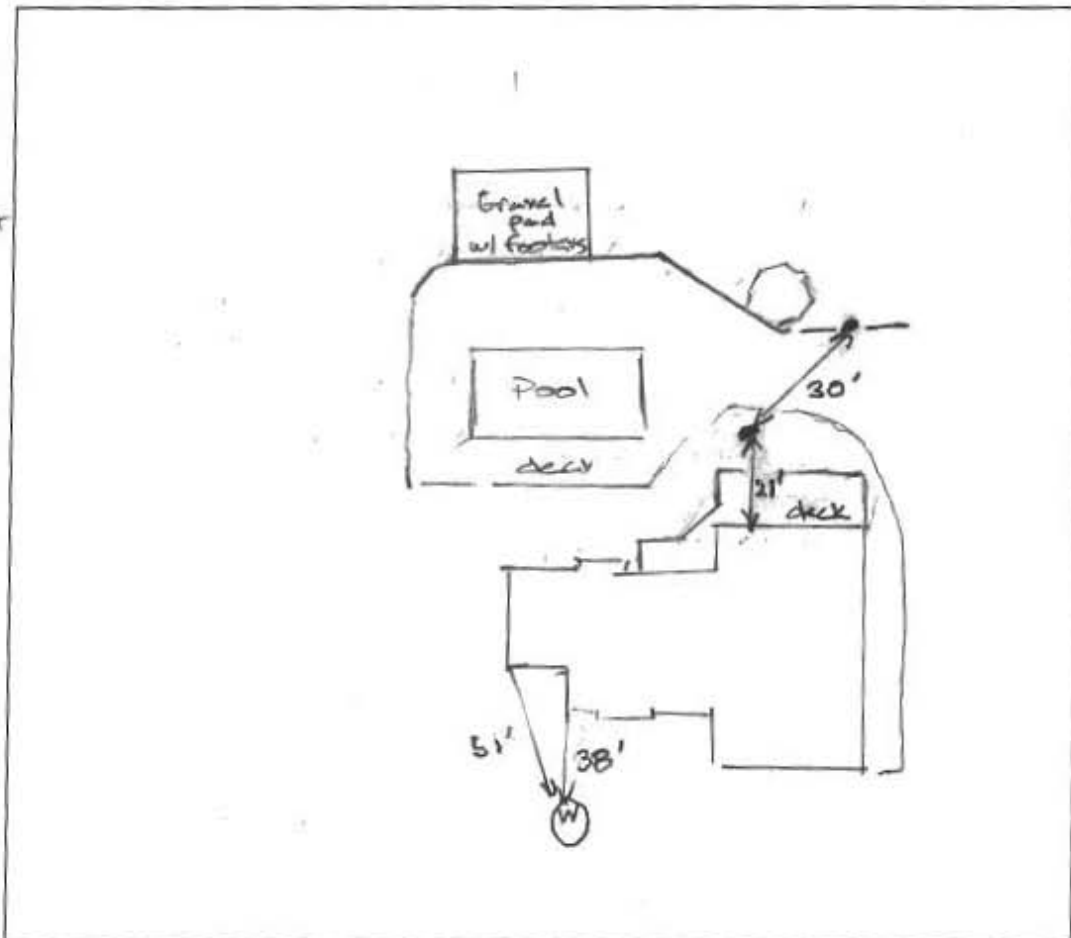
LOCATION DIAGRAM

COMMENTS: Tank cleanout is 7'6" to the deck footer,
Well pvc conduit is not flush w/ cap. observed
an ant infestation inside conduit. No evidence
of sewage surfacing or odors.

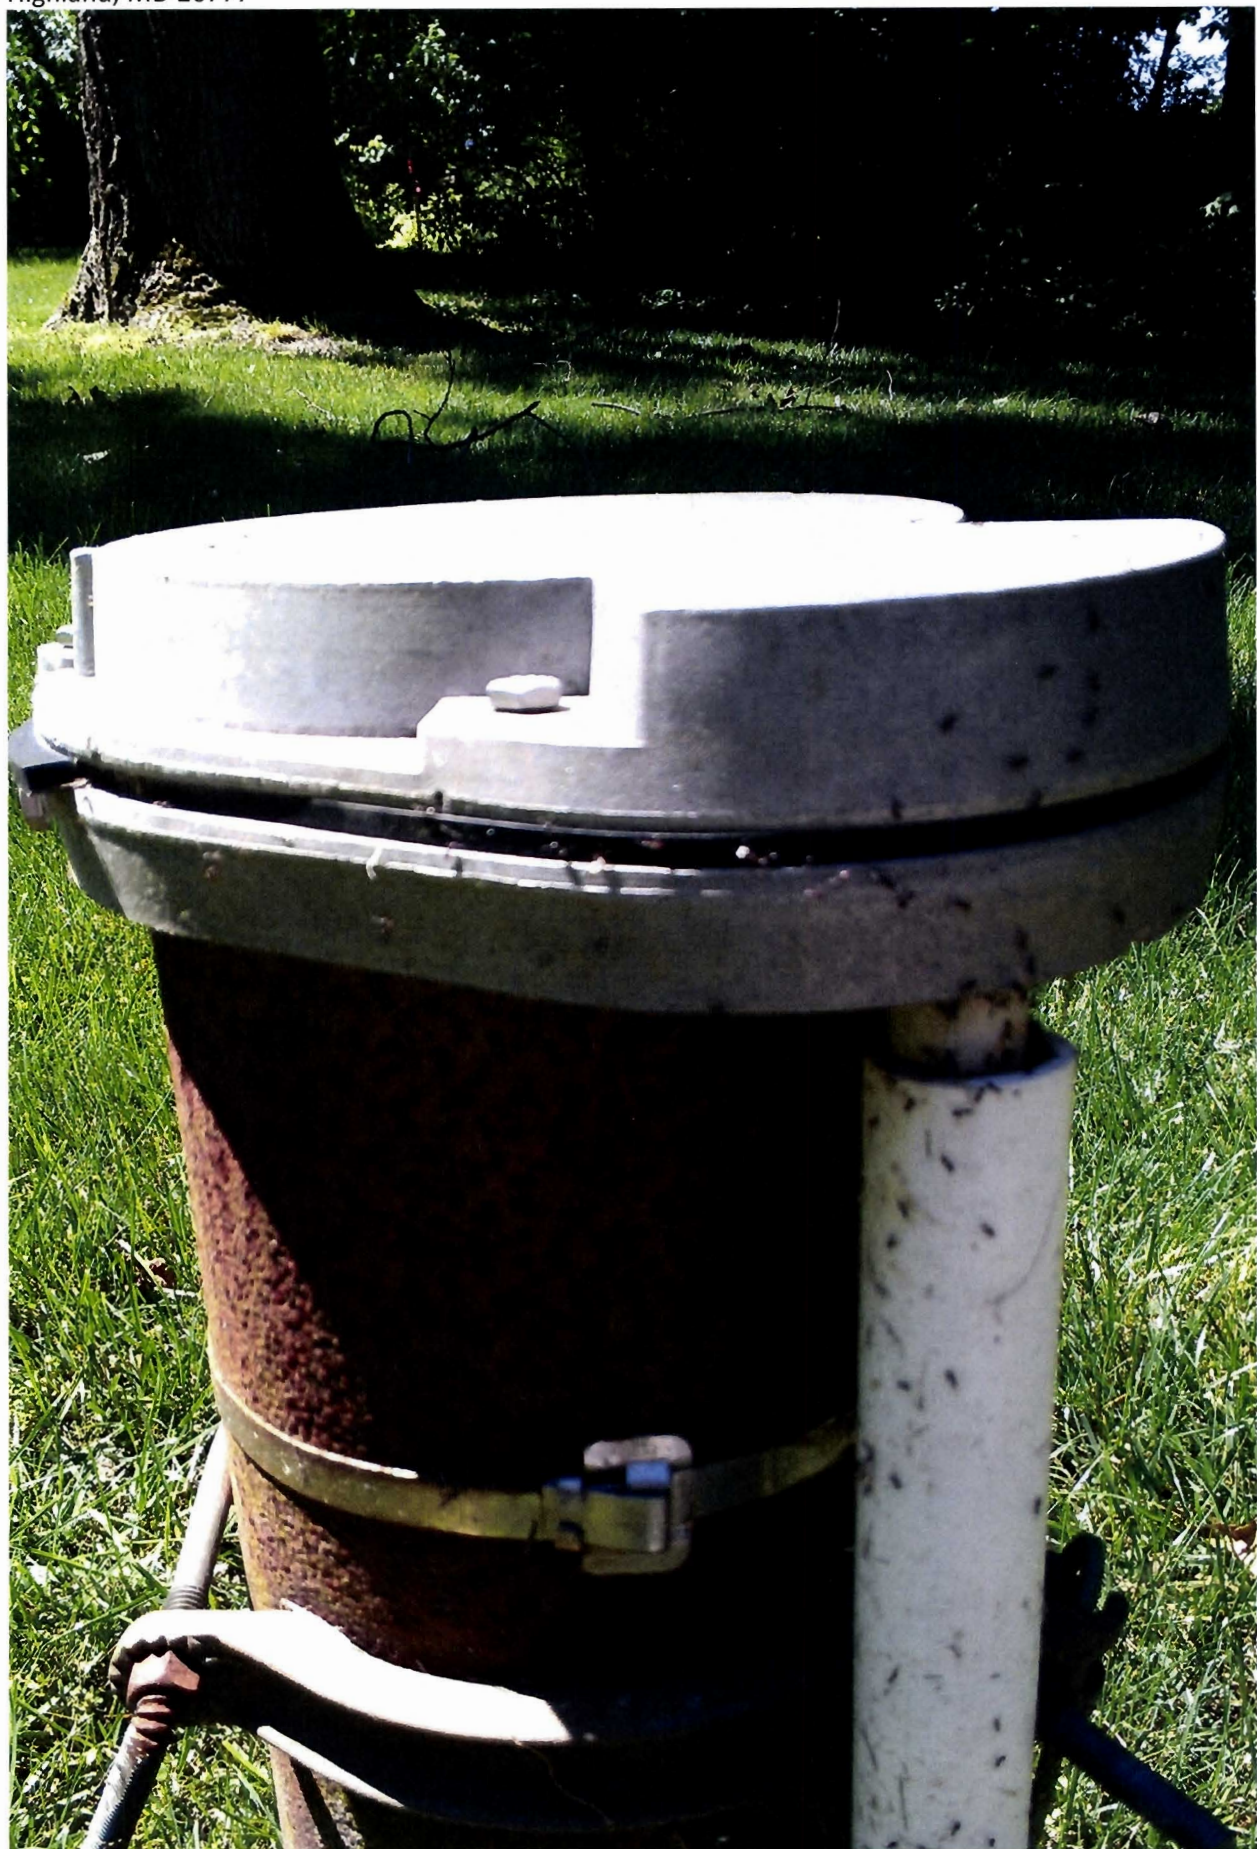
You have an unusual setup where it looks like there is a pipe inside a pipe for your conduit. The conduit is just the name of the small plastic pipe that protects the wiring for the pump. It comes out of the well cap and extends down into the ground. We suspect that the smaller, inside plastic pipe that goes all the way up into the cap is not a big enough diameter. It is supposed to extend up into the bottom half of the cap and be wide enough to provide a seal. You may need to take off the top of the cap and see if the plastic conduit is providing a seal. If not, you may need to extend the larger diameter one up into the cap after getting rid of the ants.

Our site visit confirmed that there is no visual evidence of surface failure of the septic system. We did, however discover that the well conduit had slipped from the well cap and there appears to be a nest of ants in the gap. This presents a contamination risk to the well. **We will require the conduit and cap to be repaired or replaced prior to approval of your current permit application.** We also recommend that you have a potability test performed on the well to verify that there is no contamination. That could be done by a private lab certified by the state or through our Community Hygiene Program. You could contact them at [410-313-1773](tel:410-313-1773).

Let me know when the cap/conduit are repaired and we can sign off on your permit. Thanks
