ON-SITE SEWAGE DISPOSAL SYSTEM HOWARD COUNTY HEALTH DEPARTMENT BUREAU OF ENVIRONMENTAL HEALTH

ADDRESS: 3830 Walt Ann Drive

SITE INSPECTION SHEET

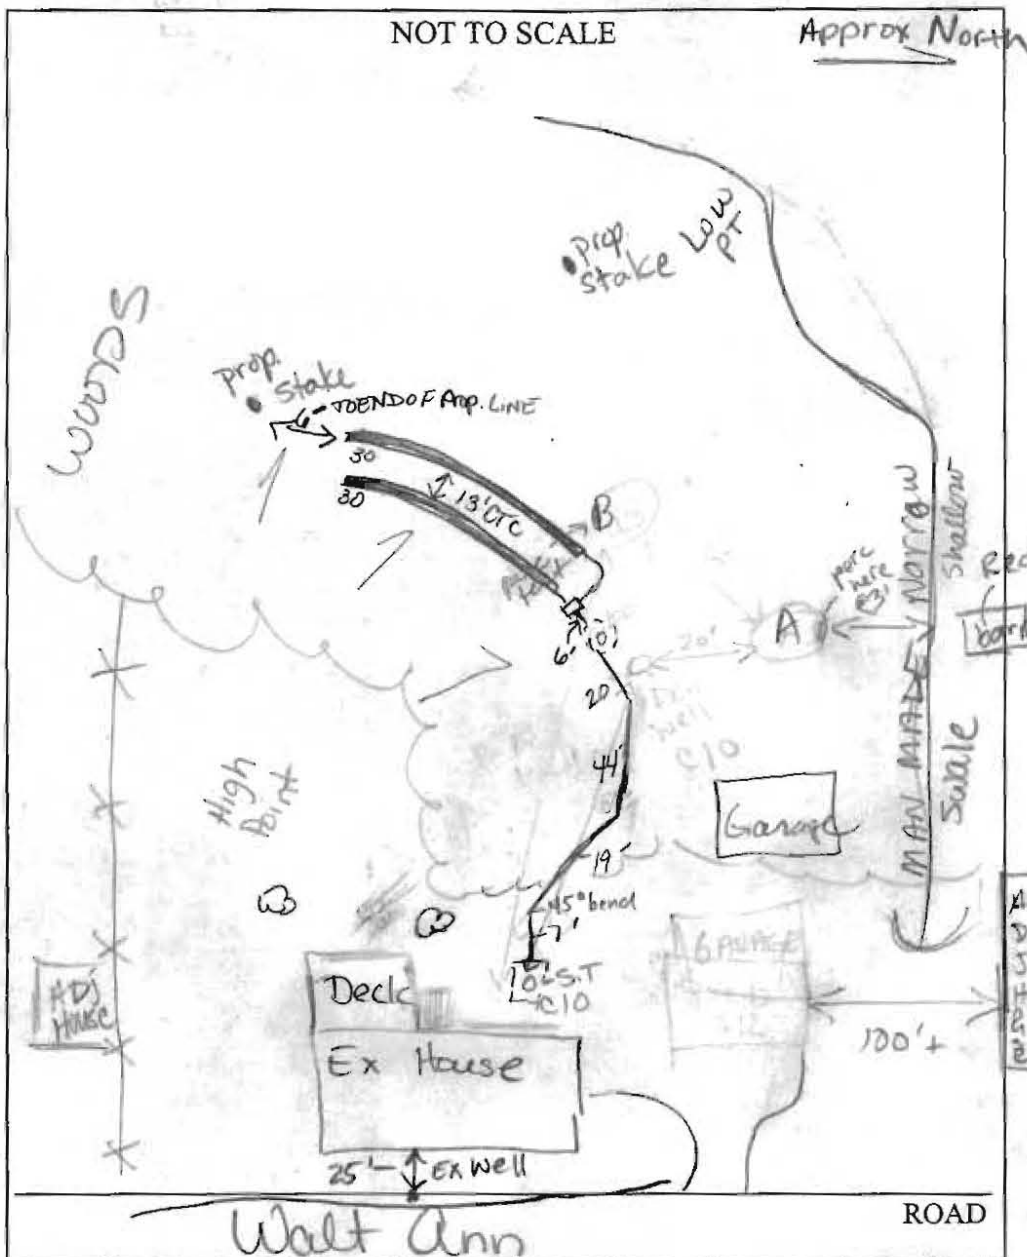
TRENCH/DRAINFIELD DATA		
WIDTH	INLET	BOTTOM
2	5 1/2	10 1/2
NUMBER OF TRENCHES		2
TOTAL LENGTH		601
ABSORPTION AREA		
DISTRIBUTION BOX LEVEL		yes
DISTRIBUTION BOX BAFFLE		yes
DISTRIBUTION BOX PORT		N/A

SEPTIC TANK DATA		
SEPTIC TANK 1 LEVEL		
CAPACITY	750	GAL
SEAM LOC	med	
TANK LID DEPTH	~10"	
BAFFLES	built in terra cotta	
BAFFLE FILTER	100K fine	
MANHOLE LOC	@ grade center	
6" PORT LOC		
WATERTIGHT TEST		
SEPTIC TANK 2 LEVEL		
CAPACITY		GAL
SEAM LOC		
TANK LID DEPTH		
BAFFLES		
BAFFLE FILTER		
MANHOLE LOC		
6" PORT LOC		
WATERTIGHT TEST

PRE-CONSTRUCTION 10/3/03 ADT wells in front of house. 4bdrm. Use ex dry well as additional storage & settling. See perc Notes (KN)

INSTALLATION 10/21/03 See perc sheet for percolation testing locations. Replaced pipe from S.T. to dry well w/ pvc. OK to cover all work (KN)

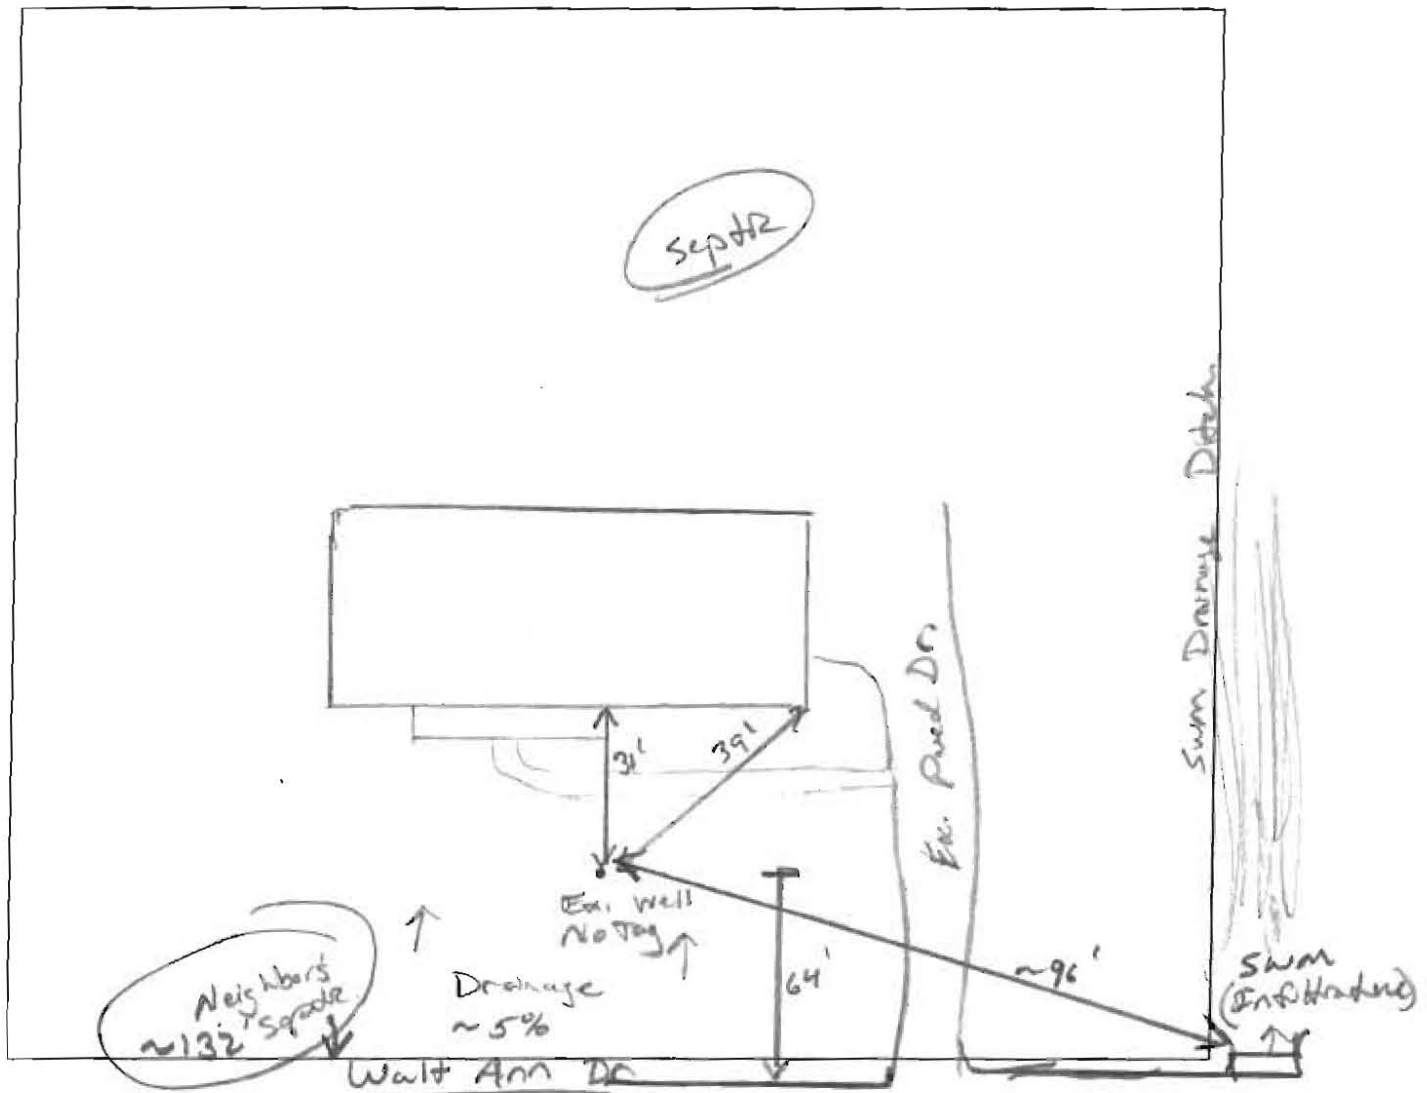
LOCATION DIAGRAM

COMMENTS: Ex well no tag, No conduit, steel casing, one pipe cap, potless?
3833 Walt Ann Dr. → septic located ~132' directly upgradient
of well. met w/ homeowner, told her to get more water tests done,
(nitrates, TDS, sodium, & coliform, turbidity). Don't think SWM is an issue
DATE: 10/1/10 INSPECTOR: JK Wolf
