# Howard County Health Department

## ONSITE SEWAGE DISPOSAL SYSTEM

**REPAIR**

PROPERTY ADDRESS: 3100 Roxbury Road Mill Rd (Rt 97)

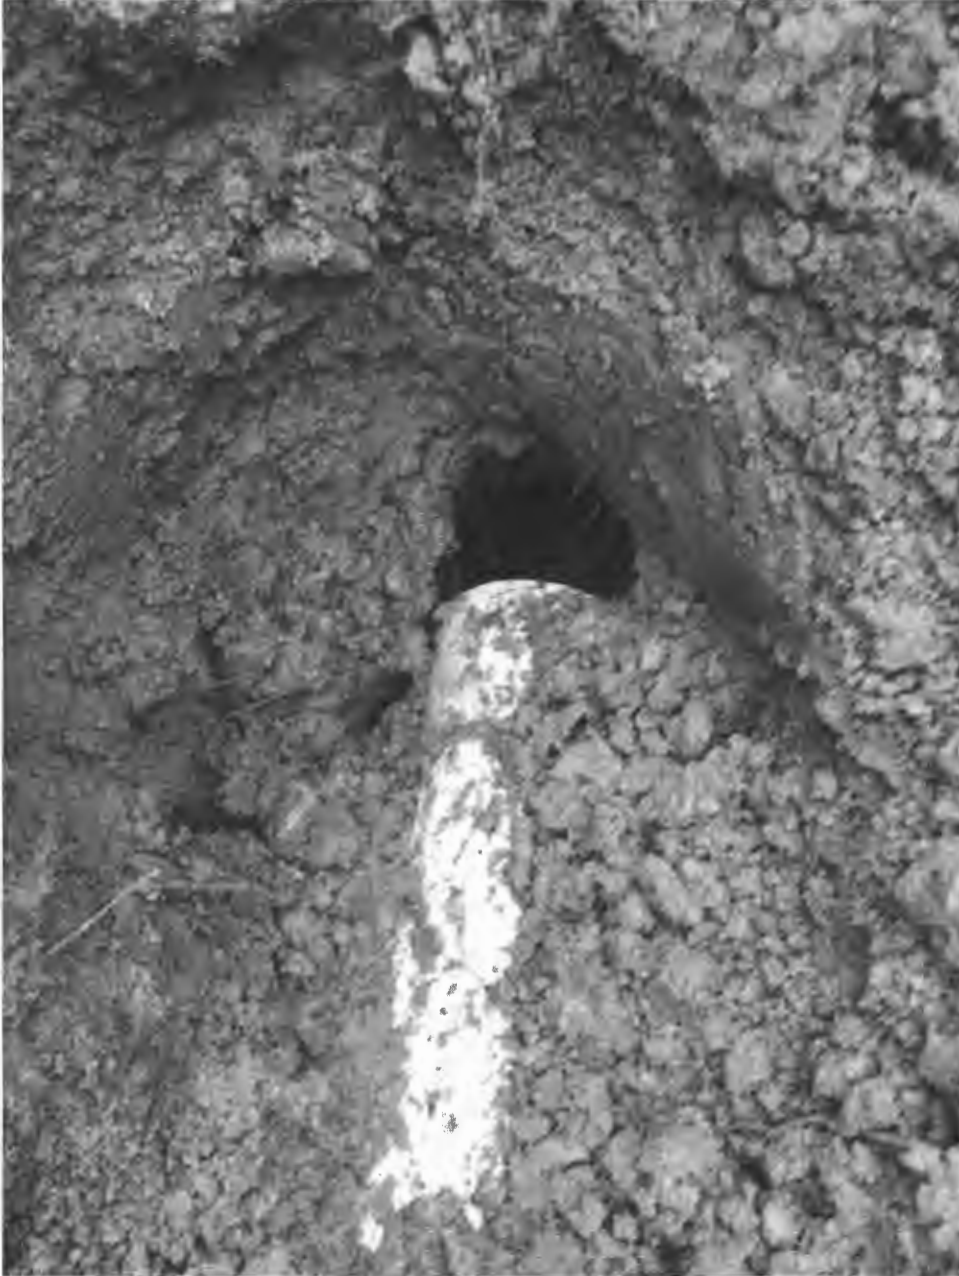
Contractor pic  
of break in  
pipe to what's  
listed on the 12/6/2000  
as built as the  
"Old trench"  
for the repair at  
the time.

INSTALLATION: 4/30/19 - site inspection for repair, contractor not onsite. (R) 5/1/19 - site inspection  
contractor rep onsite to operate back hoe, the repair was to a break in the  
pipe running to the trench to the North, SCH 40 PVC 4" line repaired, ok to backfill. (R)
