**ONSITE SEWAGE DISPOSAL SYSTEM**

**PERMIT: Repair**

PROPERTY ADDRESS: 1026 Saint Michaels Road

Date: July 27, 2015  
 Name of Evaluator: William Thompson  
 Time: 8:00 A.M.  
 Property Address:  
 1026 Saint Michaels Road  
 Mt. Airy, MD 21771  
 Recent Weather Conditions: Normal

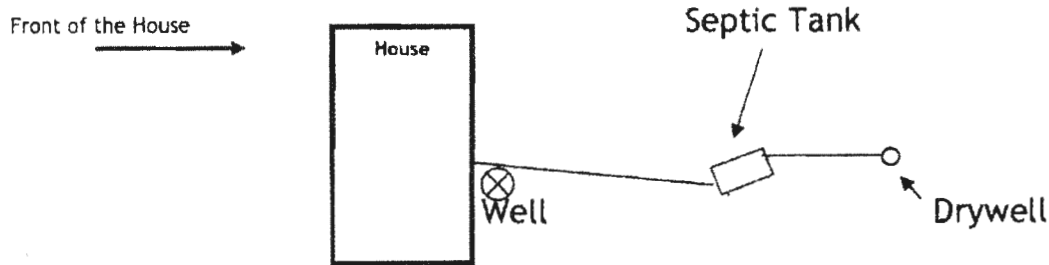
## Sketch of System

The septic tank is composed of concrete and is 1,000 gallons in capacity. The front baffle is missing; the back baffle is in place and composed of cast iron. Access is a manhole riser at grade; the septic tank is 24 inches below grade. There are 14 inches of solids indicating fair maintenance. It is recommended that the septic tank be cleaned every 2-3 years.

One drywell was located during the inspection and does not have access at grade. The side of the drywell was probed to a depth of 5.5 feet and was found to be hydraulically loaded with signs of biomat. It appears that work has been done to the absorption area recently. A hydraulic load test was not able to be performed due to a low yielding well. The absorption area will need to be replaced by a licensed contractor once the appropriate permits have been pulled from the county.
