SITE INSPECTION SHEET

OWNER: Tierney Ahearn PHONE #: \_\_\_\_\_  
ADDRESS: 15280 Sweetbay St CONTRACTOR: \_\_\_\_\_  
Woodbine MD WELL TAG #: HO-95-0633  
SUBDIVISION: Belle Haven LOT: 25 COUNTY #: 13  
PROPOSAL: Sinking patches continue to appear in yard especially  
after heavy rains

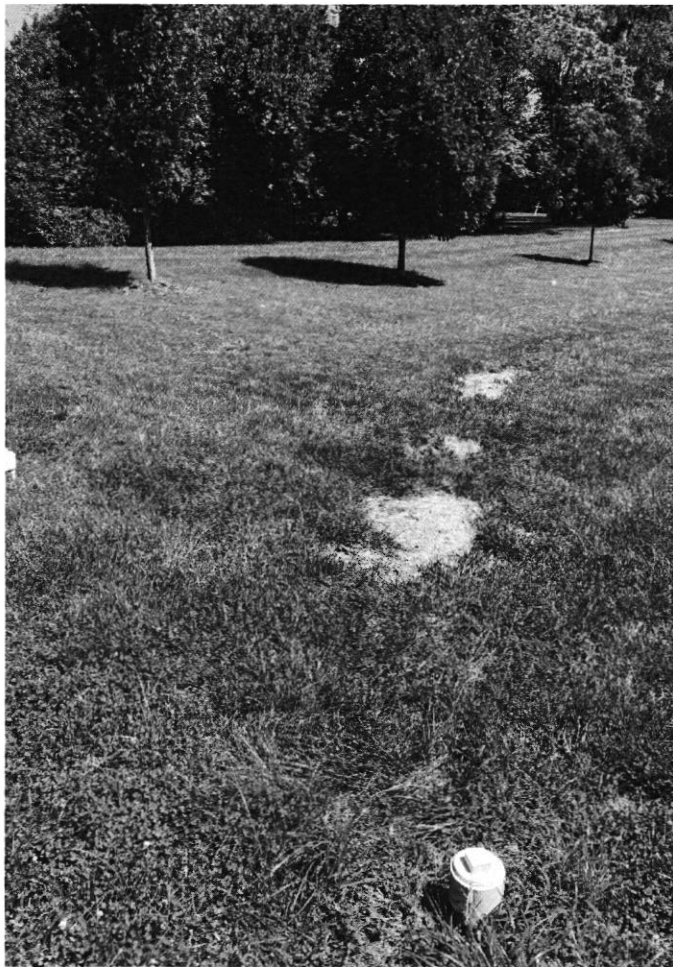
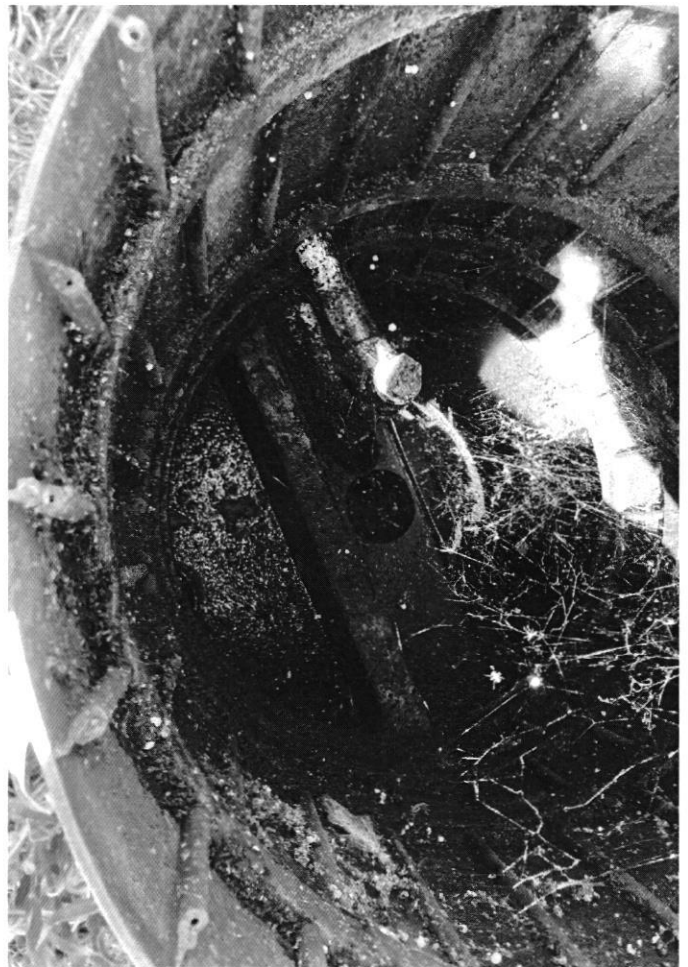
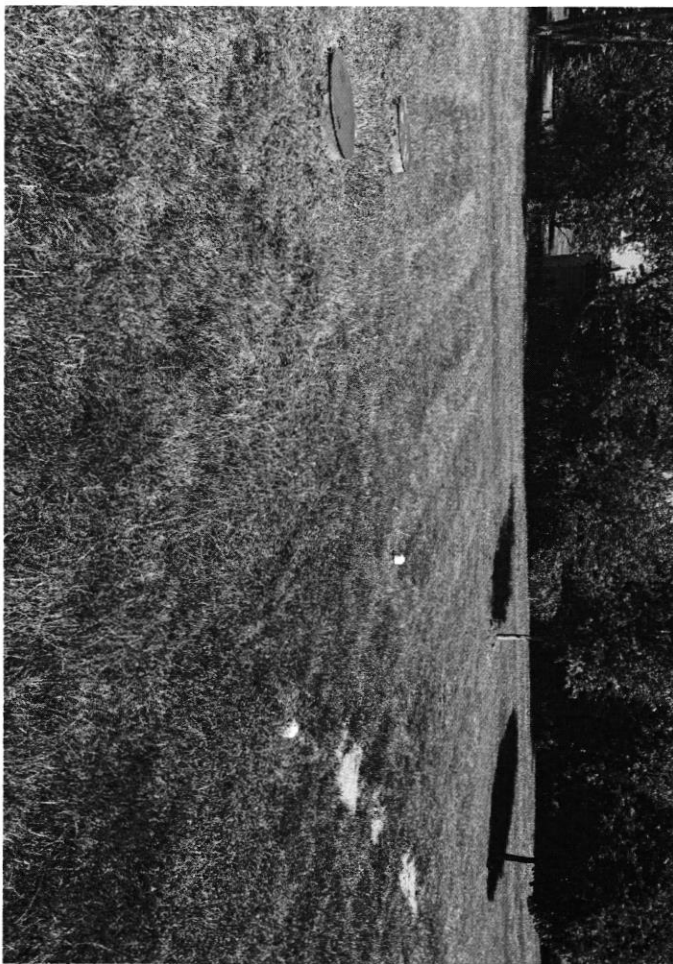
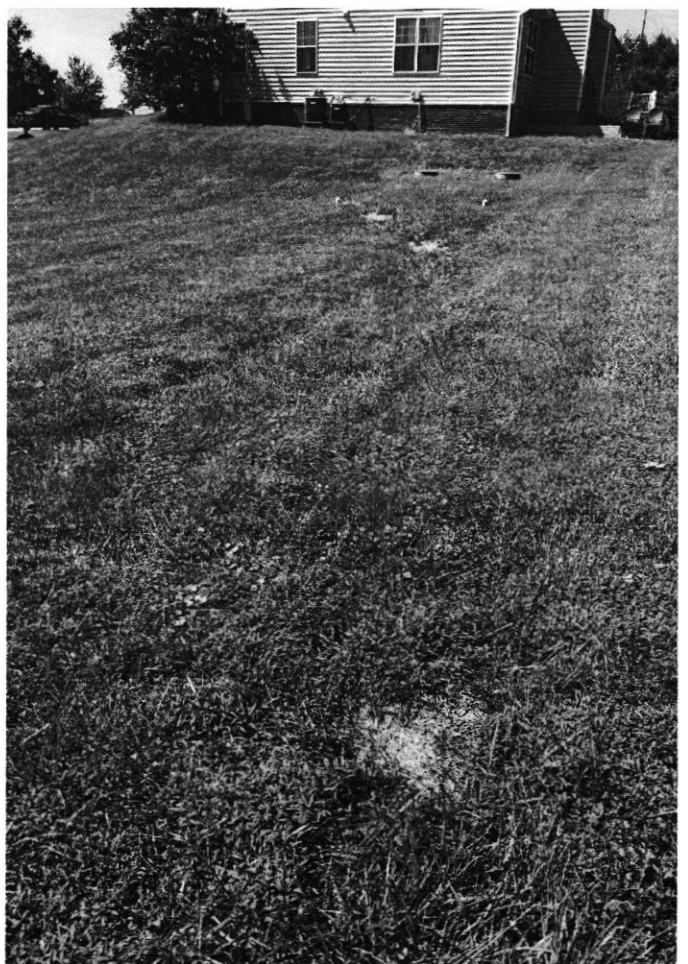
COMMENTS: Large patches of squishy soil along end of second trench. One  
patch has 1'x1'x0.5' hole. Observation pipe of second trench has water  
at the very bottom, first trench obs. pipe was dry. Lid of tank broken -  
water level normal, HOOT observed to function. Mike Sample reports  
HOOT last inspected on 4/16/21.

9/2/21 spoke with owner and advised that patches are most  
likely result of landscaping. No sign of system failure (SR)
