RECEIPT DATE: 12/14/22 **ONSITE SEWAGE DISPOSAL SYSTEM** P 572723

APPROVAL DATE: 1/24/23 **PERMIT: TANK (Repair) REPLACEMENT** A _____

PROPERTY ADDRESS: 13071 Wainright Road

INFORMATION FORM - SEPTIC SYSTEM REPAIR/UPGRADE

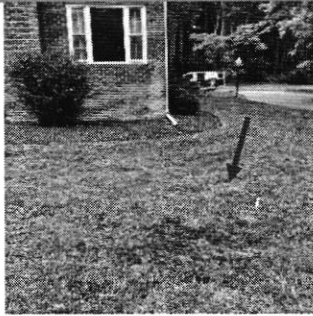
Picture 1:

This shows the septic tank in relation to the house.

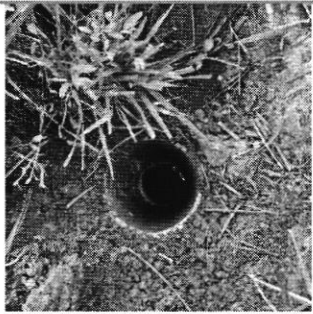
Picture 2:

This shows the access to the tank. This undersized cleanout prevented the interior of the tank from being observed.

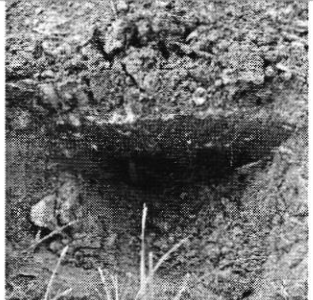
Picture 3:

System Component	Condition	Comments	
Septic Tank	<input type="checkbox"/> Acceptable <input checked="" type="checkbox"/> Unacceptable <input type="checkbox"/> Needs Further Evaluation	The septic tank is composed of cinderblock and is approximately 500 gallons in total capacity. The septic tank is accessible via a terracotta cleanout 3 inches below grade. The septic tank is 4 inches below grade. Cinderblock tanks are known to have structural integrity issues and are prone to leaking. A licensed septic contractor will need to replace the septic tank after permits have been pulled from the local county health department. Roots and disjoints were observed within the front line. The front line will need to be remediated at the time the septic tank is replaced. Please refer to page 2 and the camera septic report for further information.	
Absorption System	<input type="checkbox"/> Acceptable <input type="checkbox"/> Unacceptable <input checked="" type="checkbox"/> Needs Further Evaluation	One drainfield was believed to have been located during the evaluation. There area above the believed drainfield was observed to have been sunken in. The surrounding stone was probed and observed to be dry to a depth of at least 4 inches from the top of the stone. Due to the composition of the front baffle, the interior of the tank could not be seen. Without knowing the location of the outlet line, a hydraulic load was unable to be conducted. When the septic tank is replaced, the absorption system should be re-evaluated to verify its functionality.

This shows the tank is composed of cinderblock. The sidewall of the tank was excavated by hand to view this seam.

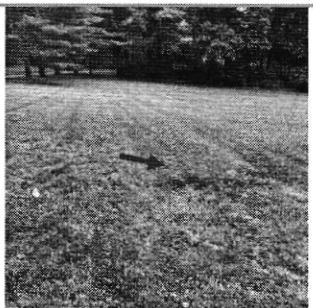
Picture 4:

This shows the sunken area. This is where the drainfield is believed to be located. At the time the septic tank is replaced, this area should be re-evaluated.
