# Howard County Health Department

### ONSITE SEWAGE DISPOSAL SYSTEM

PROPERTY ADDRESS: 3654 Sharp Road

<b>Date:</b> 3/9/2023 <b>Name of Evaluator:</b> Drew Henderson <b>Time:</b> 09:00 <b>Property Address:</b> 3654 Sharp Road Glenwood, MD 21738 <b>Recent Weather Conditions:</b> Normal		<b>Ordered By:</b> Angie Graboski  <b>Homeowner Interview:</b> The homeowner interview was sent conducted during the evaluation.	<b>Occupied:</b> <input checked="" type="checkbox"/> Yes <input type="checkbox"/> No <b>Length of Time Vacant:</b> N/A <b># of People Living in Home:</b> 6 <b>Property Age:</b> 1986 <b>System Age:</b> 1986 <b>Last Date of Cleaning:</b> ~1 Month Ago <b>Recomm'd Pumping Freq:</b> Annually
<b>Liquid level in tank is:</b> <input checked="" type="checkbox"/> Above Normal <input type="checkbox"/> Normal <input type="checkbox"/> Below Normal		<b>Bottom Solids Depth:</b> 4 Inches	
<b>Depth of tank:</b> 42 inches		<b>Type of Tank Access:</b> Cleanout	
<b>Maintenance appears:</b> <input type="checkbox"/> Good <input checked="" type="checkbox"/> Fair <input type="checkbox"/> Poor		<b># of Bedrooms:</b> 3

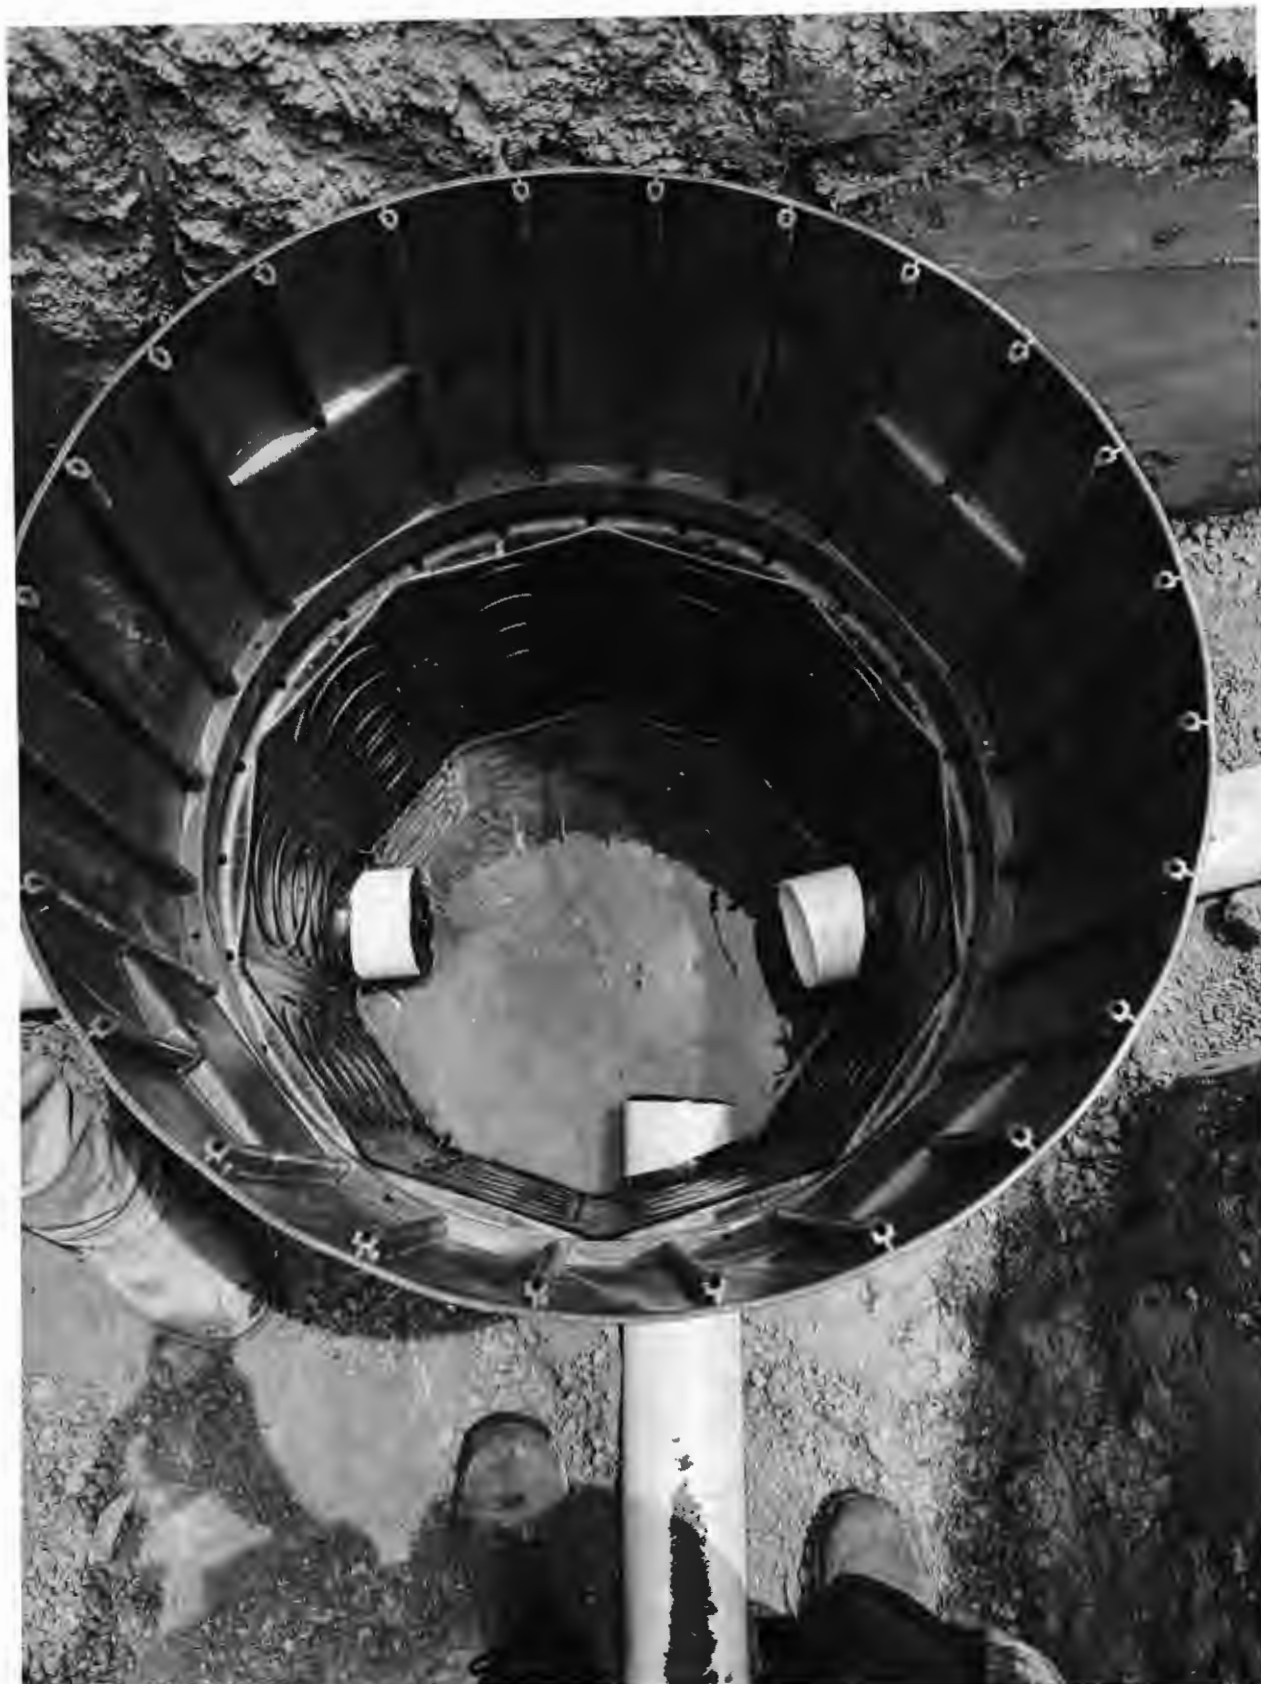
PIC OF D-box  
6/6/2023 (SP)

6/16/2023- Front line has fall, c/o installed near deck. Ex tank pumped & collapsed. O box has manhole  
& speedy levelers, leveled onsite. Lower trench @ 69' & upper @ 71'. Measured house to well. (SP)  
sending pic of installed baffle.

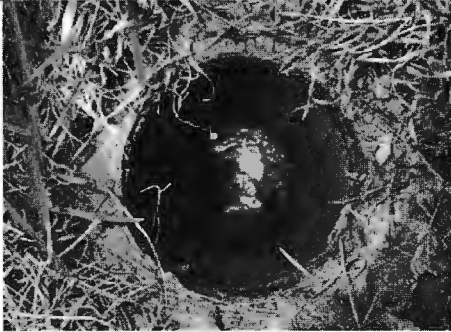
**Picture 1:**

Showing inside the cleanout into the septic tank. Liquid level in the tank was high, backing up into the cleanout and back into the house. Signs of previous high liquid levels observed inside the cleanout

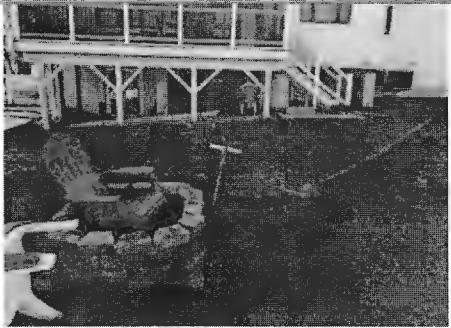
**Picture 2:**

Showing the distribution box appears to be located underneath the fire pit

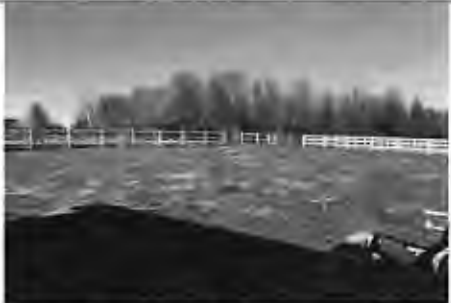
**Picture 3:**

Showing the location of the drainfields

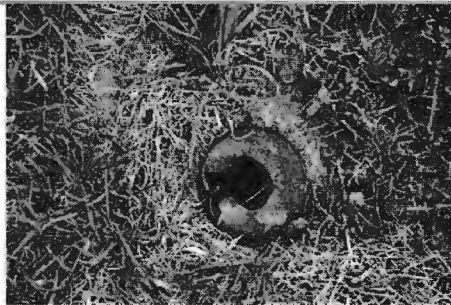
**Picture 4:**

Showing the metal cleanout cap is broken and should be replaced
