RECEIPT DATE: 3/27/2026 **ONSITE SEWAGE DISPOSAL SYSTEM** P 590378

APPROVAL DATE: 4/23/2026 **PERMIT: REPAIR - TANK REPLACEMENT** A Repair

PROPERTY ADDRESS: 12810 Linden Church Road

*All In One Home Inspections, LLC*  
SEPTIC SYSTEM INSPECTION REPORT

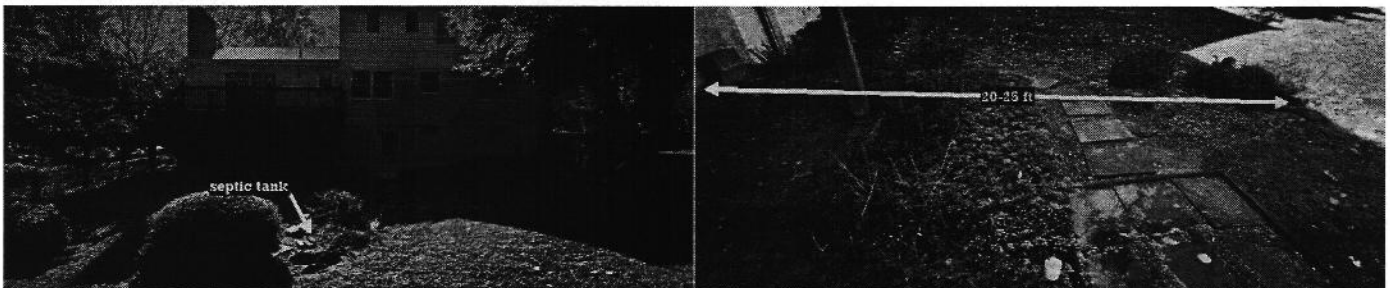
Center of the back yard of the house.

Located about 20 to 25 feet from the house.

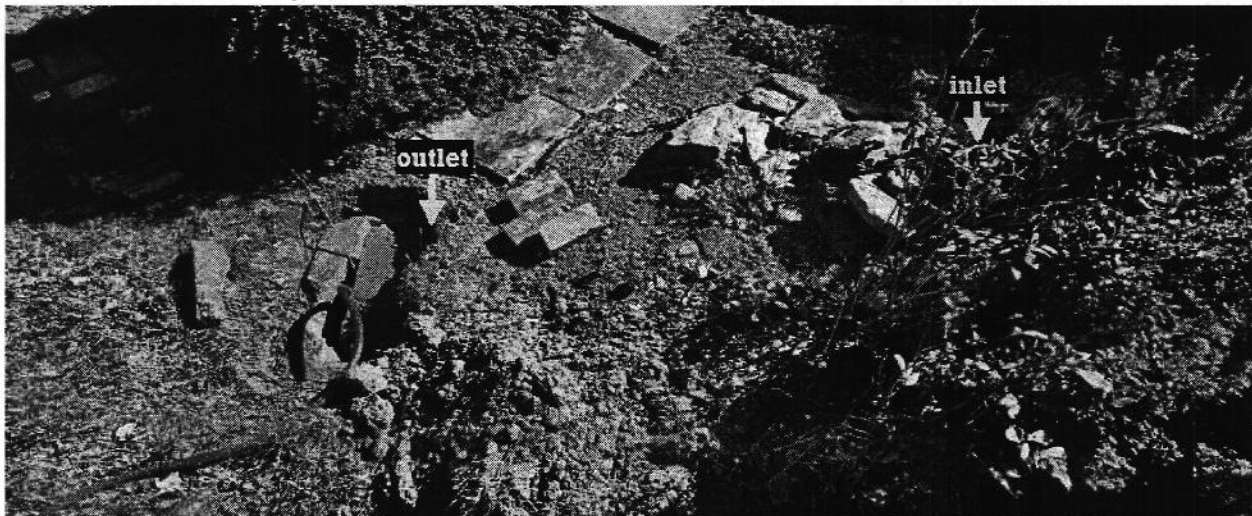
The septic tank inlet access is above grade level and the outlet access is about 3 to 4 inches below grade level.

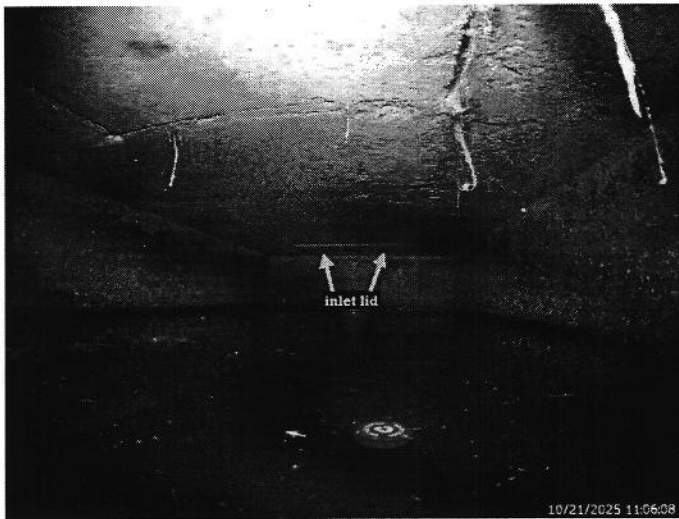
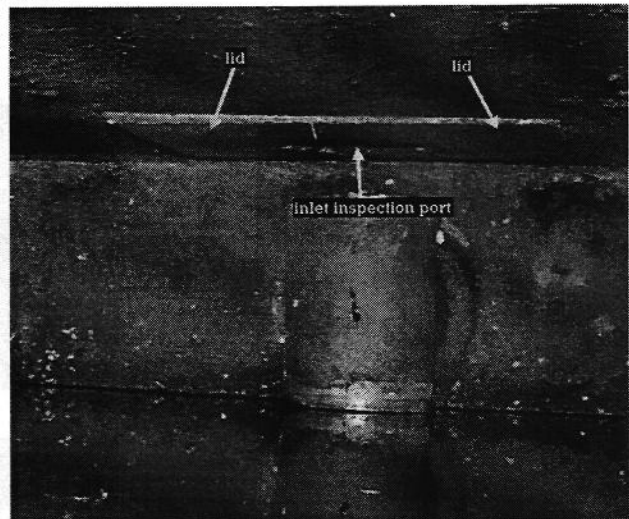
Concrete Inlet lid appears to be fully intact and working as intended at the time of the evaluation.

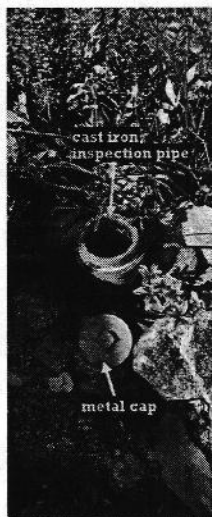
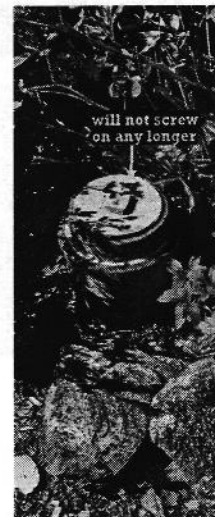
The cast iron inlet inspection pipe appears to be intact at the time of the inspection. However, the metal cap appears to be unable to screw into the top of the pipe and can easily fall or blow off and allow outside water or debris to enter the tank. Recommend a further evaluation from a licensed septic contractor to replace the cast iron inspection pipe.

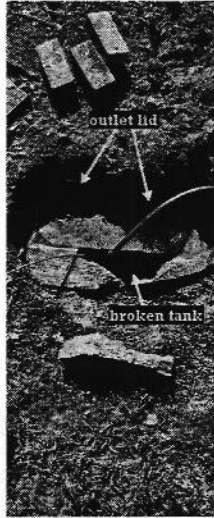
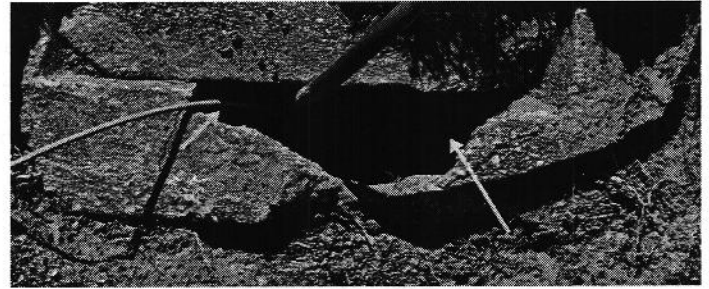
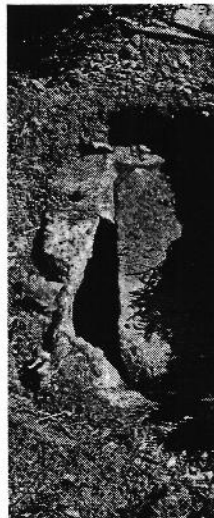
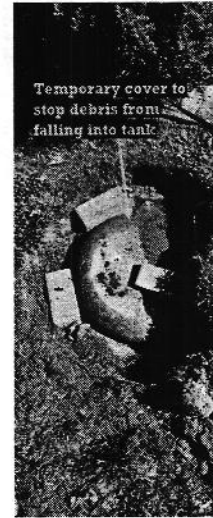
SEPTIC SYSTEM INSPECTION		
Page 5 Item: 3	Septic tank lid	<ul style="list-style-type: none"> <li>• Concrete Outlet lid appears to be intact and working at the time of the evaluation. However, due to the broken pieces missing from the tank around the outlet access, the lid is unable to create a full seal and requires a further evaluation from a licensed septic contractor for repairs or replacement.</li> <li>• The cast iron inlet inspection pipe appears to be intact at the time of the inspection. However, the metal cap appears to be unable to screw into the top of the pipe and can easily fall or blow off and allow outside water or debris to enter the tank. Recommend a further evaluation from a licensed septic contractor to replace the cast iron inspection pipe.</li> </ul>
Page 9 Item: 6	Level of solids	<ul style="list-style-type: none"> <li>• The level of solids was measured at approximately 18 inches. When the measured solids/sludge, on the bottom of the tank, are measured at 12 inches or more, it is time to consider having the septic tank pumped out. Recommend having the septic tank pumped out by a licensed Septic Pump Company.</li> </ul>

Concrete Outlet lid appears to be intact and working at the time of the evaluation. However, due to the broken pieces missing from the tank around the outlet access, the lid is unable to create a full seal and requires a further evaluation from a licensed septic contractor for repairs or replacement.

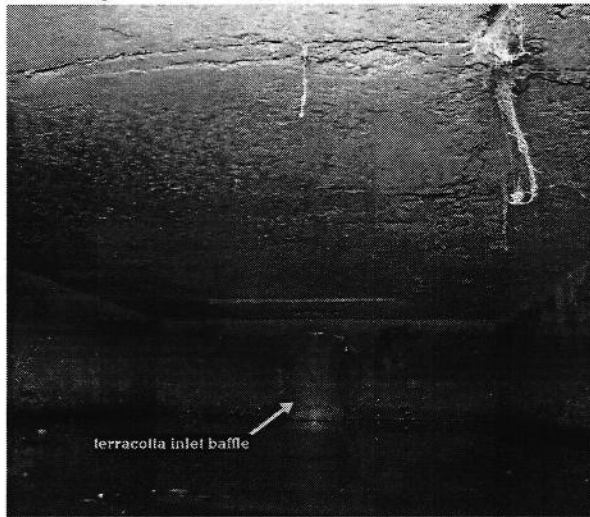
Septic System has a terracotta Inlet Baffle.

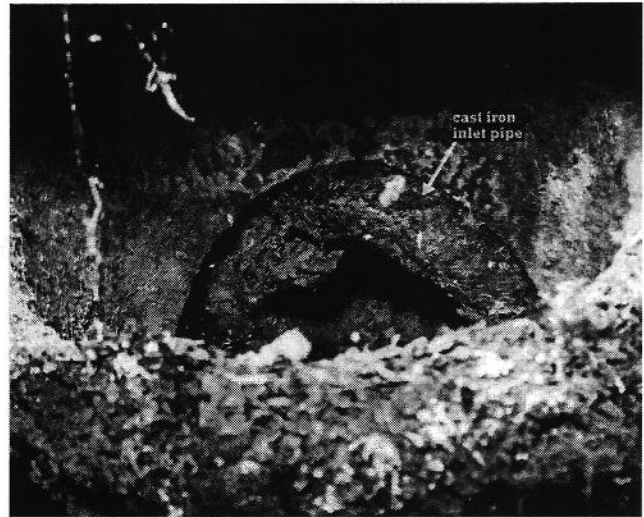
Septic System has a Metal Inlet Pipe.

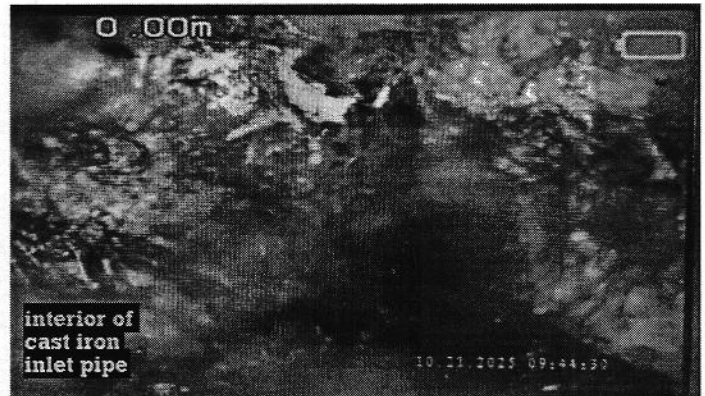
Cast iron inlet pipe appears to be working as intended at the time of the inspection. However, due to the pipe being cast iron, and its age, there is some heavy rust build up around and along the interior of the pipe. Over time, this build up can ultimately cause the inside of the pipe to completely close in and not allow waste to flow through. The pipe appears to be working at this time, but it is recommended to monitor the pipe for any possible worsening conditions, and possibly looking into having the cast iron updated to PVC, by a licensed septic contractor, some time in the future, before any issue arise.

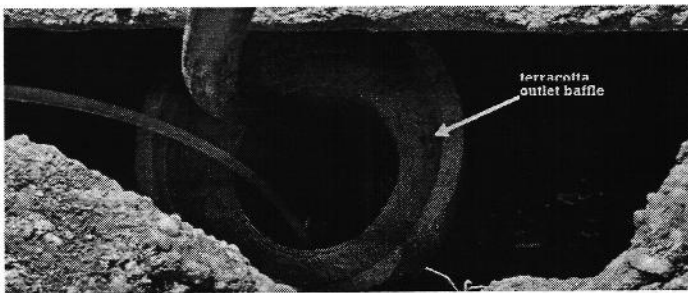
Septic System has a terracotta outlet Baffle.

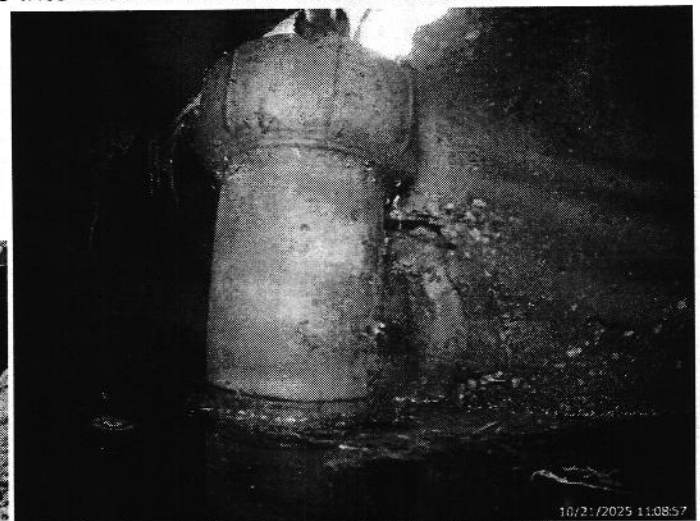
Outlet Baffle appears to be intact and working as intended at the time of the evaluation.

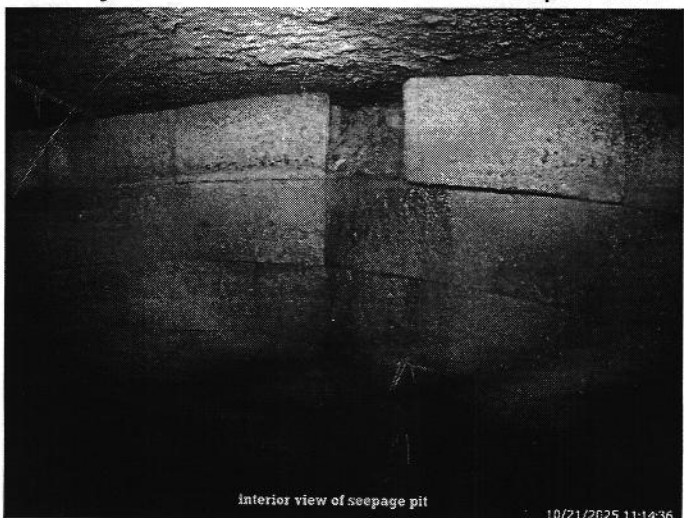
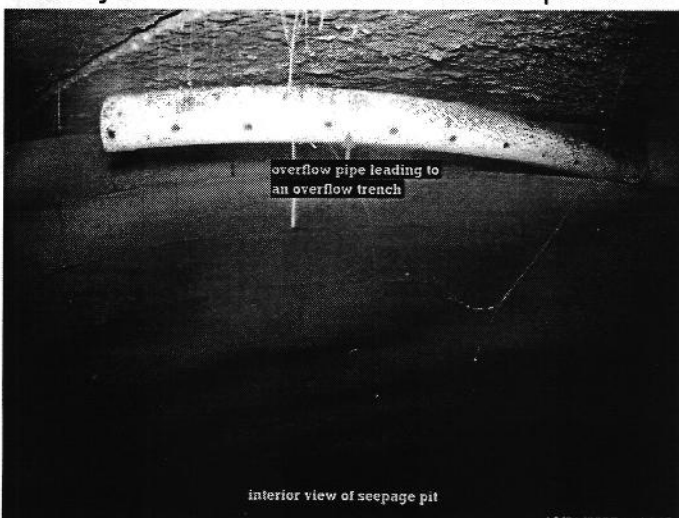
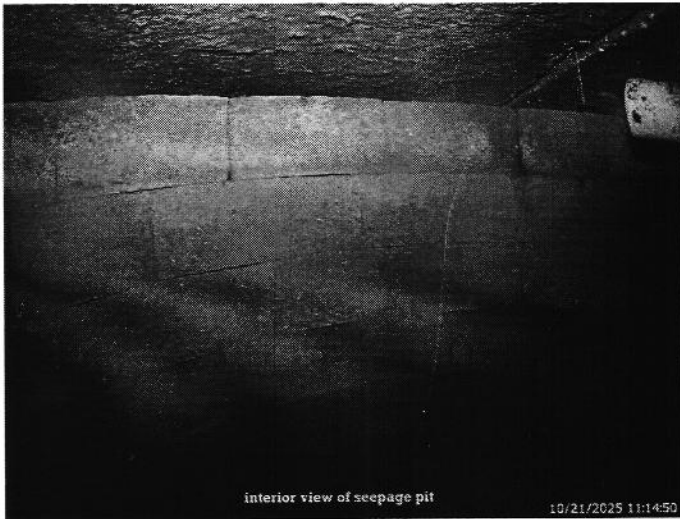
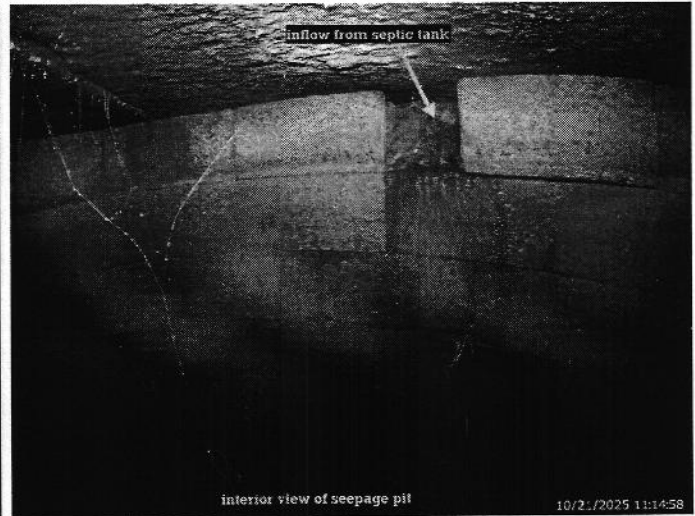
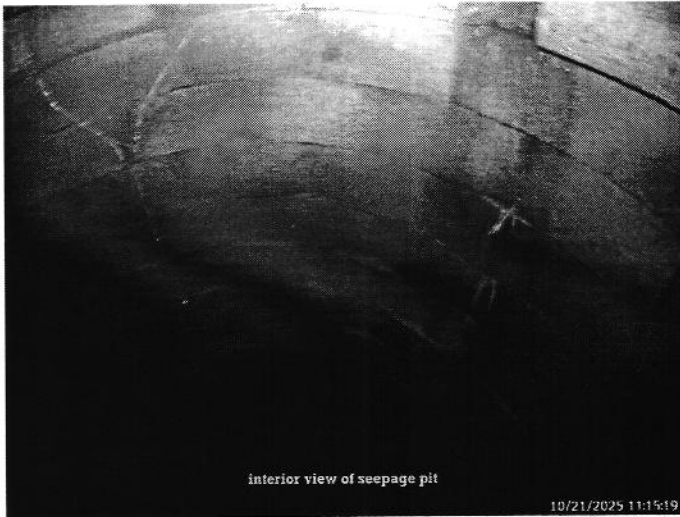
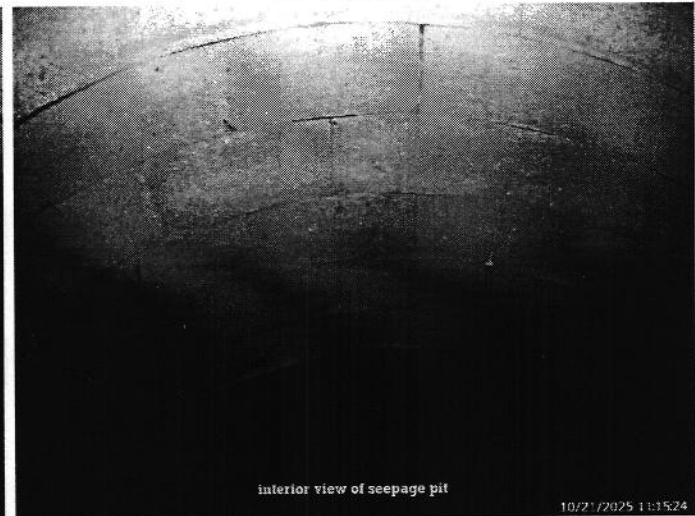
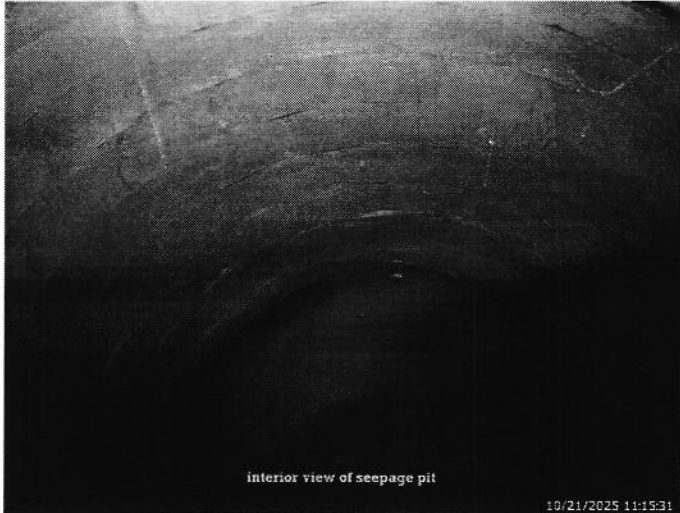
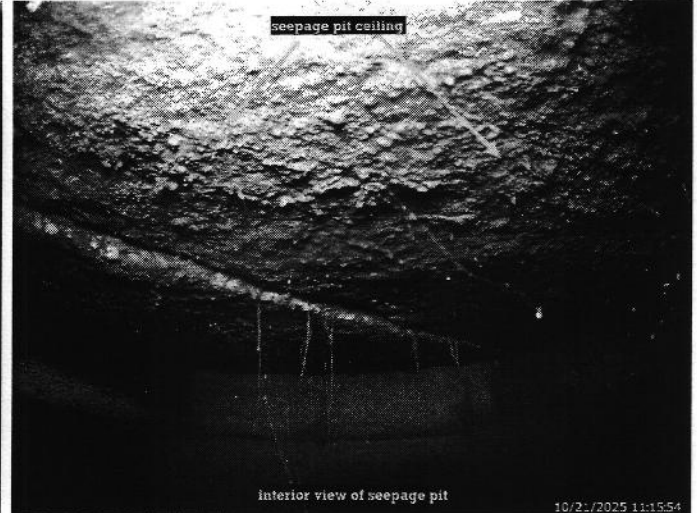
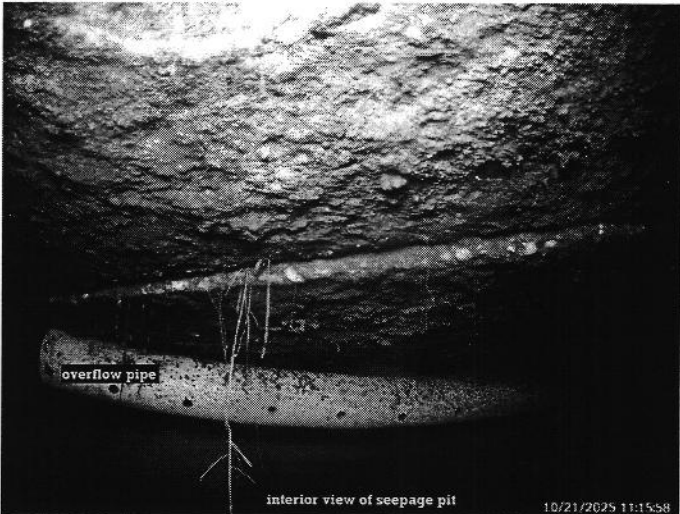
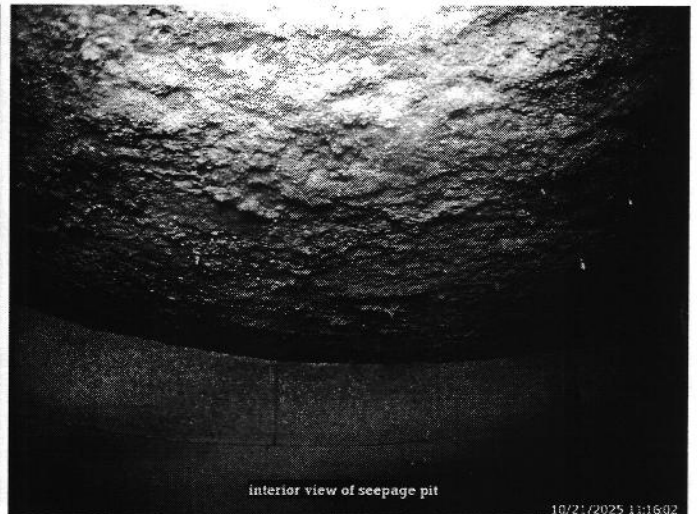
The seepage pit appears to be intact and functioning as intended at the time of the inspection.

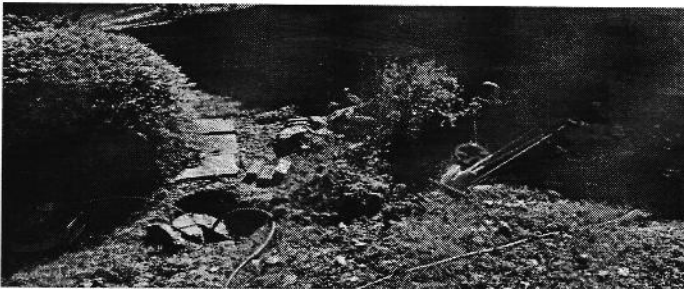
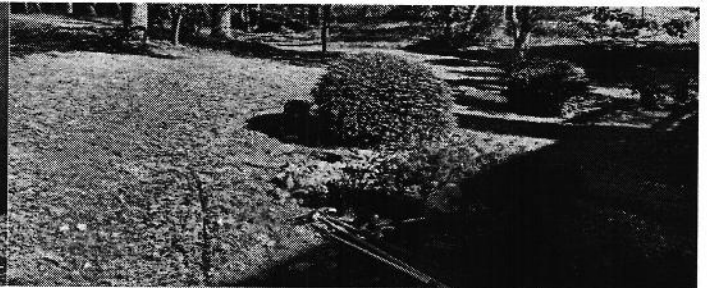
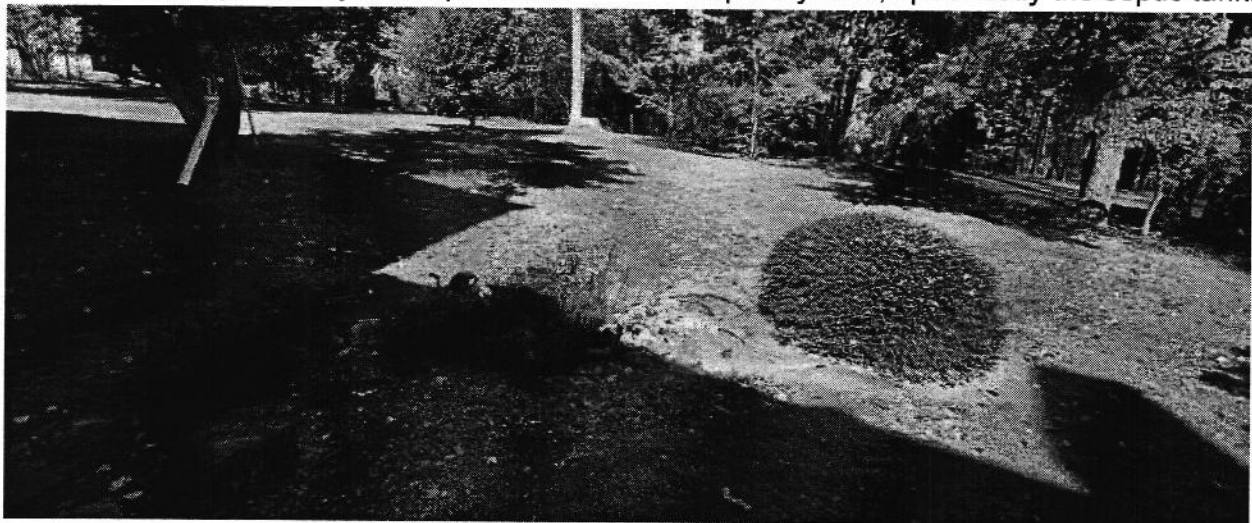
There are several plantings in the vicinity of the septic system, specifically the septic tank.

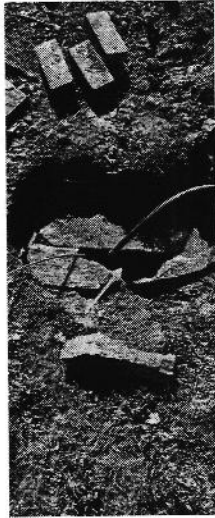
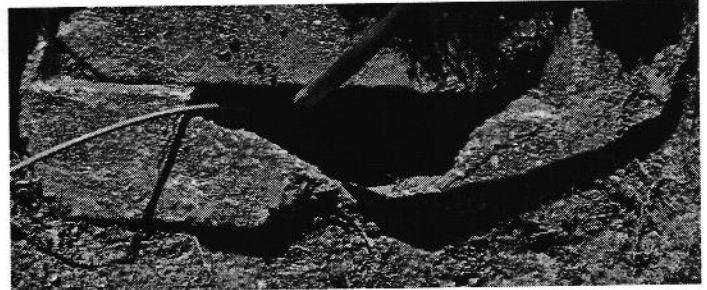
Page 10 Item: 7	Operating condition of septic tank	<ul style="list-style-type: none"> <li>• The septic tank is broken with a hole in the ceiling of the tank along the outlet wall and in the area of the outlet lid. The hole that was produced by the large piece breaking out was covered with bricks when excavating the soil from above the outlet lid. As a result of the size of the broken piece the tank is very susceptible to dirt and debris, as well as outside water, getting into the tank. The Septic tank requires a further evaluation from a licensed septic contractor as soon as possible for repairs or possible replacement.</li> </ul>

The septic tank is broken with a hole in the ceiling of the tank along the outlet wall and in the area of the outlet lid. The hole that was produced by the large piece breaking out was covered with bricks when excavating the soil from above the outlet lid. As a result of the size of the broken piece the tank is very susceptible to dirt and debris, as well as outside water, getting into the tank. The Septic tank requires a further evaluation from a licensed septic contractor as soon as possible for repairs or possible replacement.

4/23/2026 Installer not onsite for inspection. SCHD 40 4" PVC installed 4' from house. Adequate fall to tank. 6" Front & 4" back baffle installed. Saw slot inside tank. SCHD 40 4" PVC installed to drywell. New 6" obs port installed @ drywell OK to Bzafill. GP

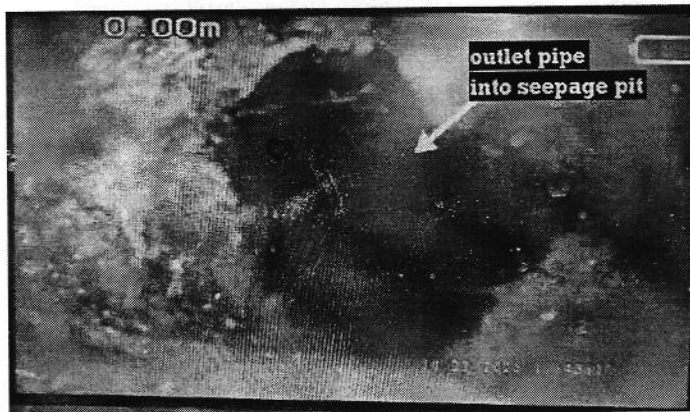
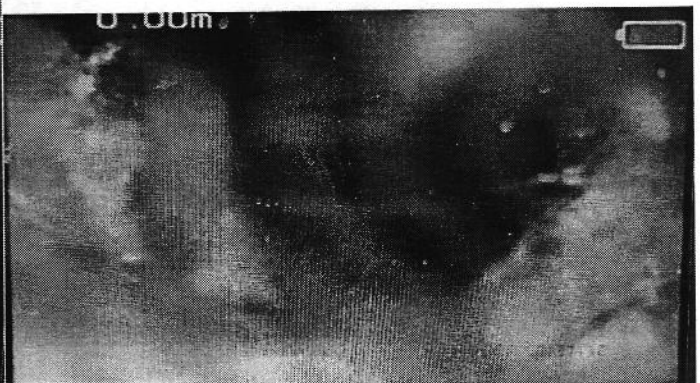
The metal outlet pipe between the septic tank and the seepage pit appears to be intact and functioning as intended at the time of the inspection. The cast iron outlet pipe does appear to have rust building up around the interior of the pipe, which does cause the inner space of the pipe to close in over time. Recommend monitoring the pipe for any possible worsening conditions.
