| SFD/REPAIR & REPLACE SUNROOM FROM TREE AND WATER DAMAGE: TRUSSES, SHEATHING, ROOFING, GAURDRAILS, INSULATION, INTERIOR FINISHES, MECHANICAL, ELECTRICAL AND MISC.**REPAIR PER ENGINEER'S REPORT, SUBJECT TO FIELD INSPECTION** | | |

CHENG RESIDENCE  
TREE IMPACT DAMAGE REPAIR  
14820 VIEW WAY COURT  
GLENELG, MD 21737

## OBSERVATIONS AND FINDINGS

Re: *Insured:* Jeffrey & Bethany Cheng  
*Location:* 14820 View Way Court  
Glenelg, MD 21737  
*Claim:* Tree Impact Damage  
*TEG No.:* T260-009

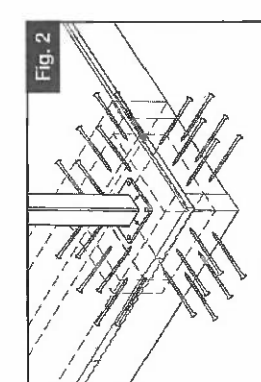
C GUARDRAIL ATTACHMENT DETAIL  
0004  
NOT TO SCALE

\*\* THESE MANUFACTURER SKETCHES ONLY SHOWS 3 LAYERS OF HORIZONTAL BLOOMING - 3 LAYERS SHALL BE PROVIDED.

- GUARDRAIL POSTS SHALL BE INSTALLED PER CODE AND MANUFACTURER REQUIREMENTS.
- INSTALL BLOOMING AT POST LOCATIONS:
  - REAR/BACK ALL POST LOCATIONS, INSTALL THREE (3) HORIZONTAL 2x8 BLOOMS BETWEEN TWO (2) VERTICAL 2x8 BLOOMS (Fig. 1).

- USING AT LEAST THREE (3) #10x31 DECK SCREWS PENETRATING THROUGH THE JOISTS AT LEAST 1" INTO THE BLOOMS (Fig. 2).
  - THE JOISTS MUST BE INSTALLED TO MEET THE REQUIREMENTS WITH SIMPSON LUGGED JOIST HANGERS.

- PREPARE TO ATTACH:
  - RAISE BOTTOM INSERT TEMPORARILY TO ALLOW ROOM TO FASTEN STEEL POST TO DECK (Fig. 3).
  - MARK HOLES THROUGH THE BOTTOM PLATE OF STEEL POST (Fig. 4).

- REMOVE STEEL POST AND DRILL 3/4" HOLE IN ALL FOUR MARKS THROUGH THE DECK BOARD AND BLOOMING.
- ATTACHING POST:
  - PROVIDE 3/4" DIAMETER HOT-DIPPED GALVANIZED (OR STAINLESS STEEL) BOLTS AND NUTS APPROXIMATELY 1" LONGER THAN THE DISTANCE BETWEEN STEEL MOUNTING PLATES (MINIMUM 5").

- PUSH 3/4" BOLTS DOWN THROUGH POST PLATE AND ATTACH NUTS (POST CAN BE LIVELoad AS NEEDED BY USING VINYL SHIMS) (Fig. 4).
- FINISHING:
  - RETURN BOTTOM INSERT TO ORIGINAL POSITION.

- SLIDE VINYL POST-JACKET OVER POST INSERT.
  - SLIDE SECOND POST INSERT INTO TIP OF VINYL POST-JACKET.
  - INSTALL BASE TRIM AROUND POST-JACKET AT DECK SURFACE BEFORE INSTALLING RAILING.

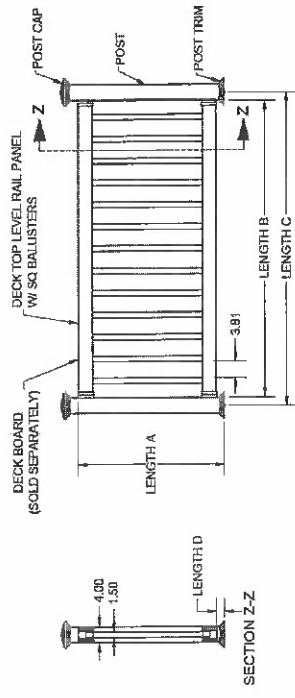
B GUARDRAIL DETAIL  
0004  
NOT TO SCALE

NOTE: (A) FINISHED RAIL HEIGHT (TOP OF RAIL TO FLOOR) = 38" - 42" (B) PANEL LENGTH = 47.75" - 59.75" - 71.75" - 85.75" - 119.75" (C) MAX SPANS = 120X36" IRC, 98X42" IBC (D) BOTTOM SPACE = 2"

1. INSTALL GUARDRAIL PER CODE AND MANUFACTURER'S REQUIREMENTS

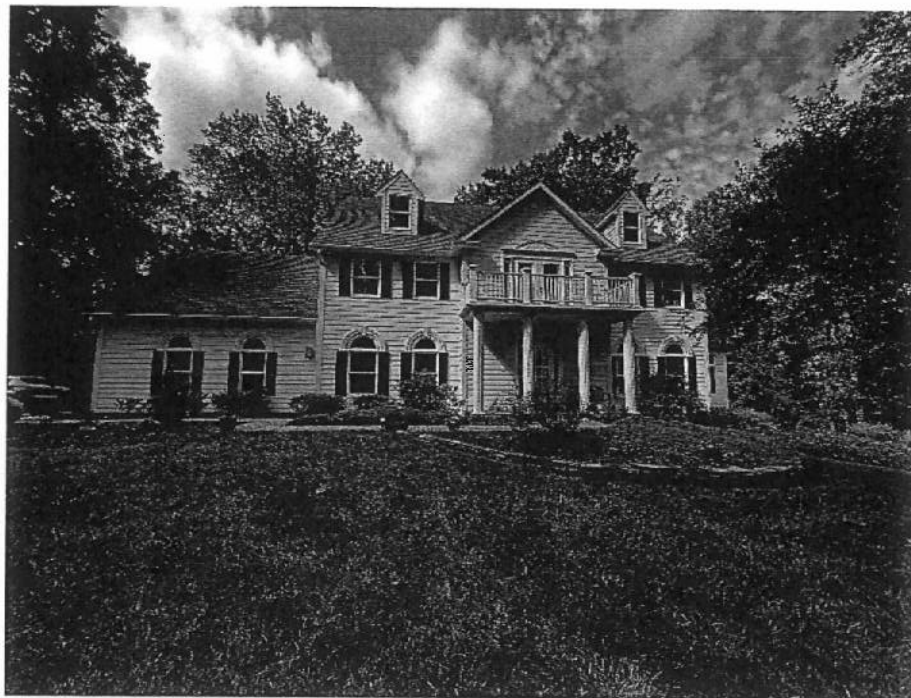
**Photograph 1 - Front elevation of residence.**

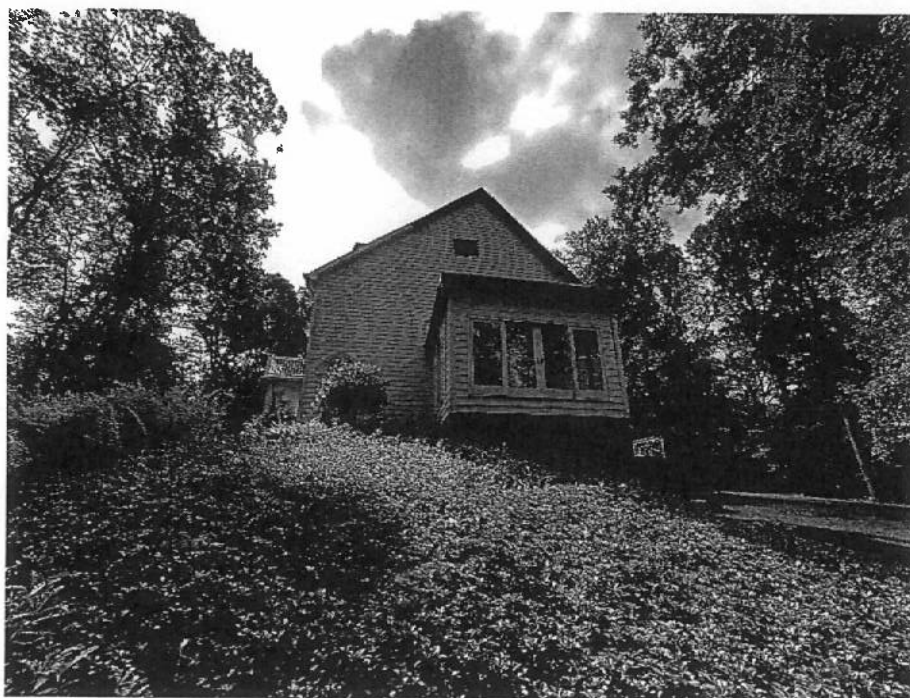
**Photograph 2 - Right-side elevation of residence.**

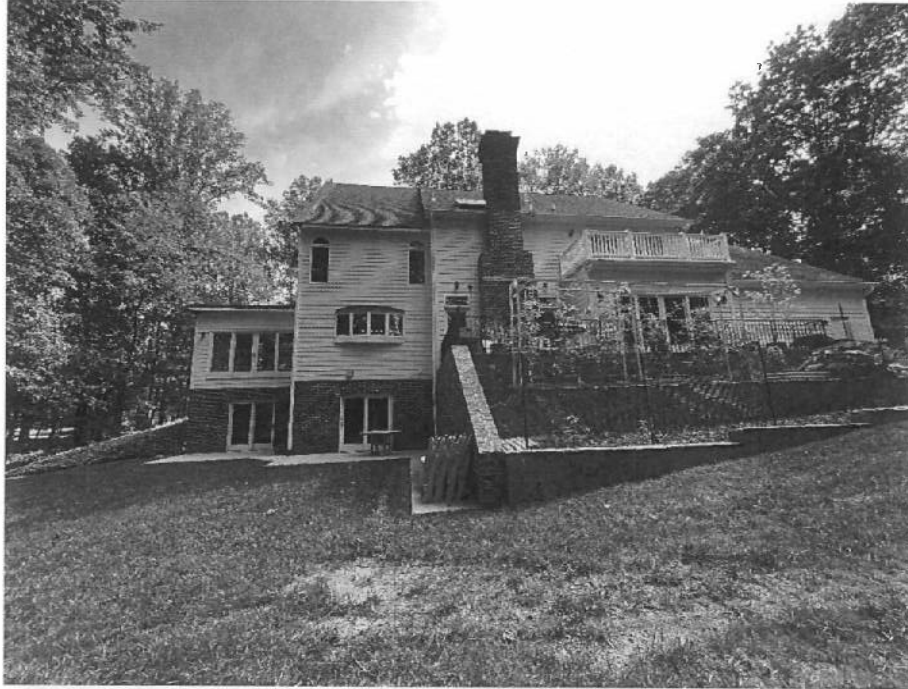
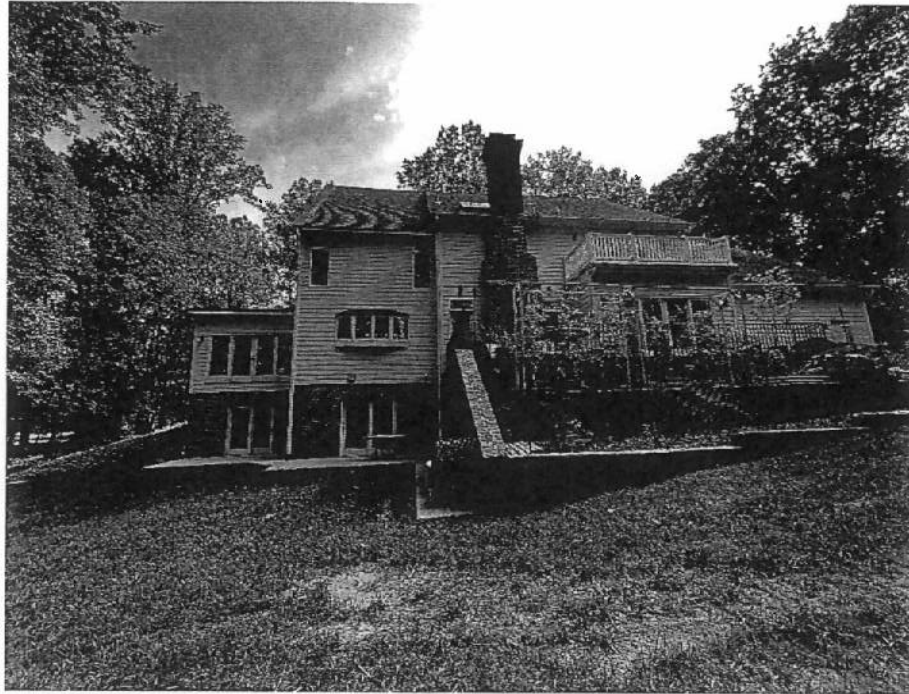
Prior to our inspection, a tree struck the sunroom and right-side gable end wall of the residence. The tree impact resulted in structural and cosmetic damage to the sunroom and residence. *See Photographs 1 to 4.*

**Photograph 3 - Rear elevation of residence.**

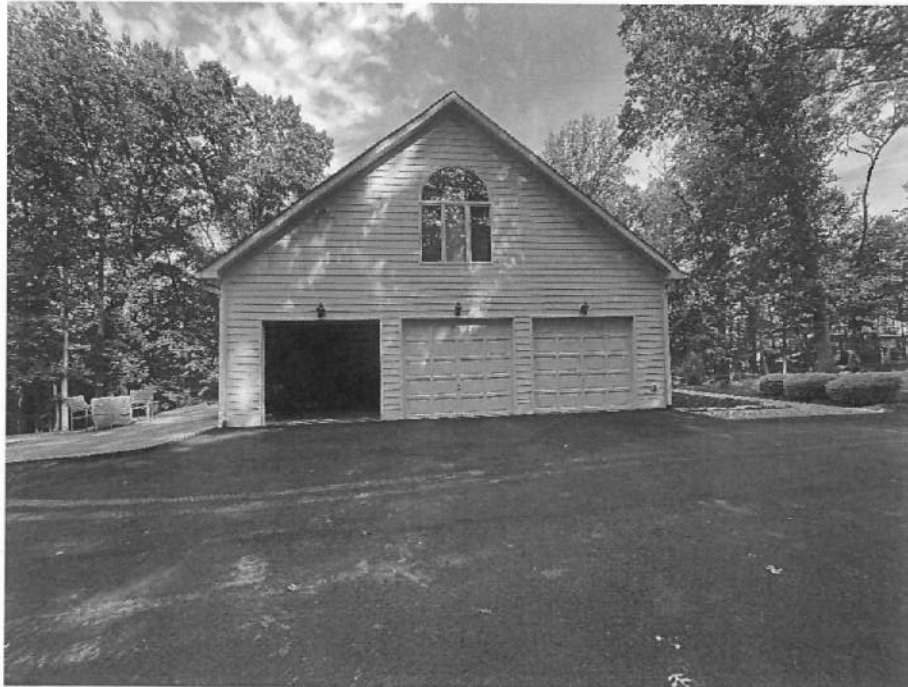
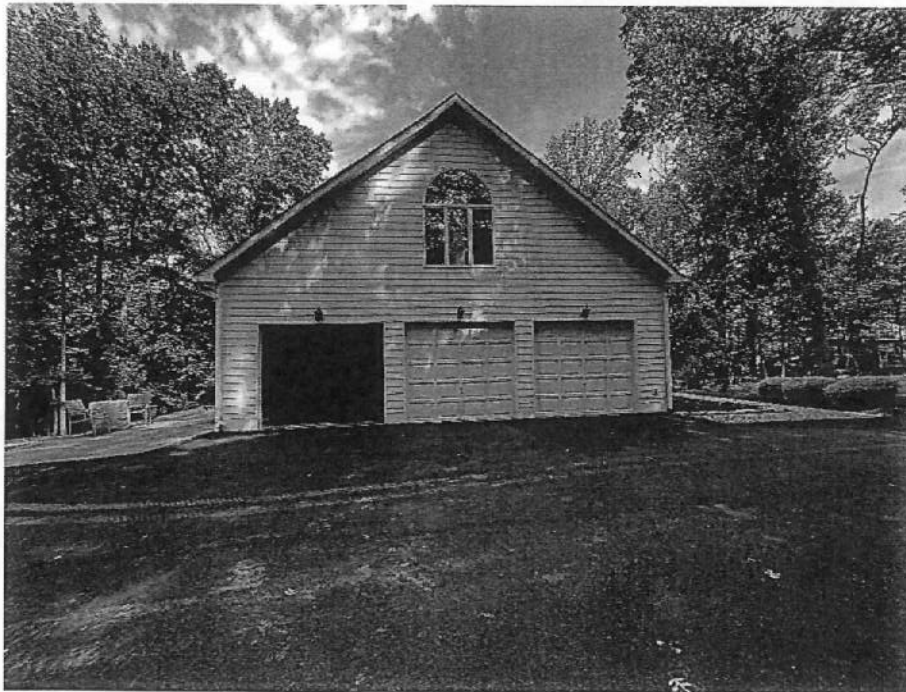
**Photograph 4 - Left-side elevation of residence.**

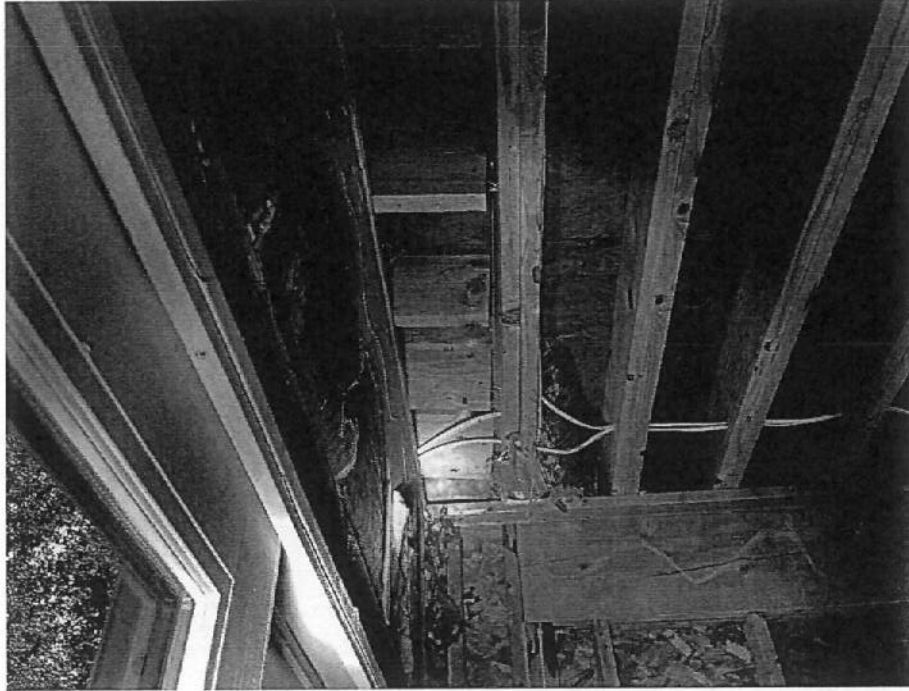
2. The plywood roof sheathing and low-slope membrane was damaged above the damaged sunroom roof rafter.
3. Several 2x8 outriggers along the outermost damaged sunroom roof rafter were dislodged and are no longer attached to the roof rafter. *See Photograph 7.*

**Photograph 7 - Detached 2x8 outriggers adjacent to damaged 2-ply 2x8 roof rafter.**

9. Provide replacement 2-ply 2x8 rafters for sunroom roof. Attach 2x8 outriggers to roof rafter with Simpson A34 framing angles at each side.
10. Provide replacement plywood roof sheathing at damaged areas of sunroom roof. The plywood roof sheathing shall match existing thickness (minimum 24/16 APA rated plywood roof sheathing with clips).

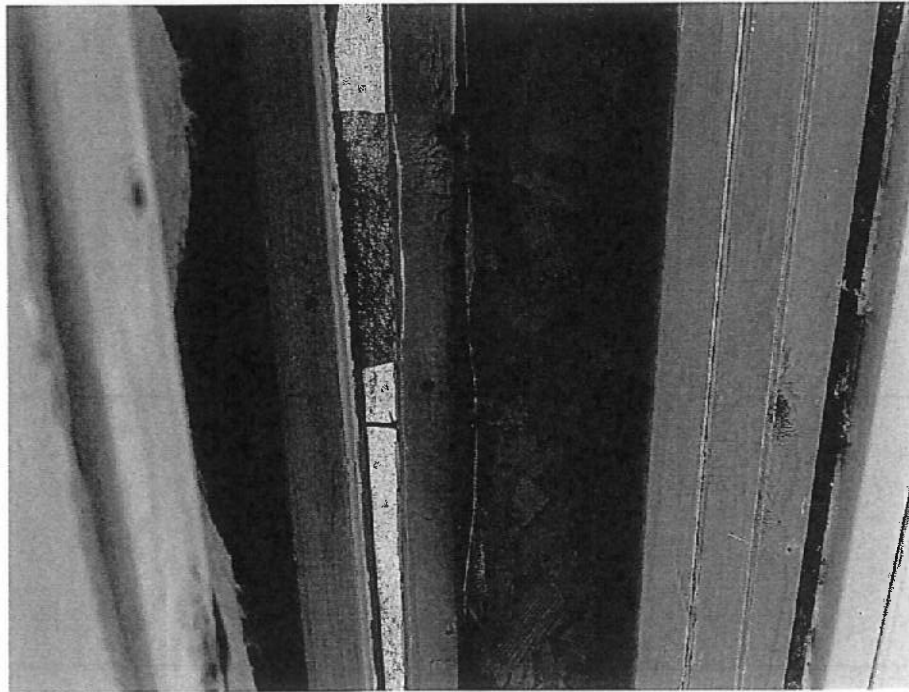
4. The rear and right-side walls of the sunroom were found to be out of plumb when measured from the rear-right sunroom corner. *See Photograph 8.*
5. The insured reported that water leakage started occurring at the left-side door/window of the sunroom after the tree impact.

**Photograph 8 - Dislodged and out of plumb right-side wall of sunroom.**

7. Remove damaged portions of plywood roof sheathing at sunroom roof.
8. Bring rear and right-side sunroom walls to plumb. Remove and reset door/window units within these walls. Address water leakage at the left-side door window.

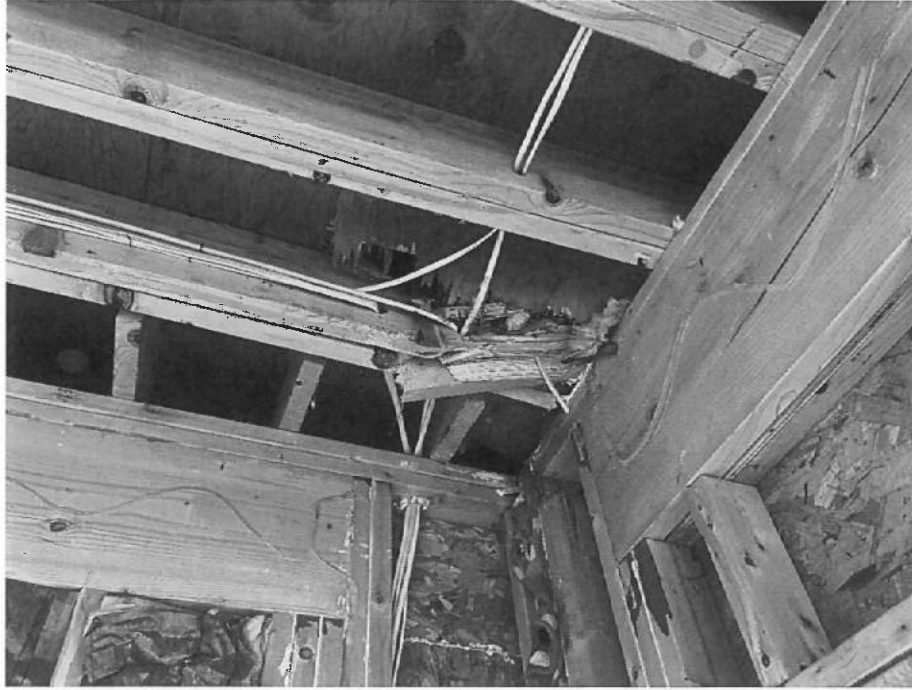
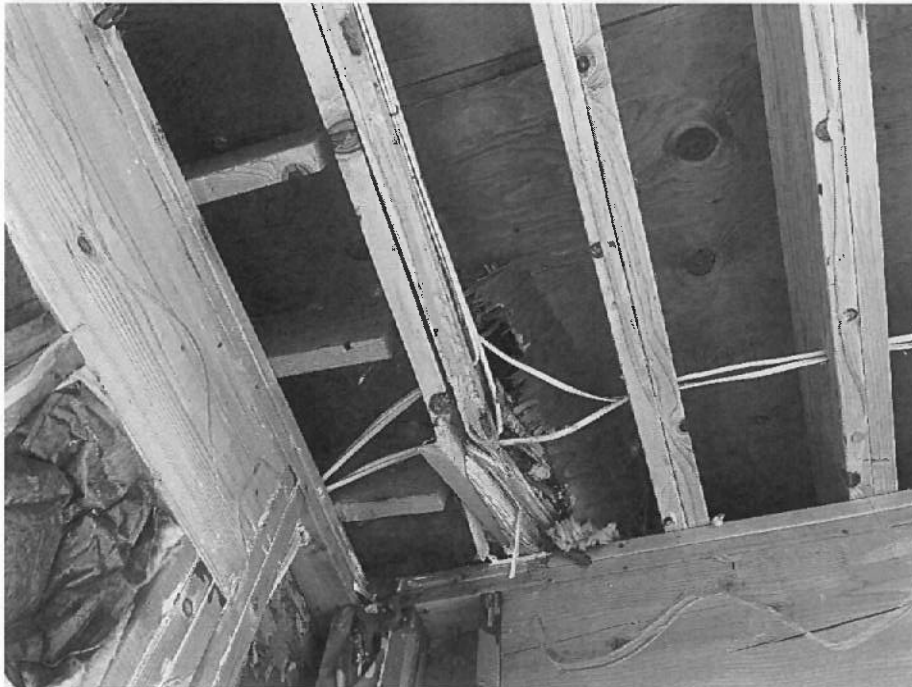
1. Two (2) 2-ply 2x8 roof rafters for the sunroom were damaged by the tree impact. These are the first two rafters at the rear side of the sunroom. Damage consists of splitting and fracturing. *See Photographs 5 & 6.*

**Photograph 5 - Damaged 2-ply 2x8 roof rafter and plywood roof sheathing for sunroom.**

**Photograph 6 - Damaged 2-ply 2x8 roof rafter and plywood roof sheathing for sunroom.**

5. Remove low slope roof membrane at sunroom roof.
6. Remove damaged 2-ply 2x8 sunroom roof rafters. Removal of 2x8 outriggers at rear face of rafter may be required to facilitate removal of roof rafter.

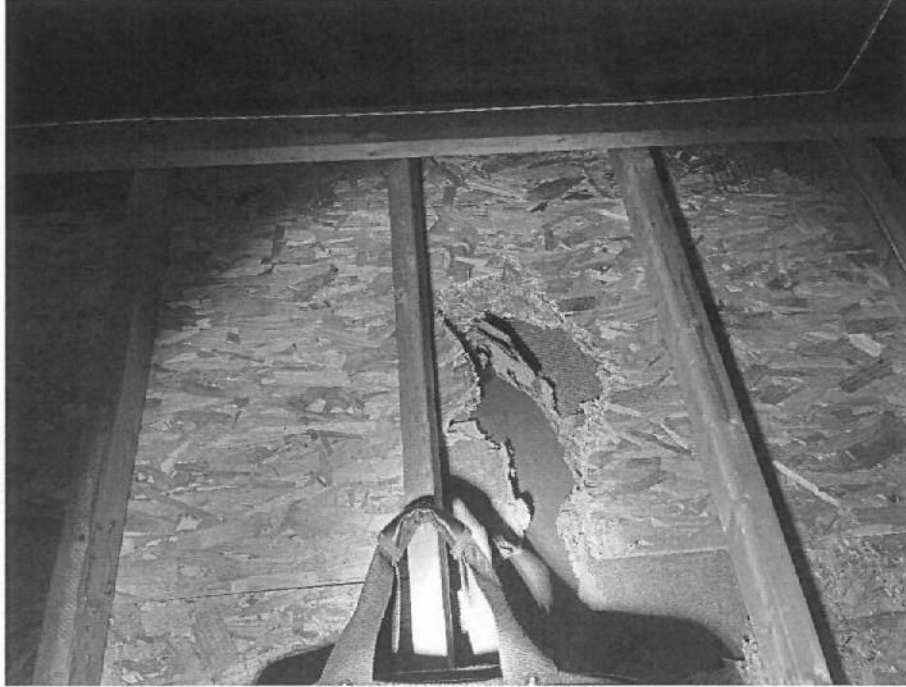
7. A portion of OSB sheathing for the right-side gable end wall of the main structure was damaged by the tree impact. *See Photograph 9.*
8. There is no evidence of damage to the residence roof framing or sunroom floor framing.

**Photograph 9 - Damaged portion of OSB wall sheathing at right-side gable end wall of residence roof.**

2. Obtain all necessary permits prior to starting work.
3. Provide temporary shoring as necessary.
4. Remove damaged portions of OSB plywood wall sheathing for residence right-side gable end wall. Provide 24/0 APA rated OSB wall sheathing for repair areas.
