PERMIT

SEWAGE DISPOSAL SYSTEM

A REPAIR

SUBDIVISION _____ LOT _____ ROAD 9722 Whiskey Bottom Road

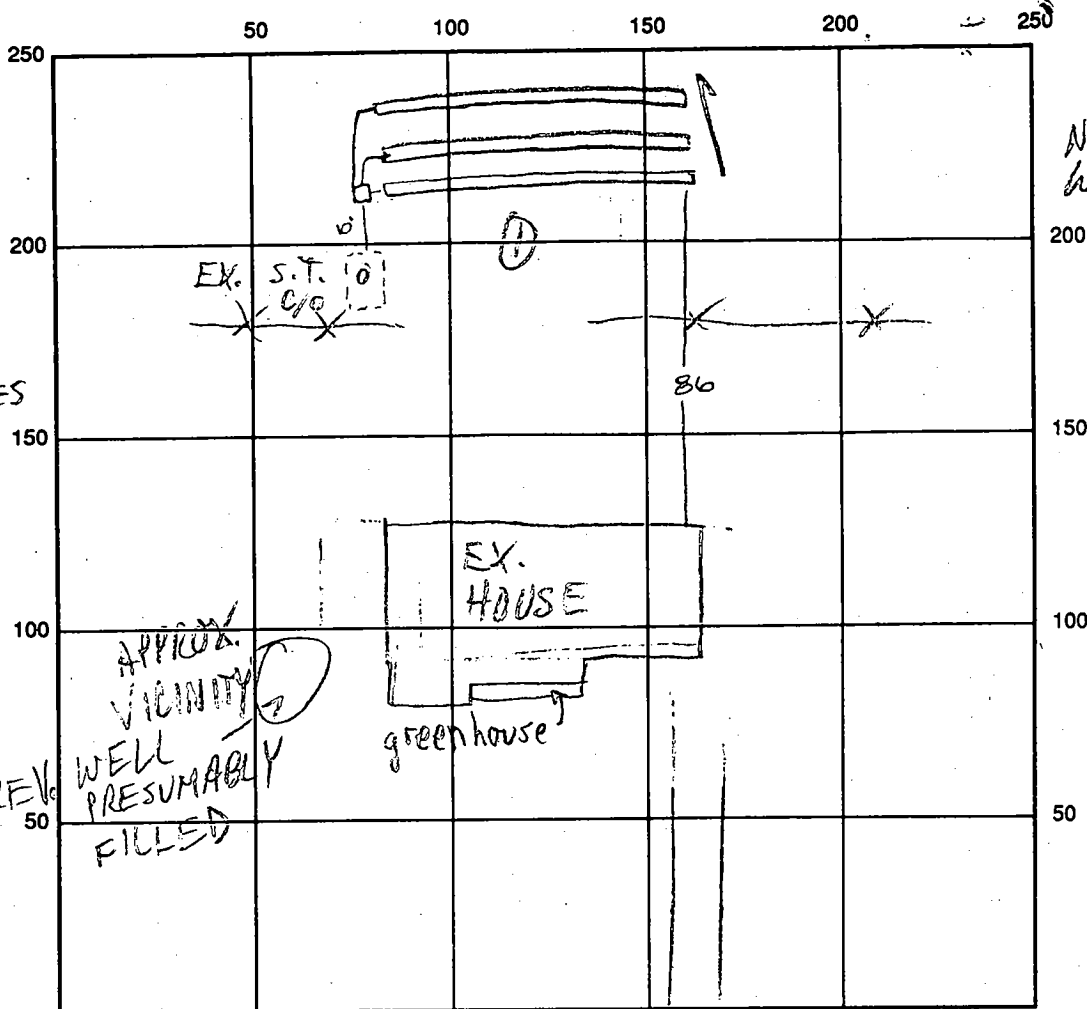
REPAIR - SEPTIC SYSTEM HAS FAILED.

DIGGING
STOPPED
DUE TO
COLLAPSE
HAZARD

APPROX.
VICINITY
PREV. WELL
PRESUMABLY
FILLED

NO
WELLS
ON
ADJ.
PROP

REMARKS: 11/17/97 TEST HOLE OK; OK TO START MR 11/19/97 OK
to cover all work final ALM

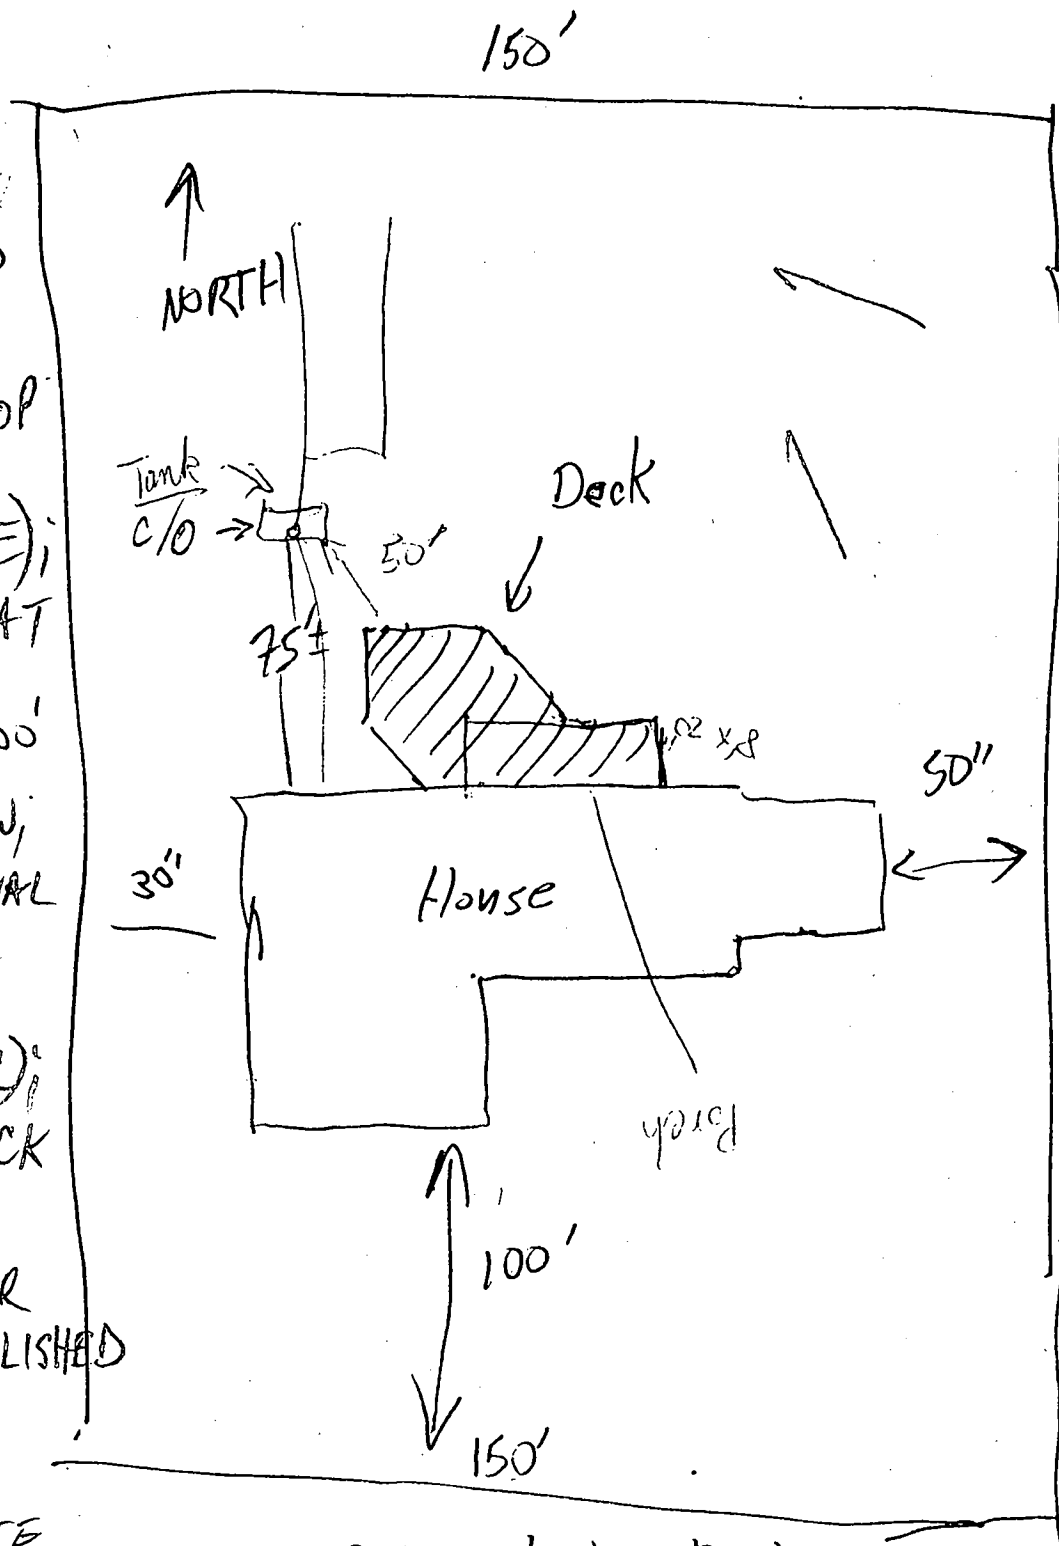
9722 Whiskey Bottom Rd
Laurel, MD 20723

10/30/97 (MR)

C/O LOCATED
AS SHOWN;
SEWAGE @ TOP
OF C/O (~4"
BELOW GRADE);
POSSIBLE THAT
DESIGNATED
"S.T." IS 300'
ACTUALLY D/W;
NO BP APPROVAL
W/O REPAIR
(PUB. SEWER
NOT AVAIL);
DECK SETBACK
LIKELY OK
ONCE REPAIR
AREA ESTABLISHED

11/19/97 SEPTIC
REPAIR
COMPLETE
