March 24, 2004

Re: Propane Tank Permit #00146794
14865 Triadelphia Road

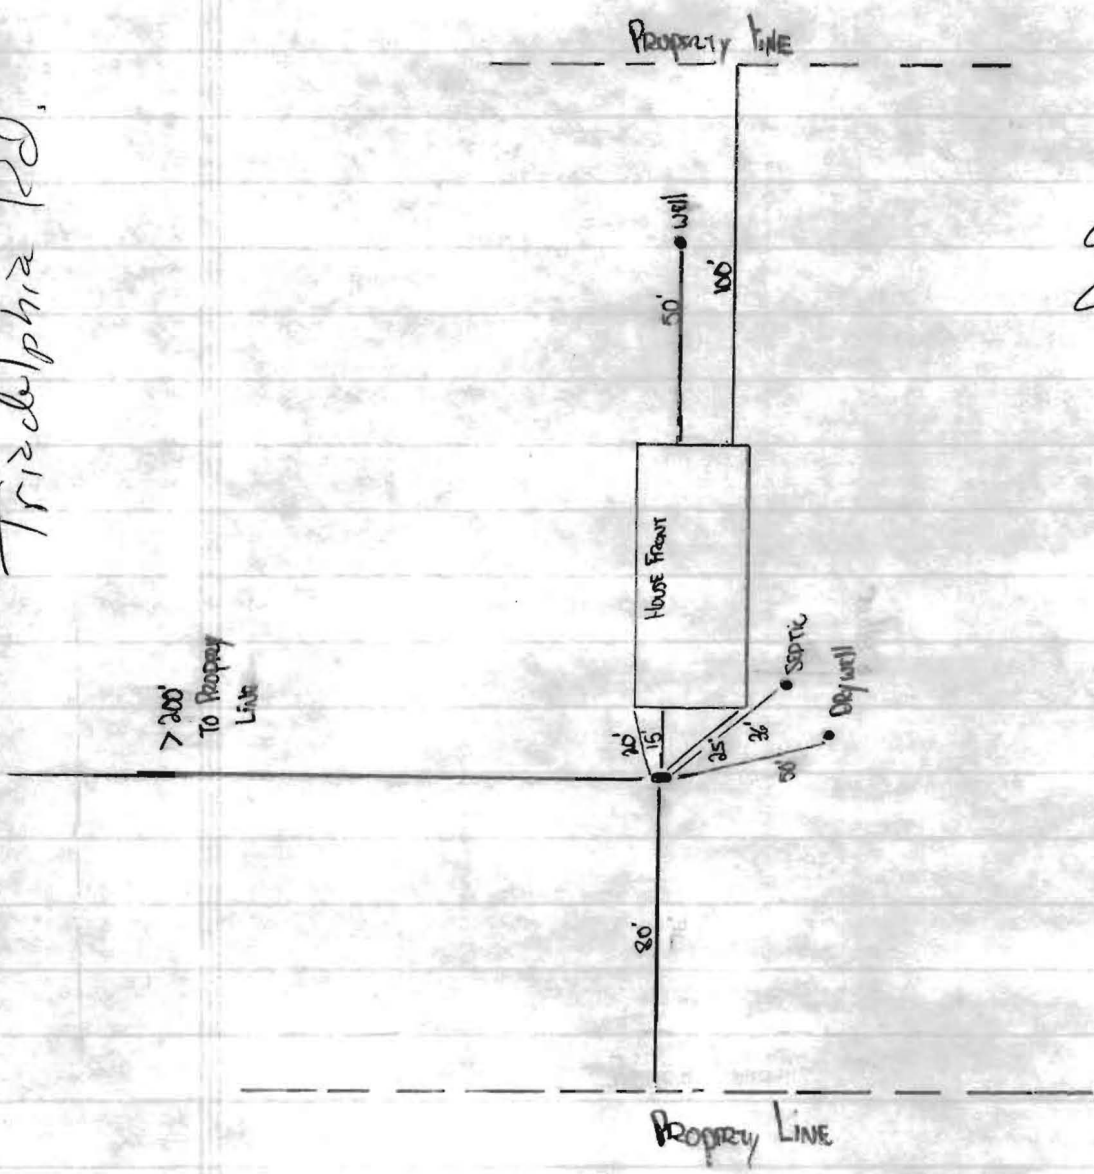
Tridulphia RD.

3/23/04 Two wells exist on property
Spoke w/ the Mrs. - said 1st well
collapsed so called J Mayne - using
that well.

Dry well appears @ inlet level
& S.T. full - around s.t. c/o
is overflow evidence w/ high
grass & water overflow - recommend
repair if not at least s.t. pumped.
Wore Ho Co. Badge - Mrs. Spoke to
me through door about well
issue

3/29/04 Site visit to perform dye test. Observed
effluent level in tank to be at operating
level and no evidence of overflow. Observed
effluent level in drywell and saw no evidence
of overflow. Put dye in bathroom on ground
level. Mentioned that well second well needs
to be abandoned by a licensed Mr. Grant well
driller. Mr. Grant acknowledged that he
would look into this. JAB

3/31/04 Site visit to verify dye test results. No
overflow observed. Permit for L.P. tank
also signed off on this day. JAB
