SITE INSPECTION SHEET

OWNER: _____ PHONE #: 410-530-4622
ADDRESS: 4910 Canvasback Dr. CONTRACTOR: Mike Stack
WELL TAG #: _____
SUBDIVISION: _____ LOT: _____ COUNTY #: _____
PROPOSAL: _____

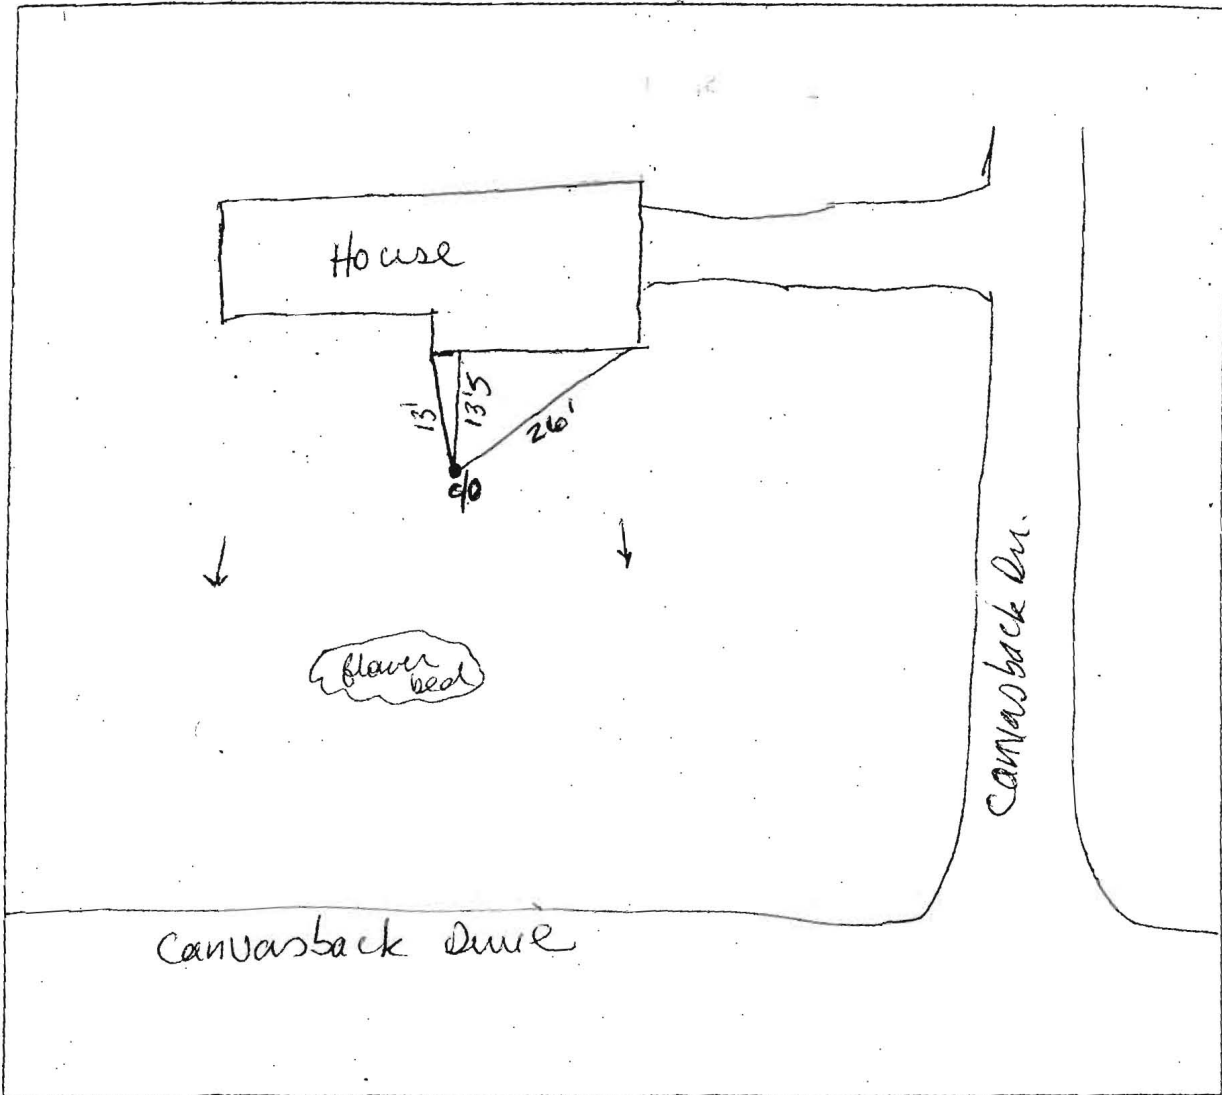
LOCATION DIAGRAM

COMMENTS: Inlet was 22" below grade, Effluent levels were
~1'5"-2' below top of tank. No evidence of parking
system.
