## INFORMATION FORM – SEPTIC SYSTEM REPAIR/UPGRADE

Property Address: 2445 THOMPSON DRIVE County file: 286606

<b>Date:</b> February 15, 2021 <b>Name of Evaluator:</b> Nicholas Riehl <b>Time:</b> 9:00 AM <b>Property Address:</b> 2445 Thompson Drive Marriottsville, MD 21104 <b>Recent Weather Conditions:</b> Normal		<b>Ordered By:</b> Jeff Berman  <b>Buyers:</b> Jayre Reaves  <b>Homeowner Interview:</b> The homeowner interview was sent and was received prior to the evaluation.		<b>Occupied:</b> <input type="checkbox"/> Yes <input checked="" type="checkbox"/> No <b>Length of Time Vacant:</b> 3 Months <b># of People Living in Home:</b> N/A <b># of People moving in:</b> Unknown <b>Property Age:</b> 1950 <b>System Age:</b> Unknown <b>Last Date of Cleaning:</b> 9/2020 <b>Recomm'd Pumping Freq:</b> 2-3 Years	
<b>Liquid level in tank is:</b> <input checked="" type="checkbox"/> Above Normal <input type="checkbox"/> Normal <input type="checkbox"/> Below Normal			<b>Bottom Solids Depth:</b> 10 Inches		
<b>Depth of tank:</b> 20 Inches		<b>Type of Tank Access:</b> Cleanout		<b>Depth of tank access:</b> At Grade

# SITE INSPECTION SHEET

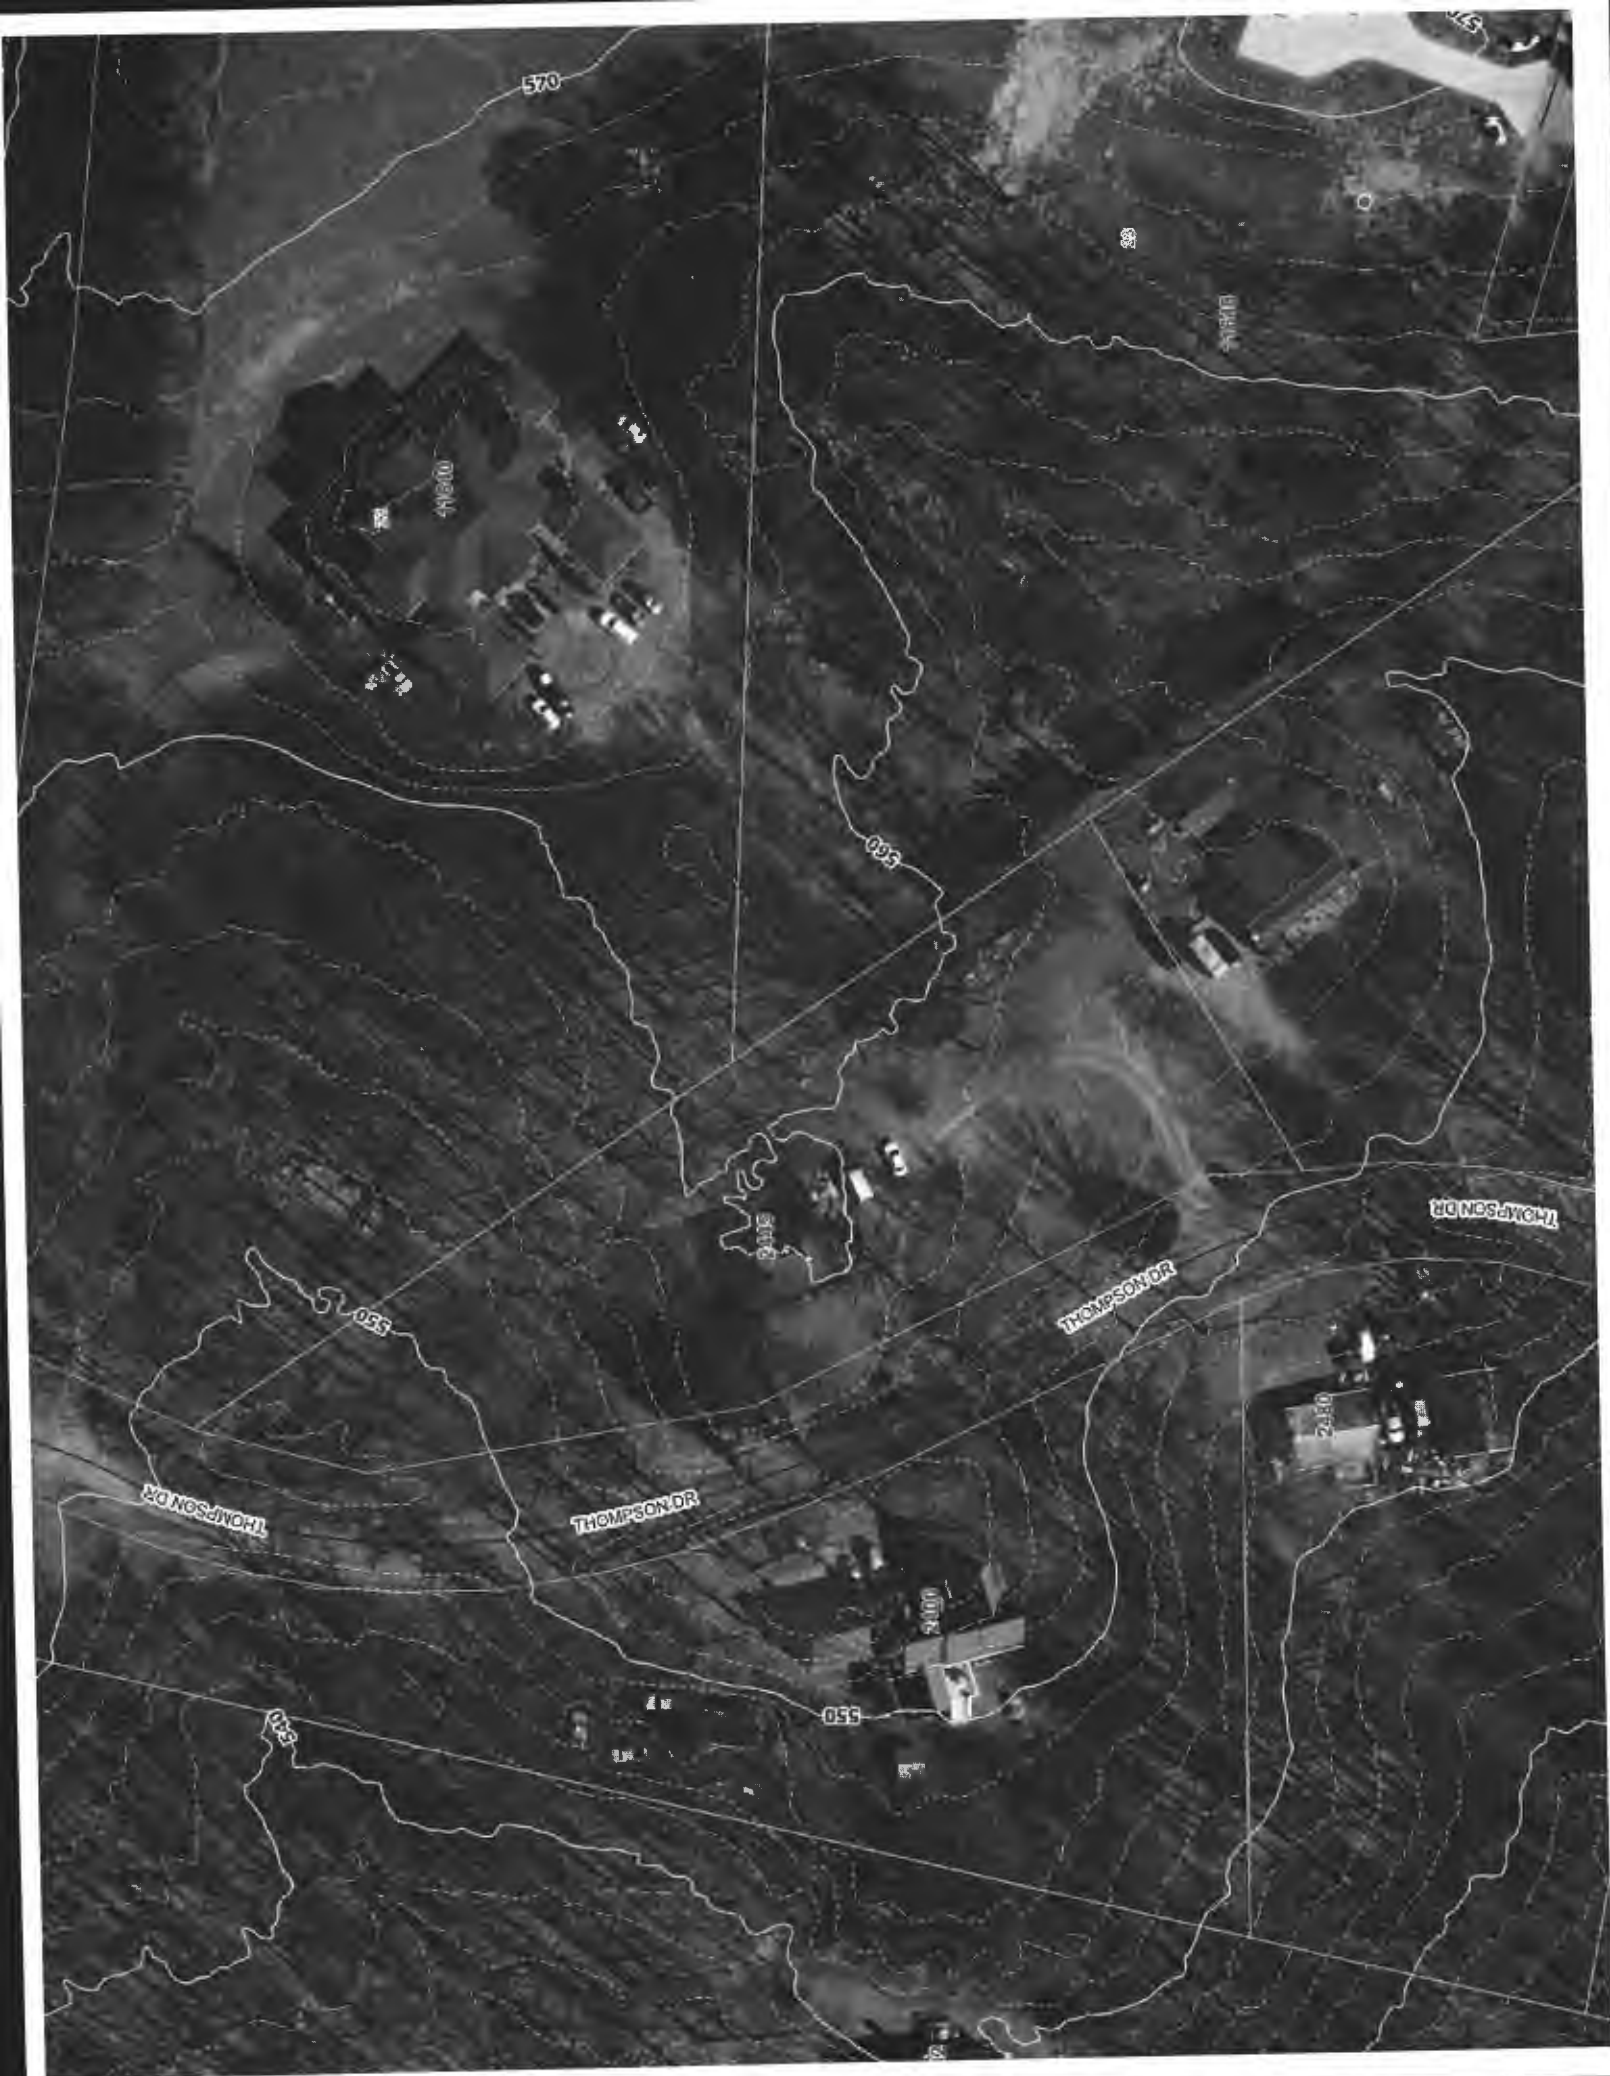
4/6/21 Install 1 x 62' trench running on contour running towards road. Ex. Drywell pumped and collapsed. (1x man)

INSTALLATION: 4/8/21 - contractor on-site, old tank & drywell pumped crushed & filled in w/ clean dirt & stone, new tank in place & mostly covered, d box installed & one trench @ 62', stone looks good, geotextile fabric in place, ok to backfill & continue (20)

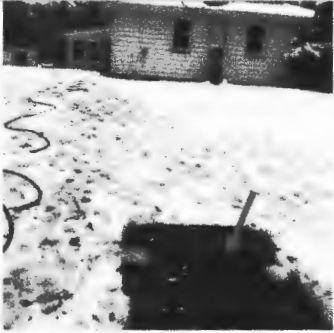
**Picture 1:**

This shows the septic tank in relation to the house.

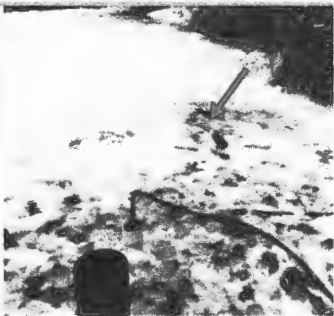
**Picture 4:**

<b>Absorption System</b>		<input type="checkbox"/> Acceptable <input type="checkbox"/> Unacceptable <input checked="" type="checkbox"/> Needs Further Evaluation		One drywell was located during the evaluation. There is no apparent access to the drywell at grade. The drywell has 4 feet of total liquid depth with 1.5 feet of liquid depth remaining. Approximately 300 gallons of water were introduced into the system with no signs of a back-up. The county will need to re-evaluate the absorption system at the time the septic tank is replaced to confirm that it is adequately sized.

This shows the drywell in relation to the septic tank.

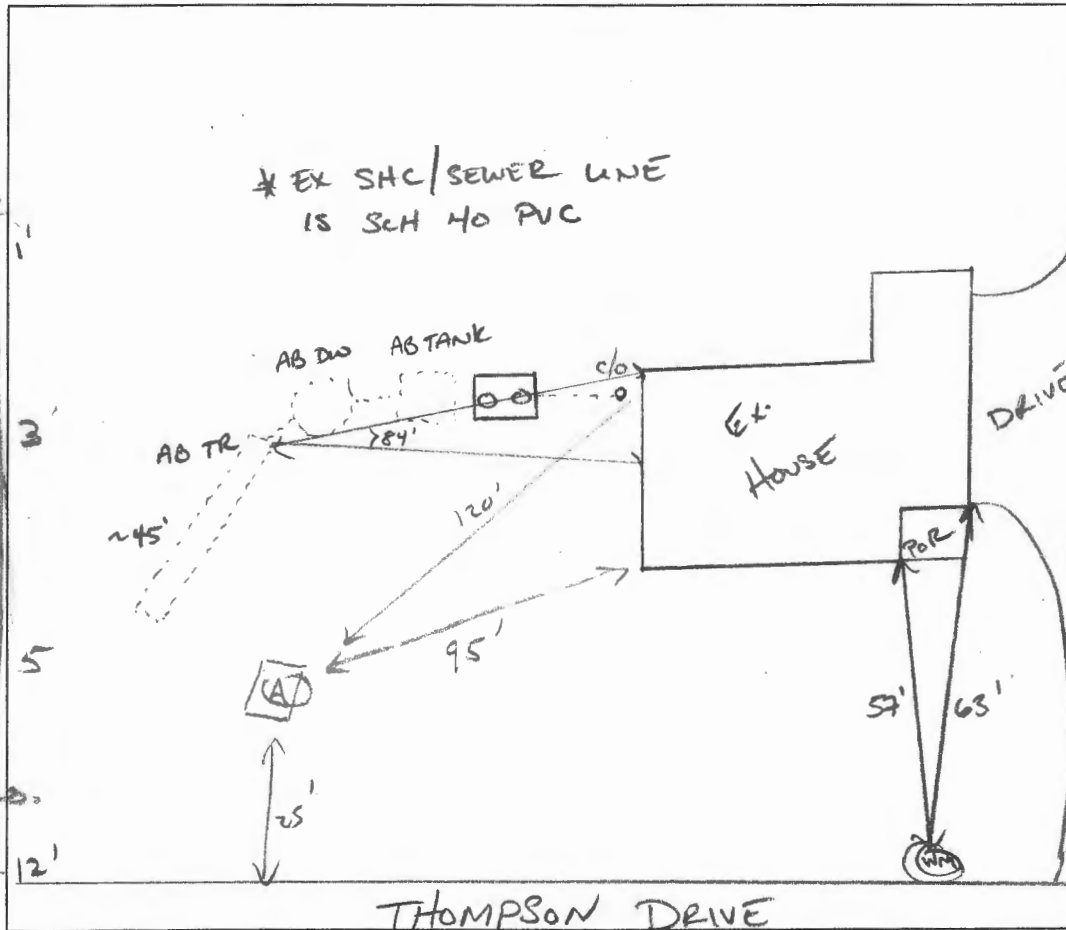
## LOCATION DIAGRAM

COMMENTS: PUMPED AND COLLAPSED CINDERBLOCK TANK AND  
DRY WELL. A TRENCH WAS DISCOVERED, COMPLETELY FULL OF  
BIOMAT/SOLIDS AND SLUDGE ~1' ABOVE TERRA COTTA PERF PIPE  
INVERT W/STANDING WATER IN AGGREGATE.
