ONSITE SEWAGE DISPOSAL SYSTEM

MINOR REPAIR

PROPERTY ADDRESS: 15913 Willis Way

Camera Septic Inspection

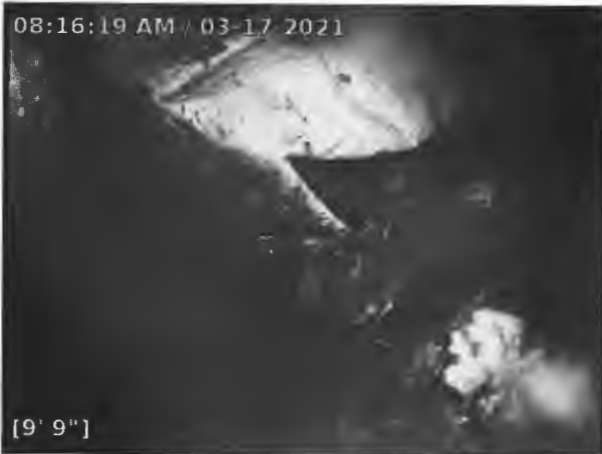
10 ft

3/17/2021 8:16:19 AM
Crushed portion of drainfield A.

INSTALLATION: 4/20/21 Contractor uncovered d-box and found it to be clear. Also uncovered the beginning of the first and second trench and found clear stone. Added pipe on top of perforated section that had been crushed in first trench, about 8' in. Observed pump tank, saw two floats. Alarm box is in riser. (SD)

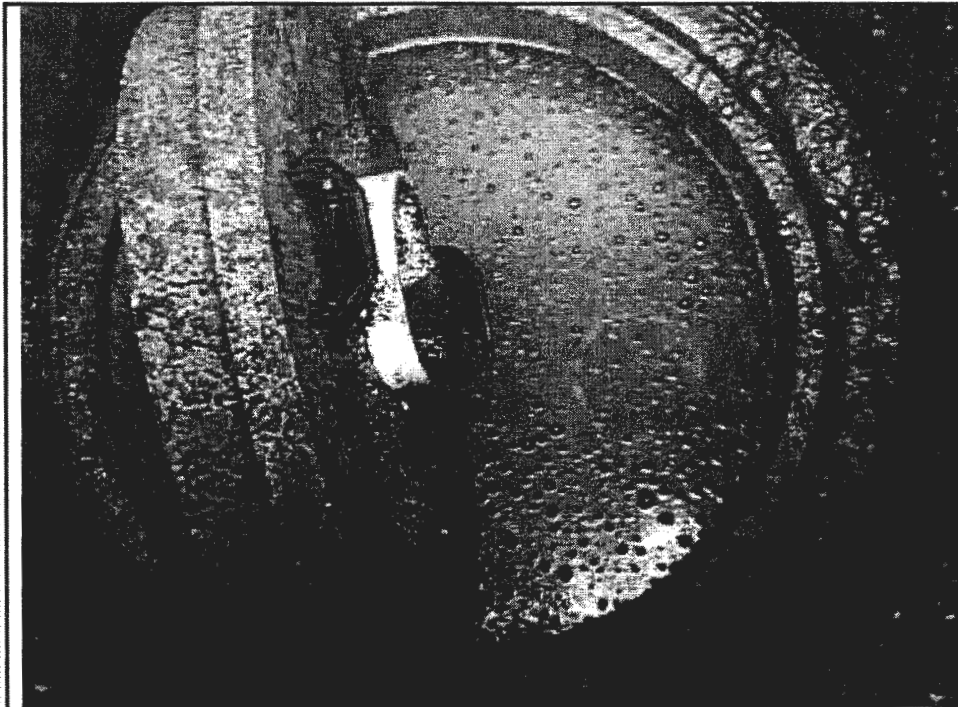
Picture 1:

System Component		Condition		Comments	
Septic Tank		<input checked="" type="checkbox"/> Acceptable <input type="checkbox"/> Unacceptable <input type="checkbox"/> Needs Further Evaluation		A camera was used during this inspection (See camera inspection). The two chambered septic tank is composed of concrete and is 1,500 gallons in capacity. Access is two manhole risers at grade; the septic tank is 39 inches below grade. Upon arrival the liquid level of the tank was above the normal operating level (See Page 2; Picture 1). Upon removing the effluent filter the liquid level of the tank dropped to the normal operating level. The effluent filter was clogged with debris, preventing the passage of effluent to the pump chamber. The front, center, and back baffles are in place and composed of PVC, PVC, and an effluent filter, respectively. The effluent filter was cleaned during this inspection. The effluent filter should be cleaned every 6 months hereafter. There are 10 inches of solids in the front chamber and 12 inches of solids in the back chamber of the tank indicating fair maintenance. The septic tank should be pumped in 6 months, then every 2-3 years thereafter.

Picture shows the above normal liquid level of the tank upon arrival. The back baffle is completely submerged.

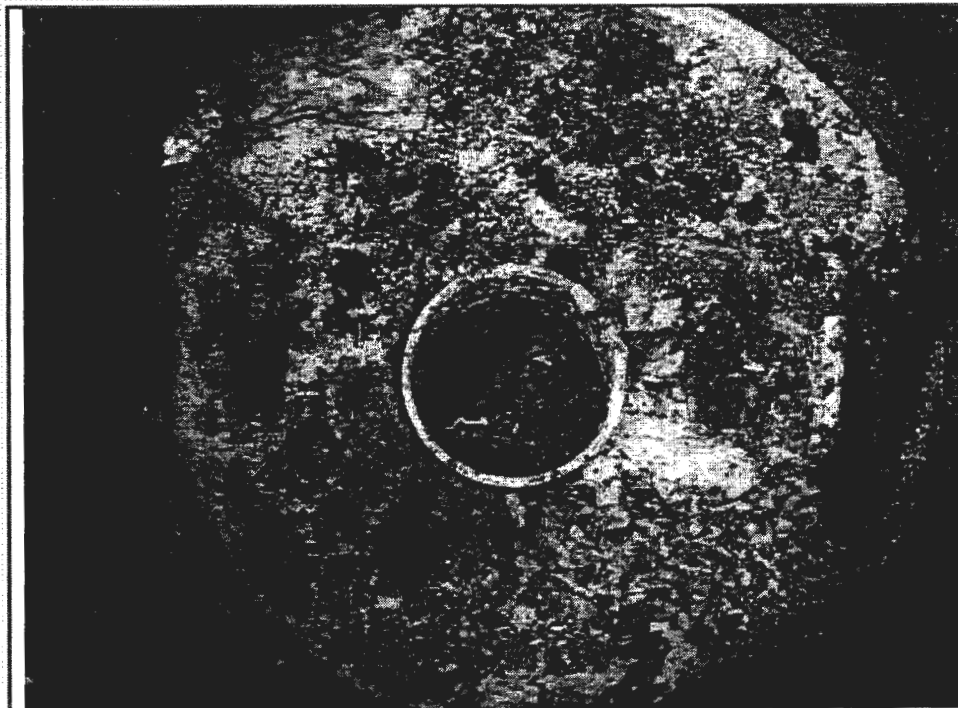
Picture 2:

Picture shows solids on top of the manhole cover of the front chamber of the tank which is evidence of previous backups.

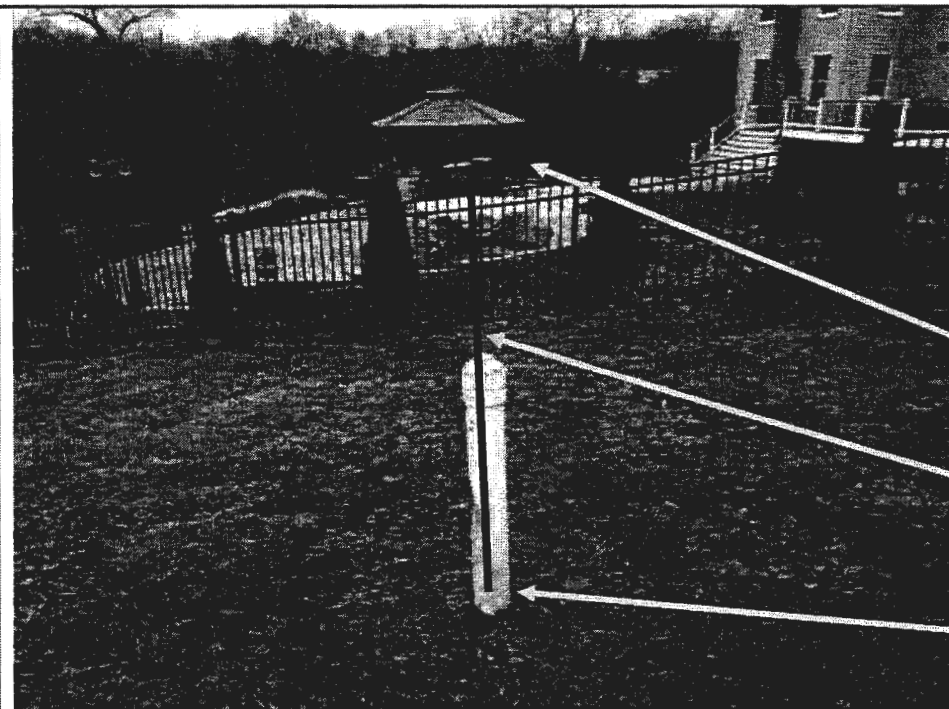
Picture 4:

Pump Present? <input checked="" type="checkbox"/> Yes <input type="checkbox"/> No		<input type="checkbox"/> Acceptable <input checked="" type="checkbox"/> Unacceptable		The pump chamber is composed of concrete and is ~1,000 gallons in capacity. Access is a 6 inch cleanout and manhole riser at grade. The pump cycled normally and was found to be functioning properly. The high water alarm panel could not be located. The high water alarm float was manually cycled in the pump chamber with no alarm heard during this time indicating that the alarm is not functioning properly or is set to silent. The location of the high water alarm panel needs to be verified to determine if remediations are needed. There appears to be a stone patio associated with the pool area over the pressurized pipe connecting the pump chamber to the distribution box (See Page 3; Picture 4). The stone patio would most likely need to be removed to facilitate any remediations to the pressurized pipe.

Picture shows the perceived location of the pressurized pipe in relation to the distribution box and patio.
