Bureau of Environmental Health

July 11, 2016

RE: Compromised replacement sand mound area

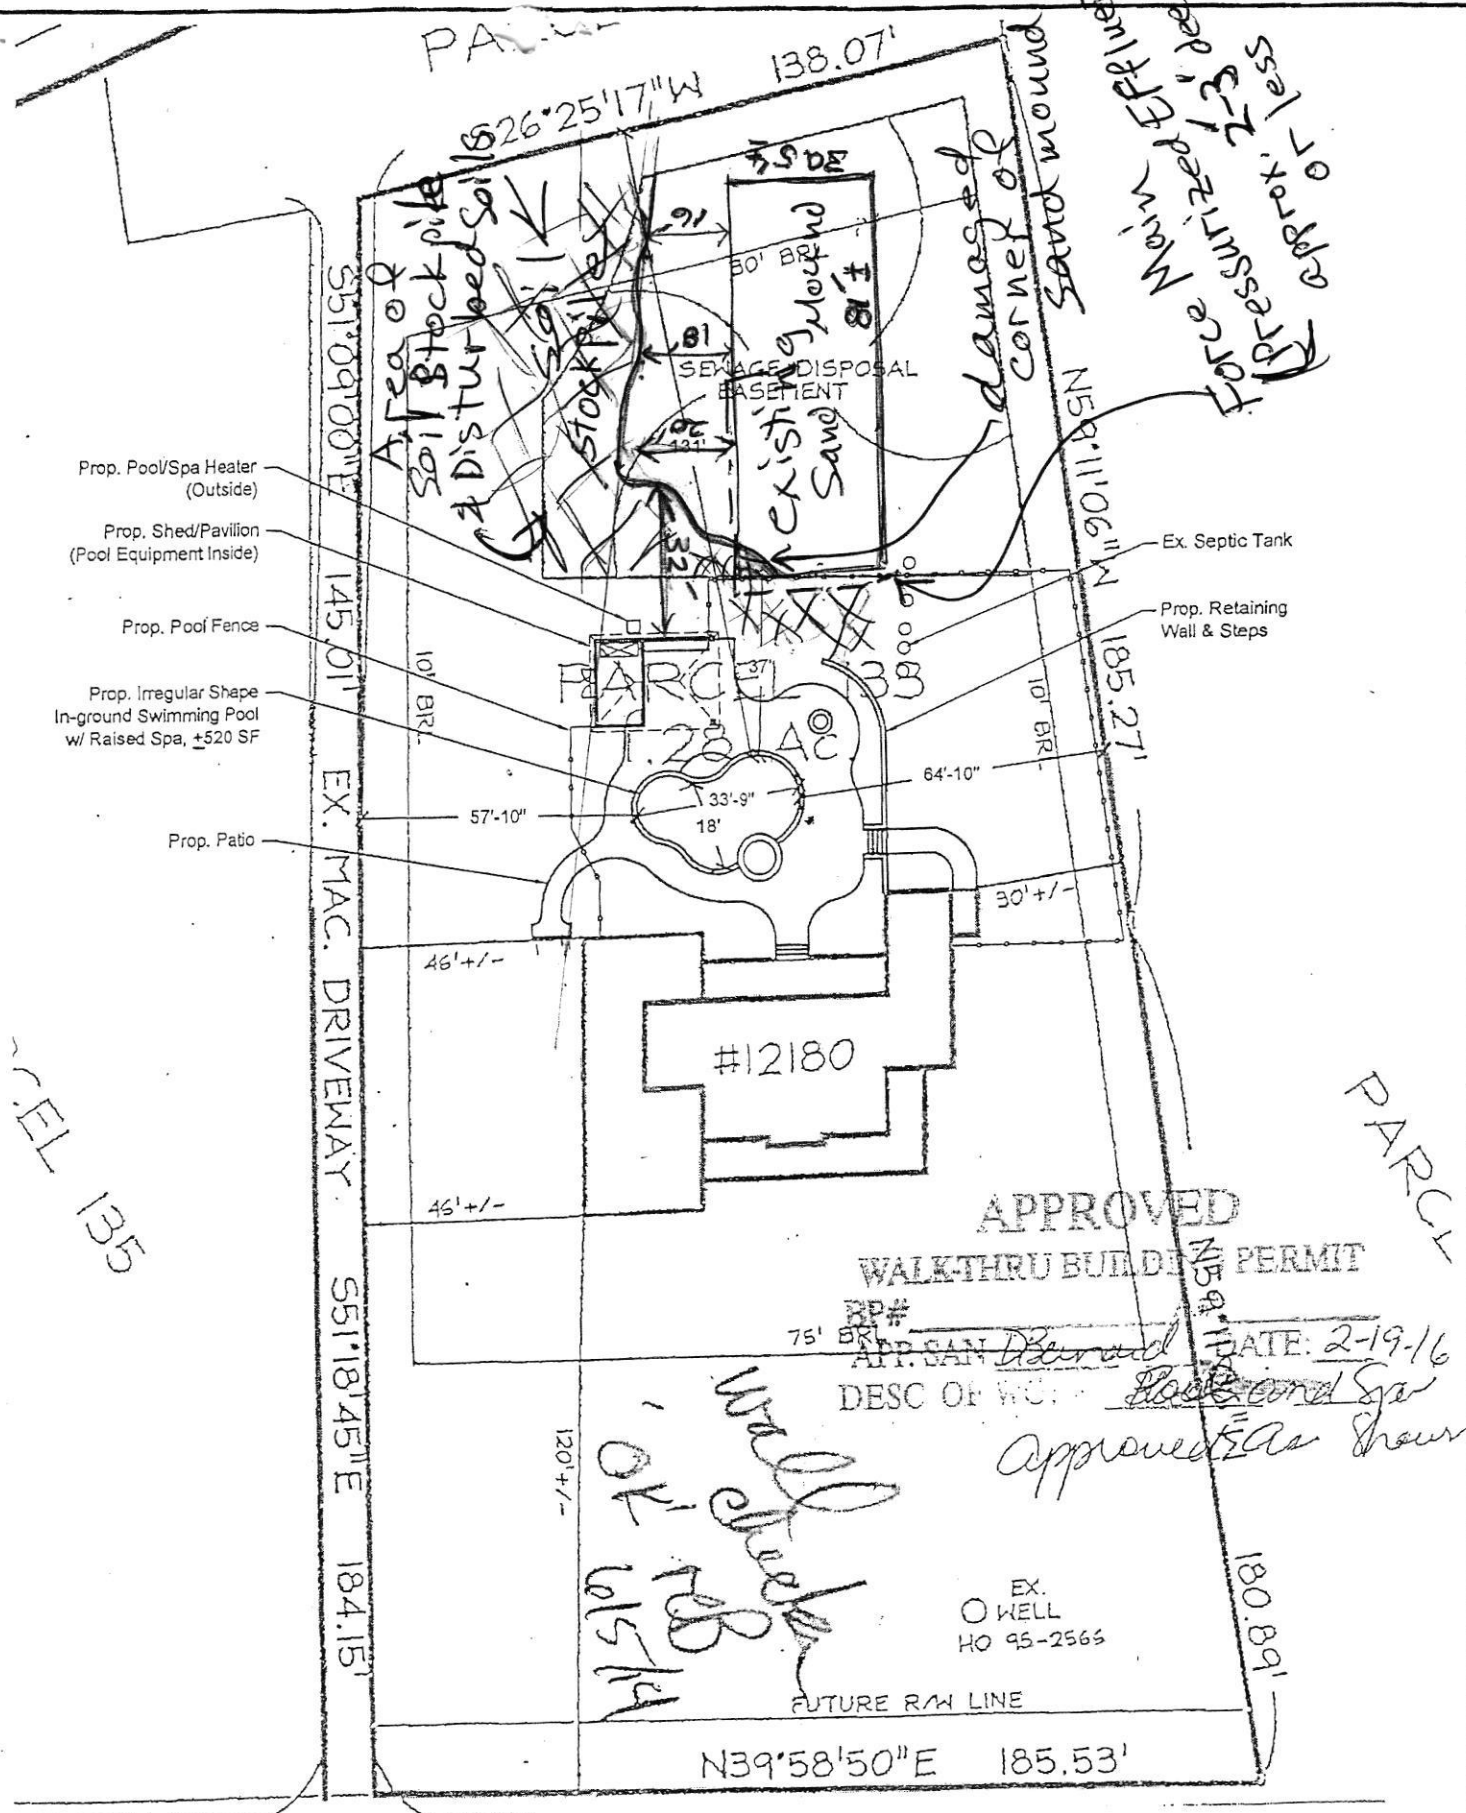
SITE PLAN
 SCALE: 1" = 40'-0"
 FEBRUARY 16, 2016

I found that the area designated for a replacement sand mound has been impacted by the operation of excavation equipment, and by the stockpile of soil. The weight of the soil stockpile is compacting the soil surface beneath it, an adverse condition for a potential sand mound area as the soil surface is the potential infiltrative surface. In the area immediately adjacent to the soil stockpile, there is evidence that soil has been removed by the excavator and that the exposed surface has been compacted as well.

The measured width of undisturbed soil between the existing sand mound and the disturbed soil ranges from 16-to-20 feet. The area of soil disturbance widens in proximity to the shed that is being constructed. I measured a distance of 32 feet from the back of the shed to the edge of the exposed soil surface. Attached is a graphic on which is illustrated the impacted portion of the Sewage Disposal Area (SDA) which is labeled as "Sewage Disposal Easement" on the drawing.

In addition to the impact on the area for the replacement sand mound, I found that the corner of the existing sand mound has been partly excavated, and the soil surface in the area where a pressurized wastewater effluent pipe is buried has been excavated. Potential damage of the buried pipe could not be determined at the time of the evaluation.

It is very important that no additional damage occurs to the area designated for future wastewater disposal. Therefore, these are actions you need to implement immediately to protect that area:
