# HOWARD COUNTY HEALTH DEPARTMENT

RECEIPT DATE: 2/21/2024 **ONSITE SEWAGE DISPOSAL SYSTEM** P 575795

APPROVAL DATE: 3/13/2024 **PERMIT: MINOR REPAIR** A \_\_\_\_\_

PROPERTY ADDRESS: 11717 Wayneridge Court

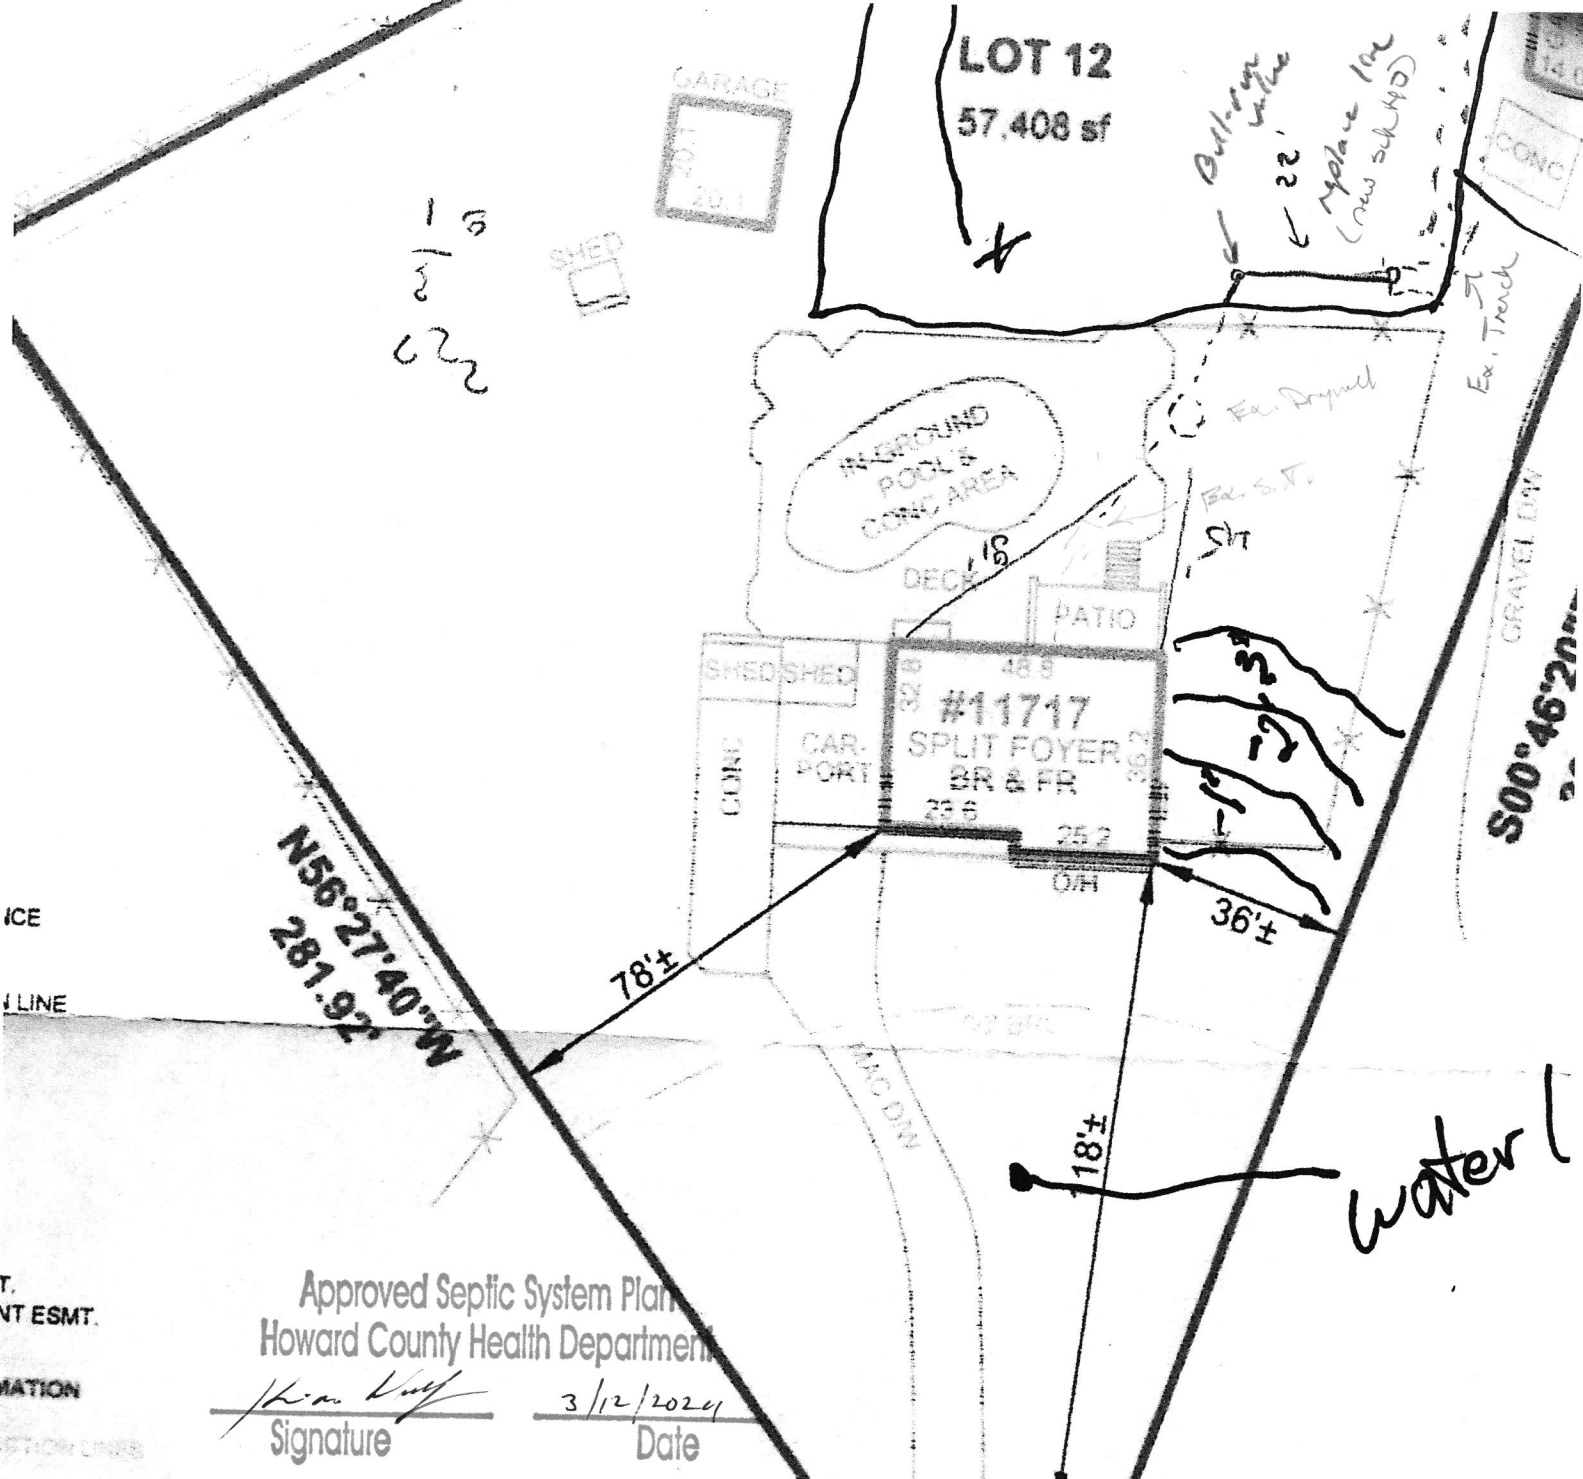
New sch 40 piping installed 3/13/2024

New obs. pipe

3/13/2024 Inspector confirmed sch 40 piping replaced w/ new fitting @ surface of backline where old ball-run valve was connected. line ran into ex. trench w/ new obs pipe installed @ beginning. stone under pipe was clear, little to no blockage no sign of water (perm)

3/12/2024 To replace old piping and ball-run valve /connections w/ new sch 40 pipe per contractor and buyer/seller's request. (perm)

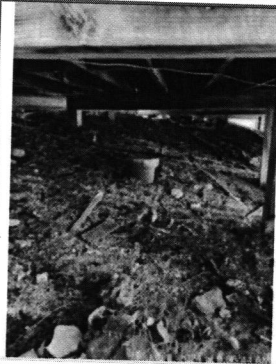
**Picture 1:**

Showing the septic tank under the deck behind the house. The access to the tank is limited due to the deck.

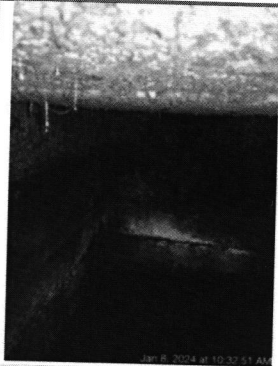
**Picture 2:**

Showing the terracotta 'T' back baffle and low liquid level in the tank. The tank appears to be homemade and will need to be replaced.

Comments: The septic tank appears to be homemade.

**Explain:** The front line and septic tank must be replaced. The front line appears to be composed of orangeburg and the septic tank appears to be composed of block and is not water-tight.

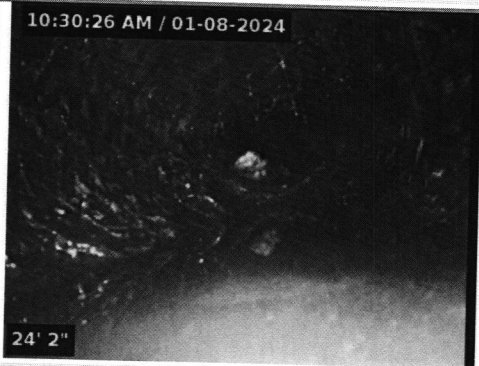
**Picture 3:**

Showing the inside of the front line. The line appears to be composed of Orangeburg and will need to be replaced.

Comments: The pipe material outside the house appears to be orangeburg.

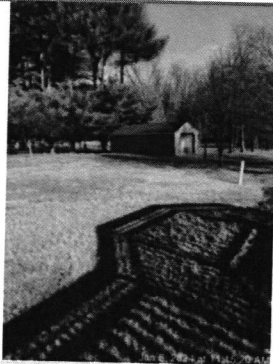
**Picture 4:**

Showing the general location of the absorption system.

Comments: the system was too deep to probe. The area above the drainfield was found to be dry.
