RECEIPT DATE: 3/20/2026 **ONSITE SEWAGE DISPOSAL SYSTEM** P 5-90382

APPROVAL DATE: 3/31/26 **PERMIT:** REPAIR A _____

PROPERTY ADDRESS: 3611 Scheel Dr, Ellicott City, MD 21042

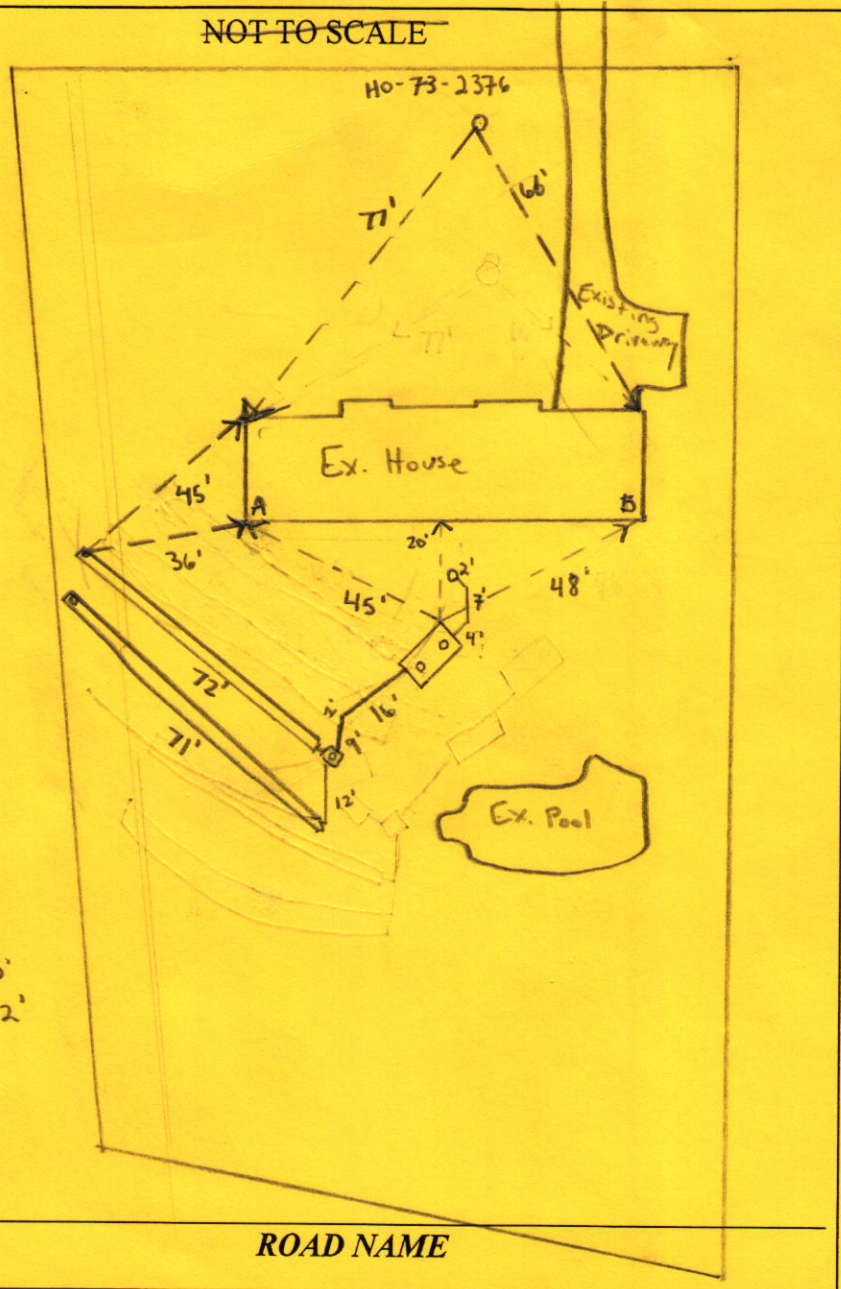
Measurements
 D-box - A : 50'
 D-box - B : 82'

TRENCH/DRAINFIELD DATA		
WIDTH	INLET	BOTTOM
3'	2.5'	6'
NUMBER OF TRENCHES	2	
TOTAL LENGTH	143'	
ABSORPTION AREA	429 ft ² + Sidewalk	
DISTRIBUTION BOX LEVEL	Yes	
DISTRIBUTION BOX BAFFLE	Yes	
DISTRIBUTION BOX PORT	Yes

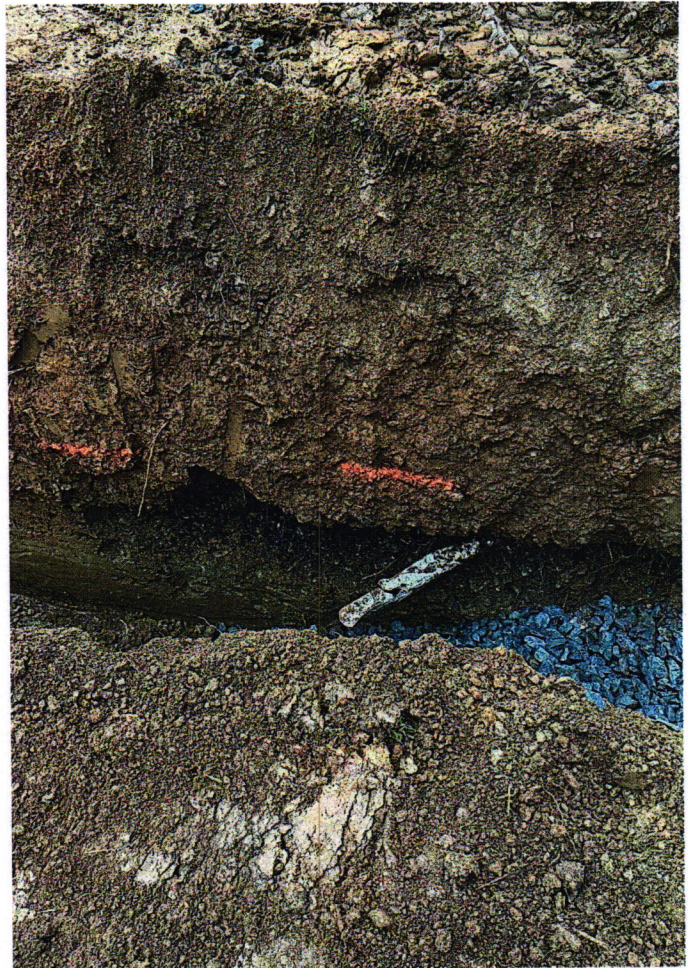
3rd trench found while digging upper trench, ran perpendicular to trench being dug. 4' inlet. Encountered trench for about 4 feet. (MB)

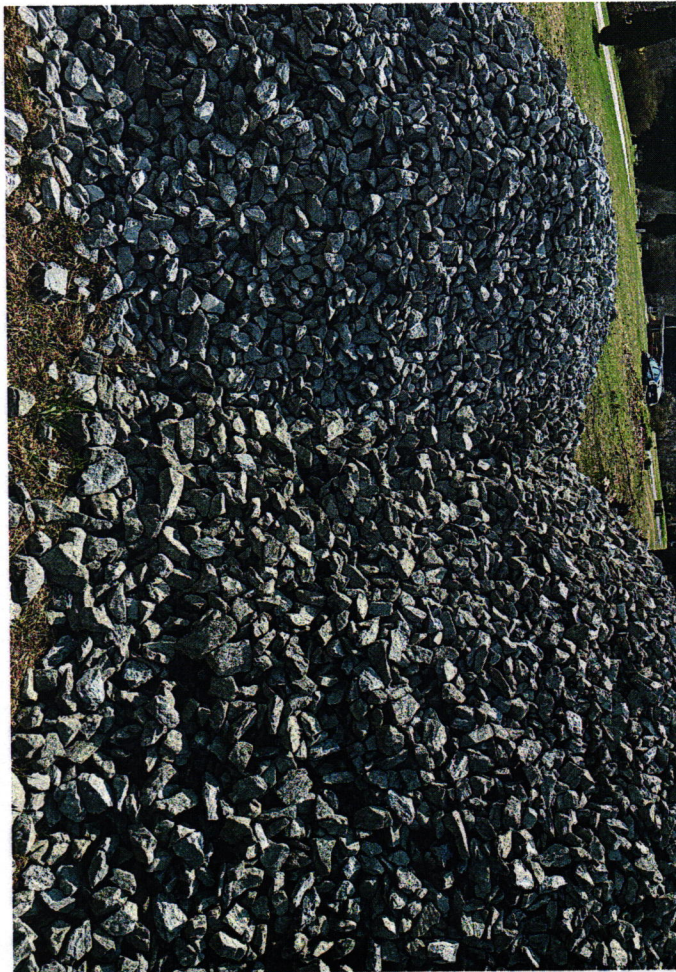
Rejected pile of stone on the right. Most pieces were

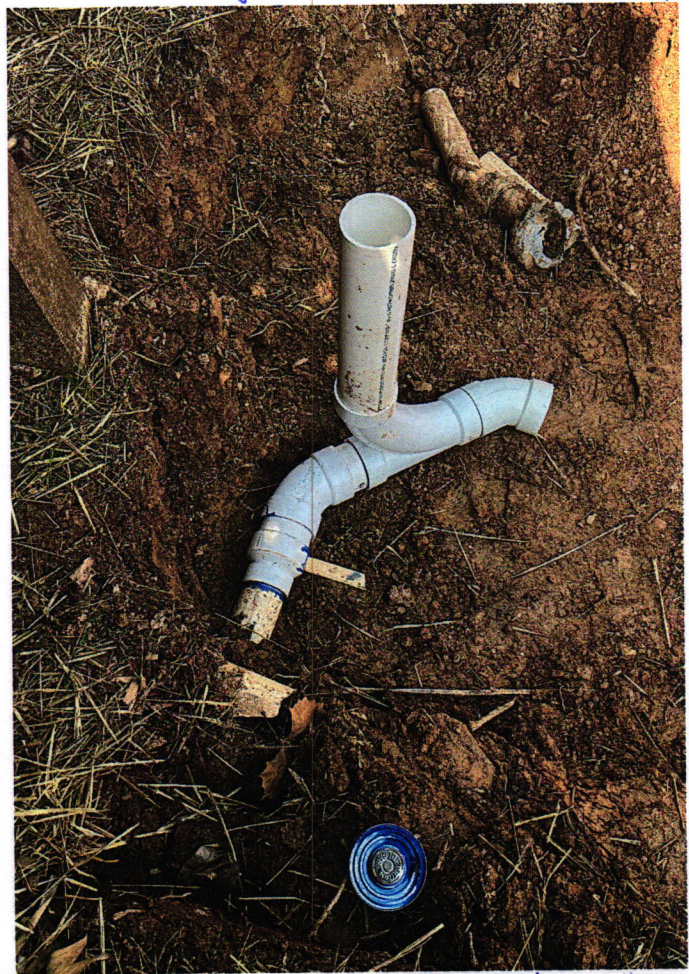
Front line originally was 3". Contractor ferroced to 4". (MB)
