RECEIPT DATE: 12/30/2025 **ONSITE SEWAGE DISPOSAL SYSTEM** P 5-90306

PROPERTY ADDRESS: 3447 Huntsman Run, Ellicott City, MD 21042

House Sewer replacement

Sketch of 3447 Huntsmans Run Ellicott City, MD 21042

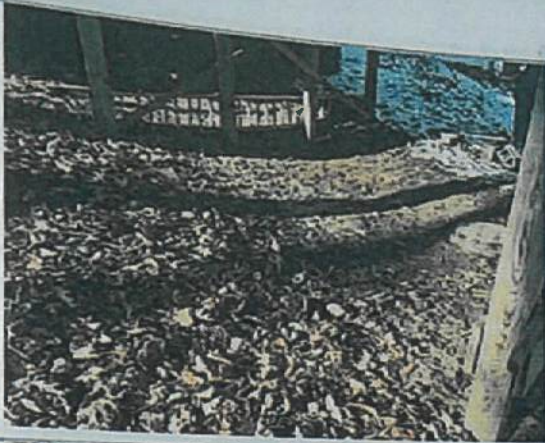
Picture 1:

This picture shows the location of the septic tank riser, as well as the deck above the system.

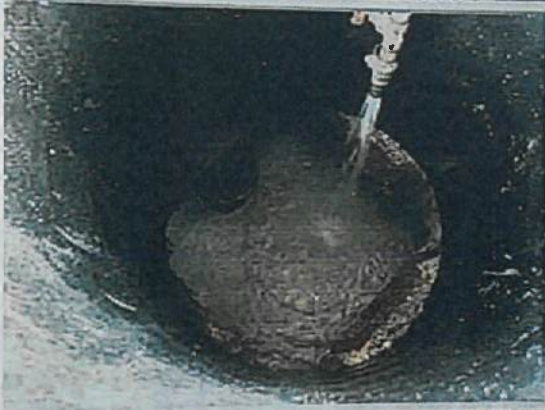
Picture 2:

This picture shows the terracotta back baffle.

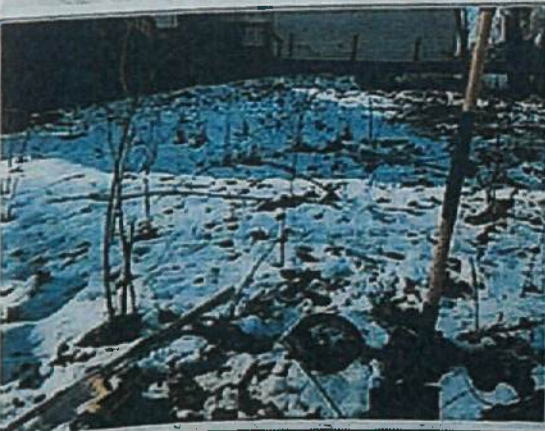
Picture 3:

This picture shows the location of the drywell.

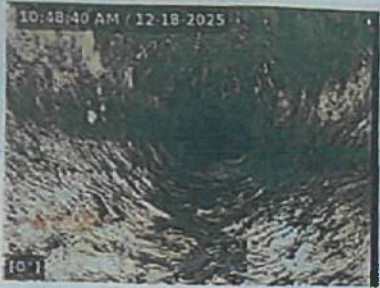
0"

Start of the front line.

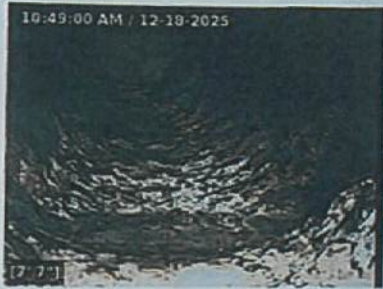
7' 7"

There is an upward bend.

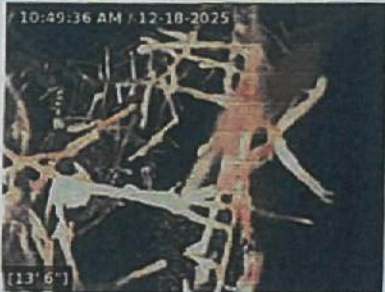
13' 6"

The camera was introduced into the front line via the cleanout over the front end of the tank and was progressed to the house. The front line is composed of cast iron. There is visible root intrusion in the line; the line will need to be remediated, which may include replacement. The camera was introduced into the back line via the riser over the back end of the tank and was progressed to the drywell. The back line is composed of PVC. The drainfield line was unable to be scoped.

Visible root intrusion in the line.

1/22/2026 - Installer onsite for inspection. Long drop installed @ front line, 22". Full HD installed near foundation. SCHED 40 PVC used. 6" Front baffle installed @ front of tank. 6" Port installed at the front of tank. OK to backfill. (SP)

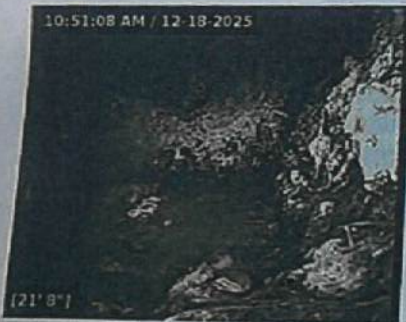
21' 7"

The cleanout in the basement was reached.

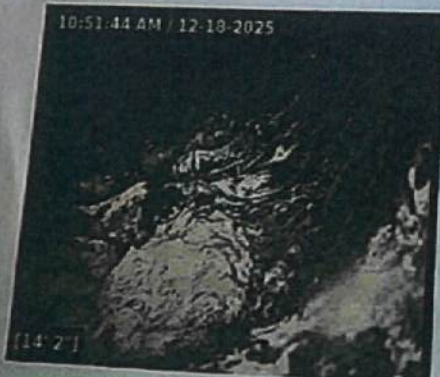
14' 2"

Build-up visible in the line.

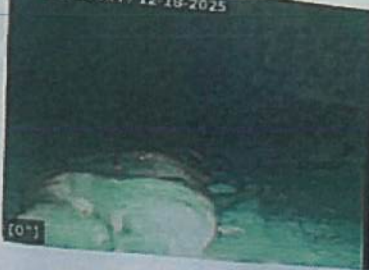
0"

Start of the back line.

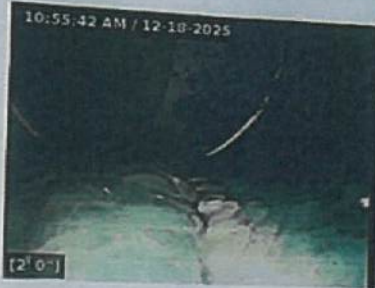
2' 0"

There is a left turn.

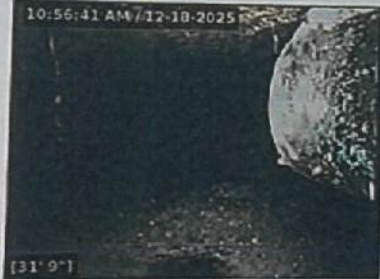
31' 9"

The drywell was reached.

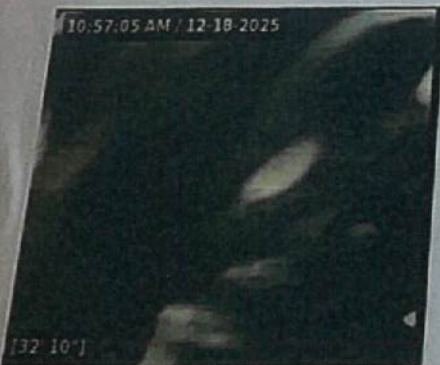
32' 10"

The drywell was measured to have approximately one foot of liquid depth remaining.
