RECEIPT DATE: 4/15/2026 **ONSITE SEWAGE DISPOSAL SYSTEM** P 591016

APPROVAL DATE: 4/22/2026 **PERMIT: REPAIR - Minor** A Repair  
*Kmw*  
**Repair**

PROPERTY ADDRESS: 925 Sunset Valley Drive

<b>Date:</b> March 31, 2026 <b>Name of Evaluator:</b> Tyler Young <b>Time:</b> 8:00 AM <b>Property Address:</b> 925 Sunset Valley Drive Sykesville, MD 21784 <b>Recent Weather Conditions:</b> Normal	<b>Ordered By:</b> Lucy Renehan  <b>Buyers:</b> Patrick Mullinex  <b>Homeowner Interview:</b> The homeowner interview was sent and received prior to the evaluation.	<b>Occupied:</b> <input checked="" type="checkbox"/> Yes <input type="checkbox"/> No <b>Length of Time Vacant:</b> N/A <b># of People Living in Home:</b> 4 <b># of People moving in:</b> 2 <b>Property Age:</b> 1990 <b>System Age:</b> 1990 <b>Last Date of Cleaning:</b> Unknown <b>Recomm'd Pumping Freq:</b> 3-4 Years
<b>Liquid level in tank is:</b> <input type="checkbox"/> Above Normal <input checked="" type="checkbox"/> Normal <input type="checkbox"/> Below Normal		<b>Bottom Solids Depth:</b> >24 Inches
<b>Depth of tank:</b> 17 Inches	<b>Type of Tank Access:</b> Cleanout	<b>Depth of tank access:</b> At Grade

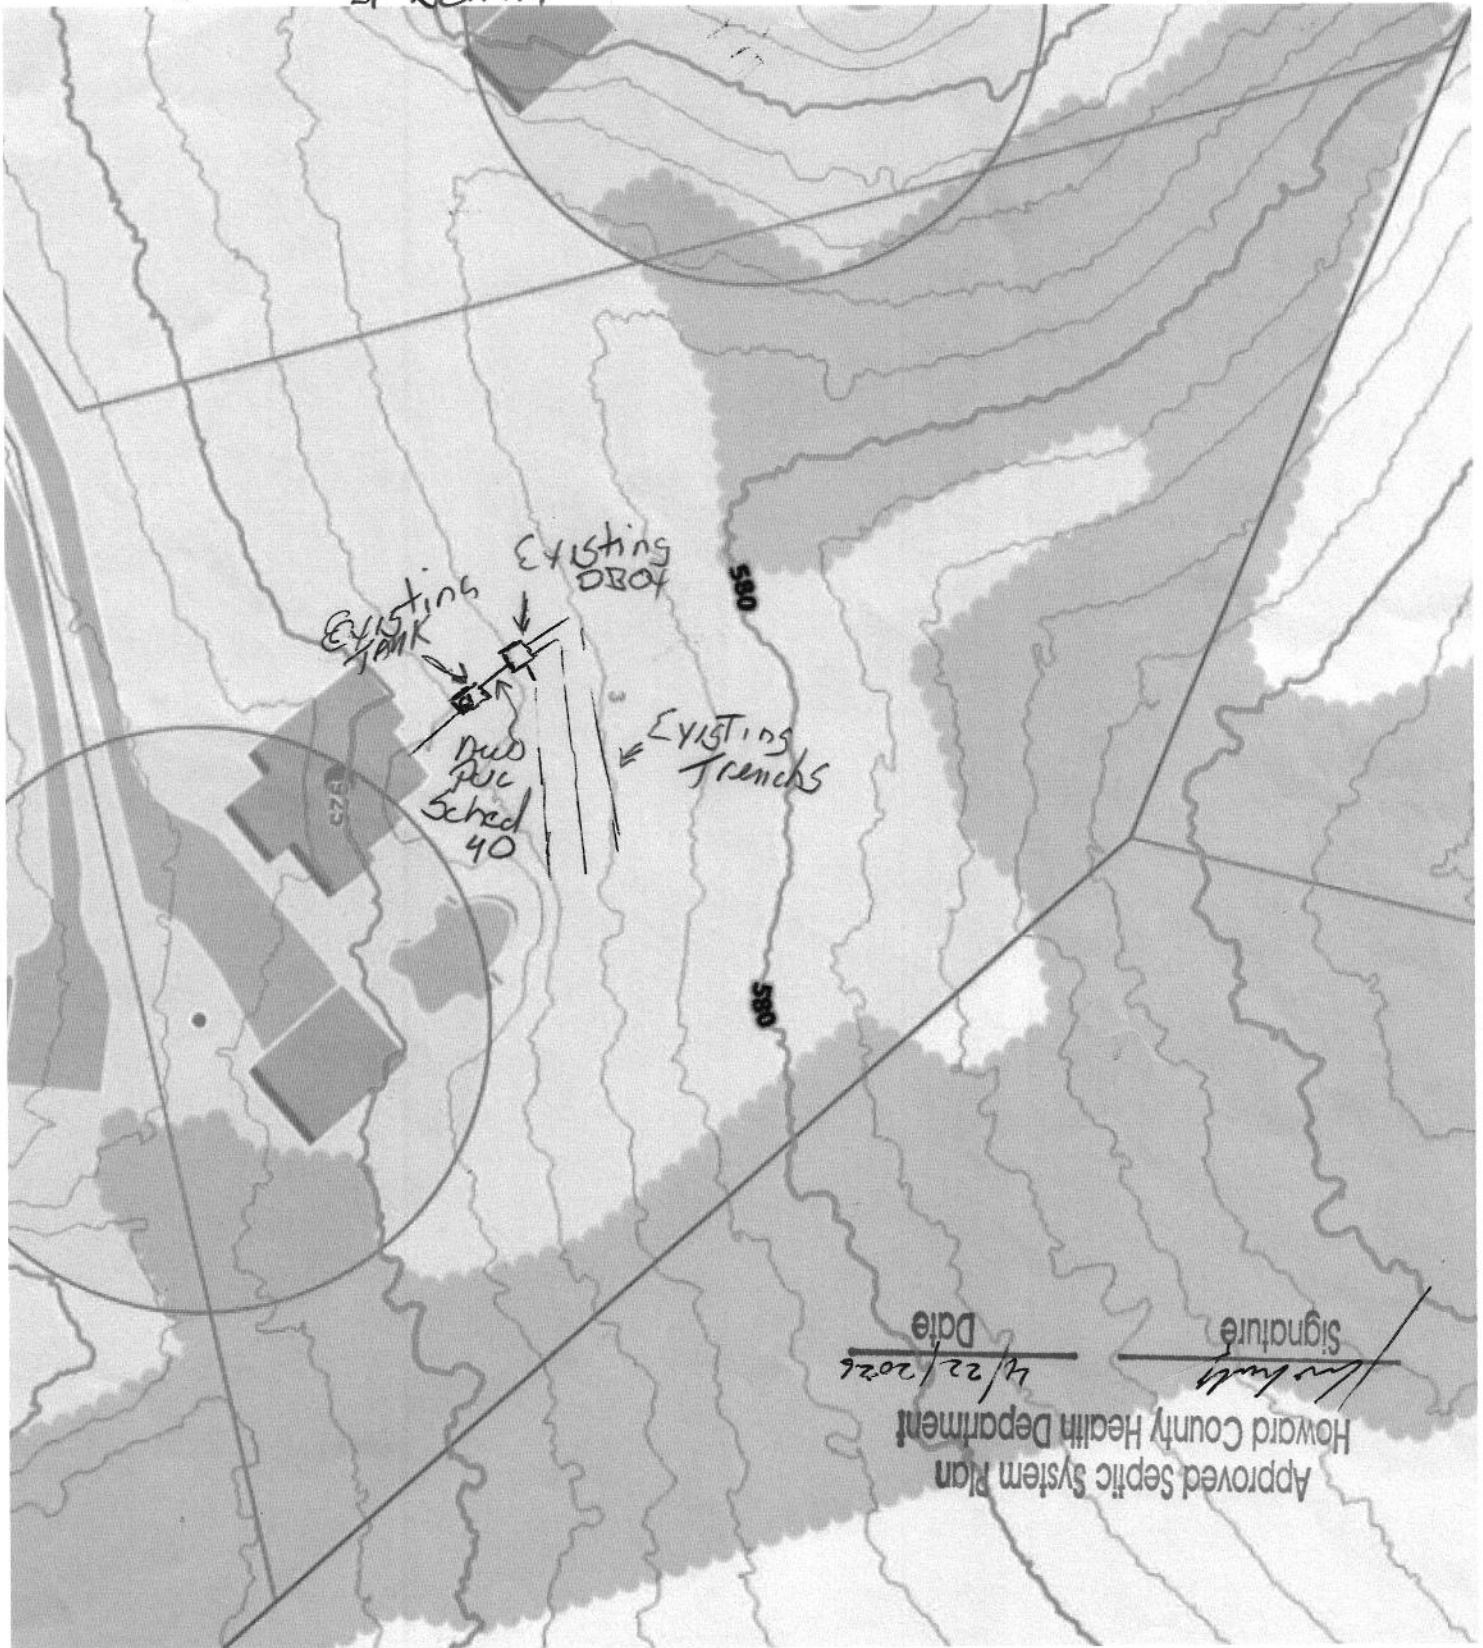
Pumping Septic Tank  
Replacing Line from back of Tank to D. Boy  
including replace D Boy due to roots

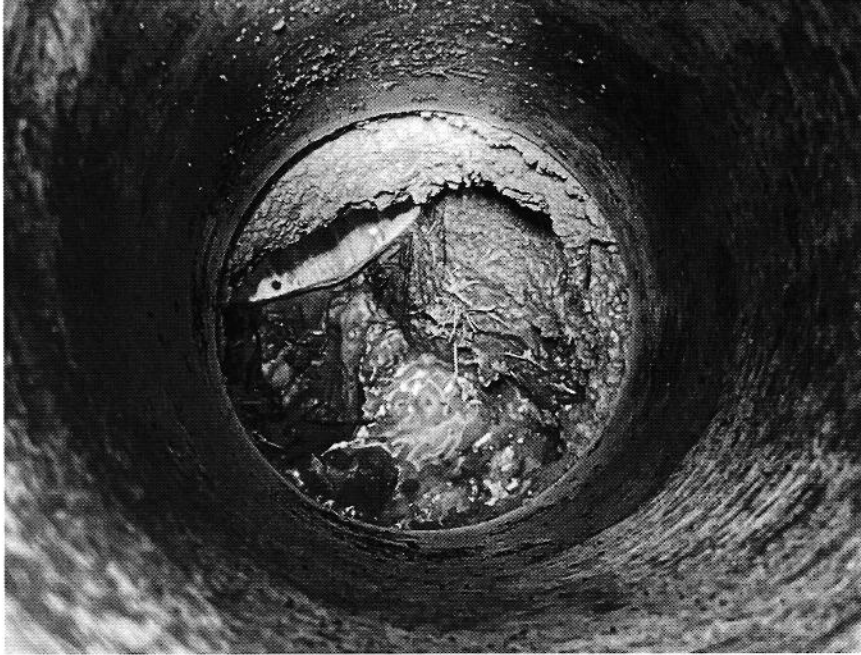
**Picture 1:**

<input type="checkbox"/> Aeration System	<input type="checkbox"/> Tank Size: 1,250 gallons	<input type="checkbox"/> Drywell (Number of: ) <input type="checkbox"/> Cesspool
<input type="checkbox"/> Other:	<input type="checkbox"/> Unknown: _____	<input type="checkbox"/> _____
System Component	Condition	Comments
<b>Septic Tank</b>	<input checked="" type="checkbox"/> Acceptable <input type="checkbox"/> Unacceptable <input type="checkbox"/> Needs Further Evaluation	The septic tank is 1,250 gallons in capacity and composed of concrete. The tank is 17 inches below grade; a 6" PVC cleanout serves as access at grade. The front and back baffles are in place and composed of concrete. The solids level in the tank is greater than 24 inches, indicating poor maintenance. It is recommended that the tank be cleaned, then every 3-4 years thereafter. During the inspection, root intrusion was observed around the inlet of the tank. These roots were not causing an issue at the time of inspection but should be removed and the area around the inlet be properly sealed. Due to these roots around the inlet, this system is labeled as, "Acceptable with Concerns".

Showing root intrusion around the inlet of the septic tank.

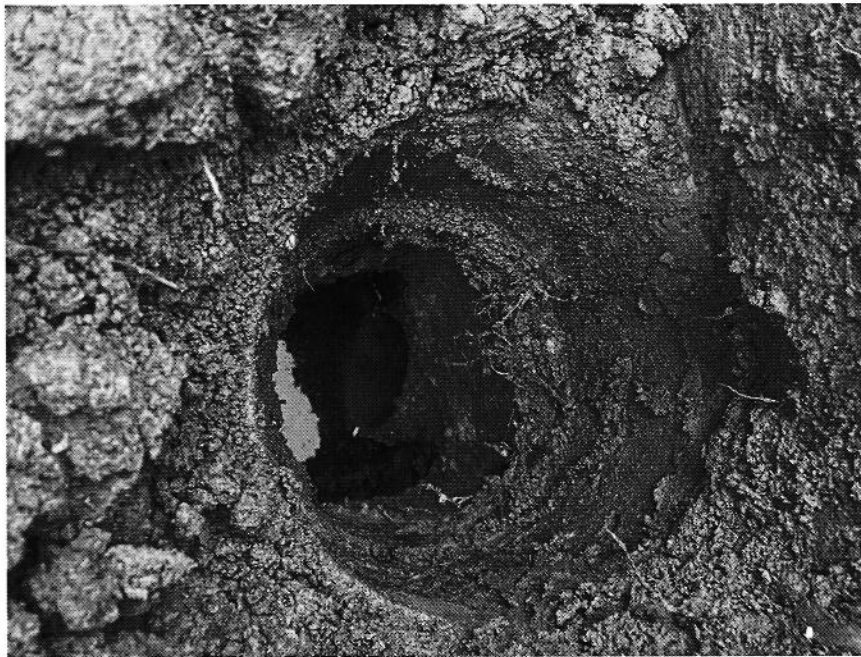
**Picture 2:**

Showing a backup occurring in the back line of the septic tank.

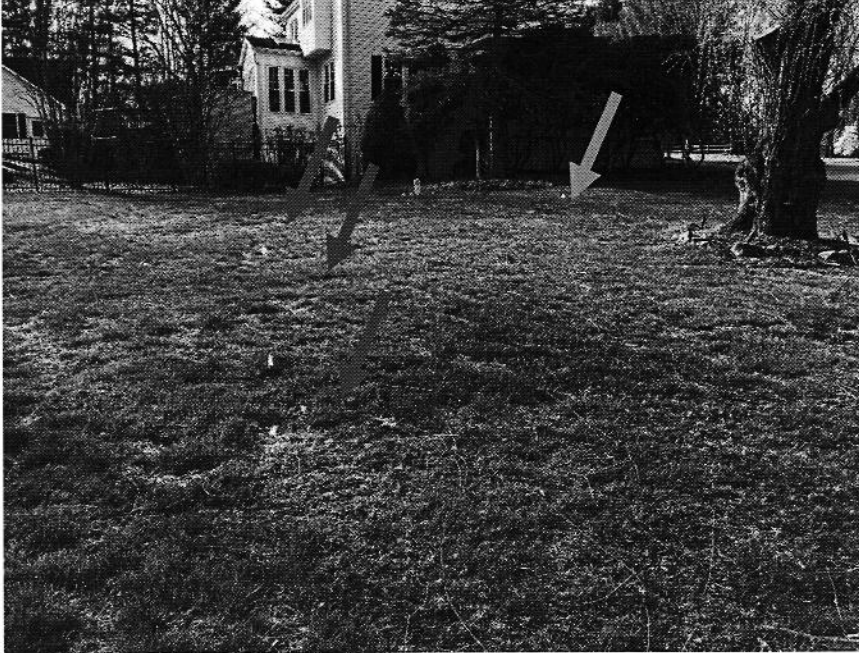
**Picture 3:**

Showing the locations of the septic tank (red arrow), distribution box (yellow arrow), and located drainfields (blue arrows). Please note the large tree near the d-box. Removal of this tree may be necessary for future repairs.

Additionally, minor depressions were observed over the drainfields. It is suggested these areas be leveled to prevent stormwater from pooling over the drainfields.

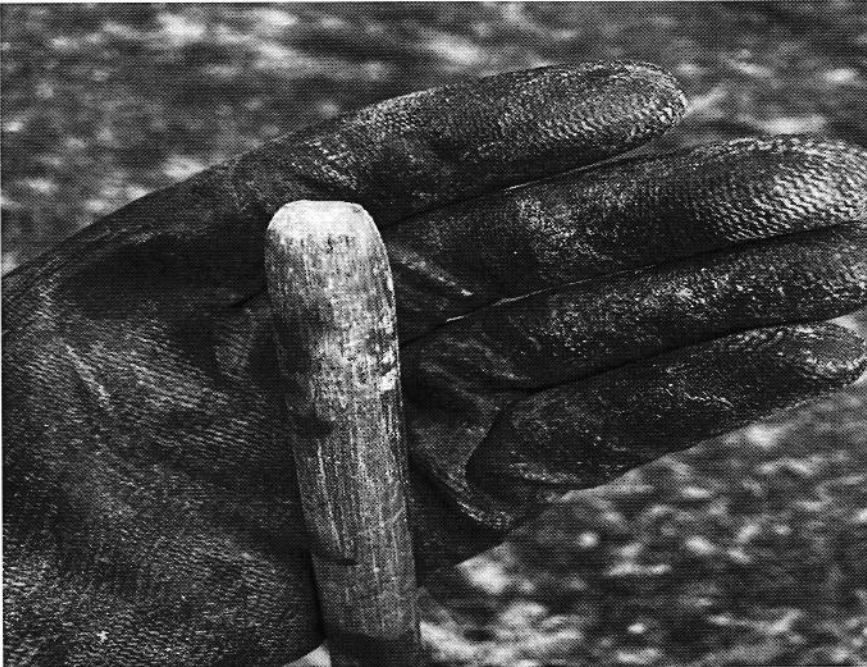
**Picture 4:**

Showing stone residue from probing the located drainfields.
