Permit Type Building/Residential/Alteration/SFD Permit Number B26003080 Opened Date 08/28/2026  
Description of Work SFD/ TREE DAMAGE REPAIRS TO GARAGE TO INCLUDE: REPLACE (2) TRUSSES AND JACK TRUSSES. REPLACE SHINGLES, SHEATHING, DRYWALL, AND INSULATION AS NEEDED.

July 28, 2026

Re: *Insured:* *Hull/Johnson Residence*  
*Location:* *3271 Florence Road*  
*Woodbine, MD 21797*  
*Claim:* *Tree Impact Damage*  
*Claim No.:* *129621-GR*  
*TEG No.:* *T101-165*

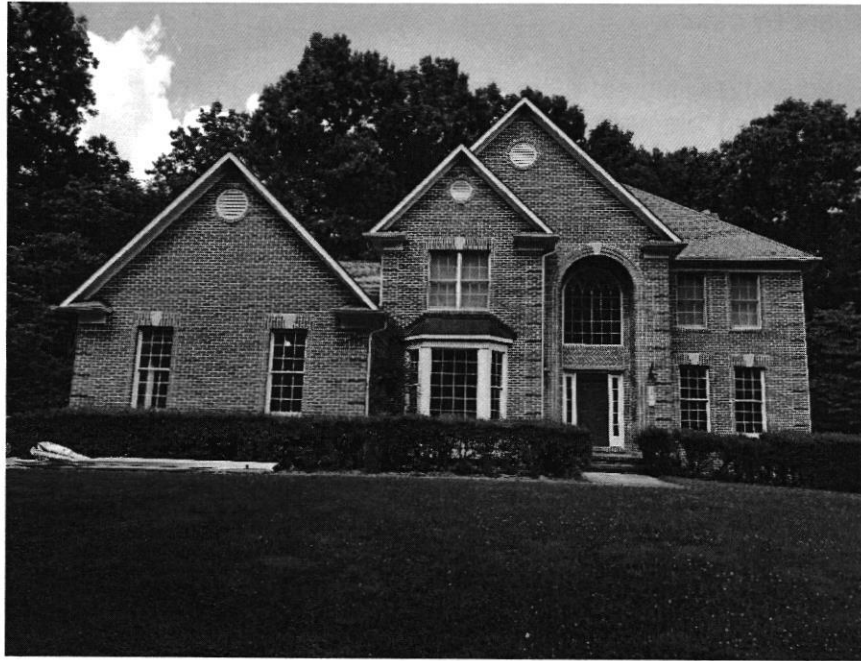
8. Numerous gutters, downspouts, trim pieces, etc. from the left side were damaged by the tree impact. Damaged components were stacked in front of the garage. See *Photograph 1*.

Photograph 1 - View of the front elevation of the subject property.

15. Replace damaged brick at the left-side exterior wall.
16. Repair interior finishes.
17. Remove and replace damaged soffit vents, ridge vents, trim, gutters, downspouts, etc.

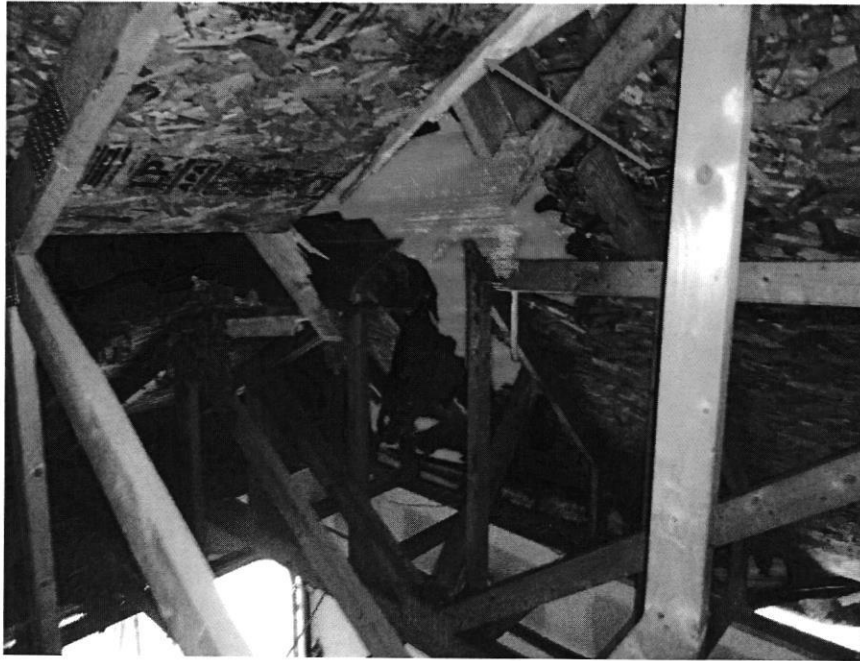
1. The 2-ply girder truss at the left-side of the garage that runs front to rear was damaged by the tree impact. The top chord and vertical web located approximately 10' back from the front of the girder truss were fractured by the tree impact. The metal plate connections were damaged that connect with the damaged truss members. See *Photograph 5*.

2. The first standard wood roof truss to the right of the 2-ply girder truss was damaged by the tree impact. Typical damage consists of a fractured top chord and displaced gusset plates. See *Photograph 5*.

Truss member fracture and damage at the metal plate connections were observed at the 2-ply girder truss at the point of impact. This truss cannot be repaired as typically plate reinforcement and truss member reinforcement needs to occur on both faces of the wood roof truss. Since this is a 2-ply truss, access is only provided to one side of each truss, since the trusses are sandwiched together. The required capacity cannot be achieved in this configuration. Therefore, full replacement of the 2-ply girder truss is required.

Photograph 5 - View of damaged 2-ply girder truss and stepdown truss on the left-hand side of the garage.

8. Remove all of the 2x6 overbuild roof rafters that make up the left-side slope of the front roof overbuild.
9. Remove and replace the damaged girder truss and adjacent standard wood roof truss. Replacement truss design are by others. Obtain signed and sealed engineering drawings from truss manufacturer. Dimensions shall be verified by manufacturer on site.

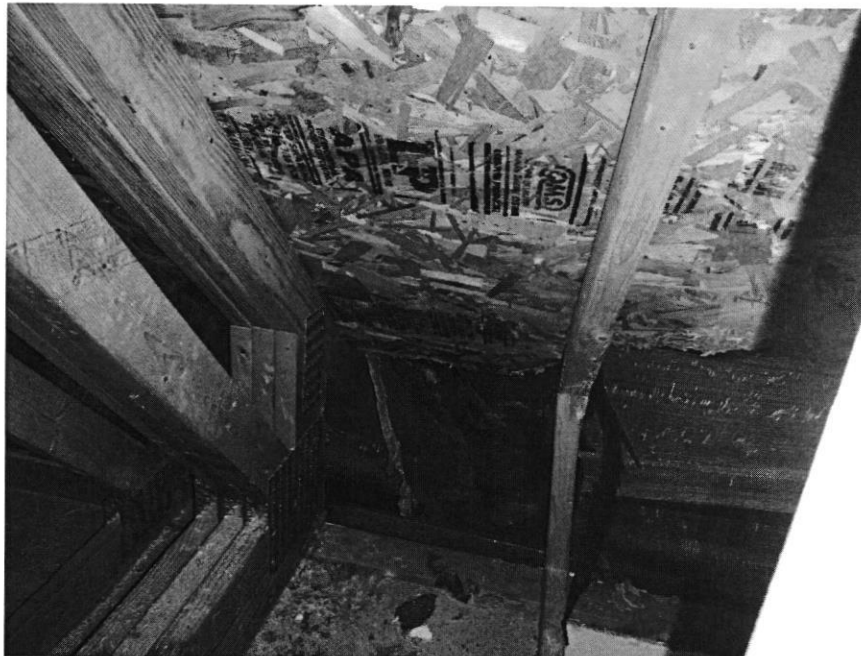
3. Starting from the front of the 2-ply girder truss, the first five (5) jack trusses were damaged by the tree impact. Typical damage consists of fractured members and displaced gusset plates. Damaged OSB roof sheathing was present throughout this area. See *Photographs 6 and 7*.

Photograph 6 - View of damaged jack truss.

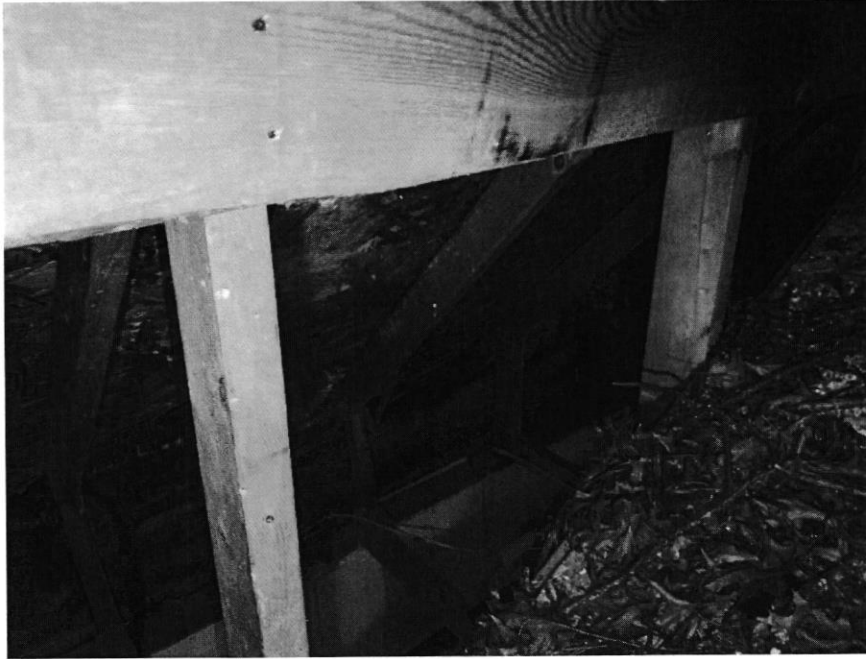
Photograph 7 - View of damaged jack trusses.

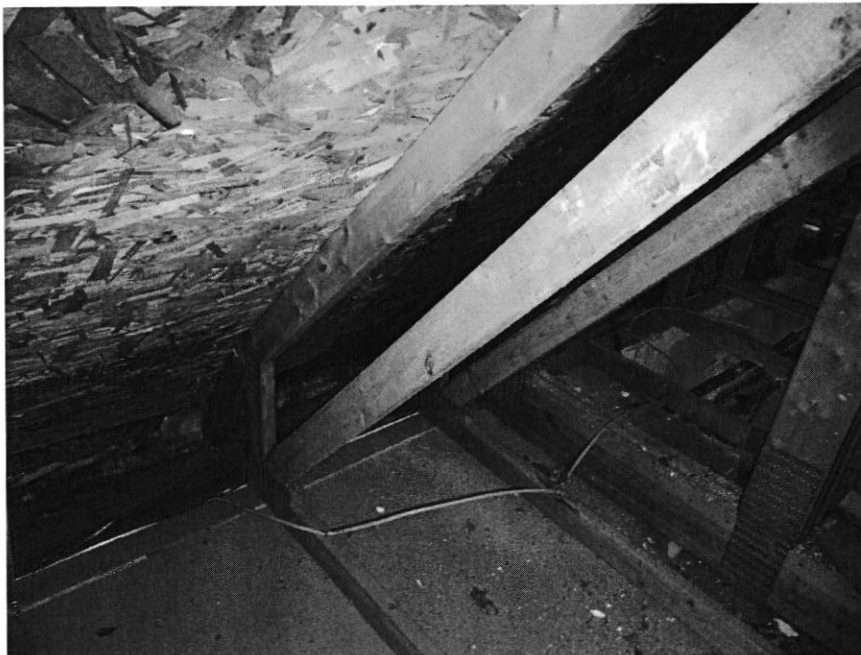
4. Starting from the front of the gable roof at the front wall of the garage, the third standard wood roof truss had a fractured top chord at the left-side eave. See *Photograph 8*.

Photograph 8 - View of damaged roof truss.

13. Repair the top chord of the third standard metal plate connected wood roof hip truss from the front wall. Provide 2x4 reinforcing scabs on each side of the top chord.

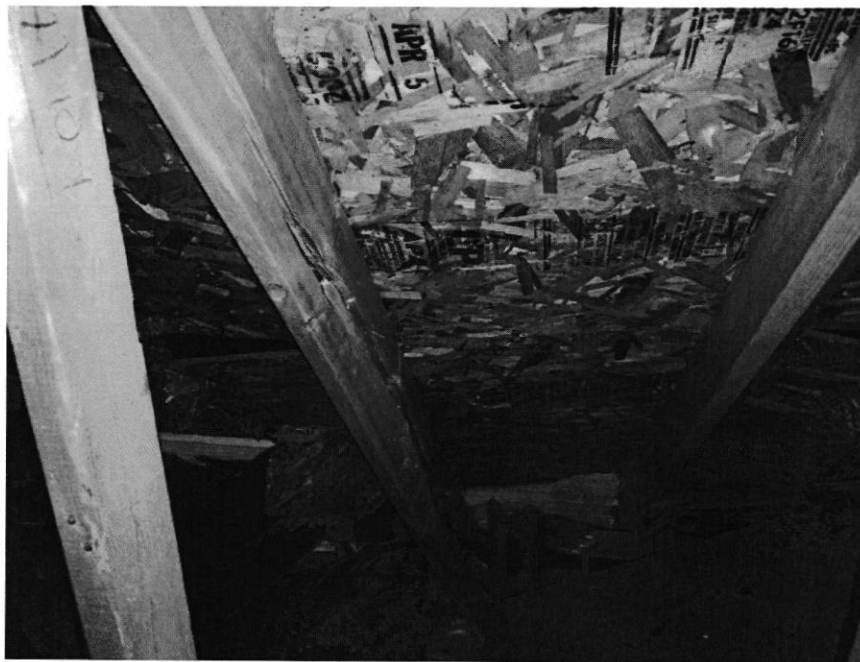
5. Several 2x6 overbuild roof rafters that make up the left slope of the front roof overbuild were found fractured by the tree impact. Starting from the front of the slope, roof rafters #1 to #7 were damaged. See *Photographs 9 to 11*.

Due to the extent of damage, it is recommended that all of the 2x6 overbuild roof rafters on the left-side slope of the front roof overbuild be replaced. These overbuild roof rafters are damaged from the impact, but the replacement is also required to facilitate the removal and replacement of the 2-ply girder truss.

**Photograph 9 - View of damaged roof rafters and OSB sheathing.**

12. Provide new 2x6 roof rafters (min #2 SPF) along the left slope of the front roof overbuild. Rafters will connect to the ridge of the right-side overbuild trusses with plywood gusset plates. Rafters will bear on the 2-ply girder truss on the left side with a Simpson A35 framing angle. For jack trusses 1-3, a 2x10 ledger board will be provided along the top of the jack trusses where the girder truss slopes downwards. Secure the ledger board to the jack trusses with a Simpson A35 framing angle on one side.

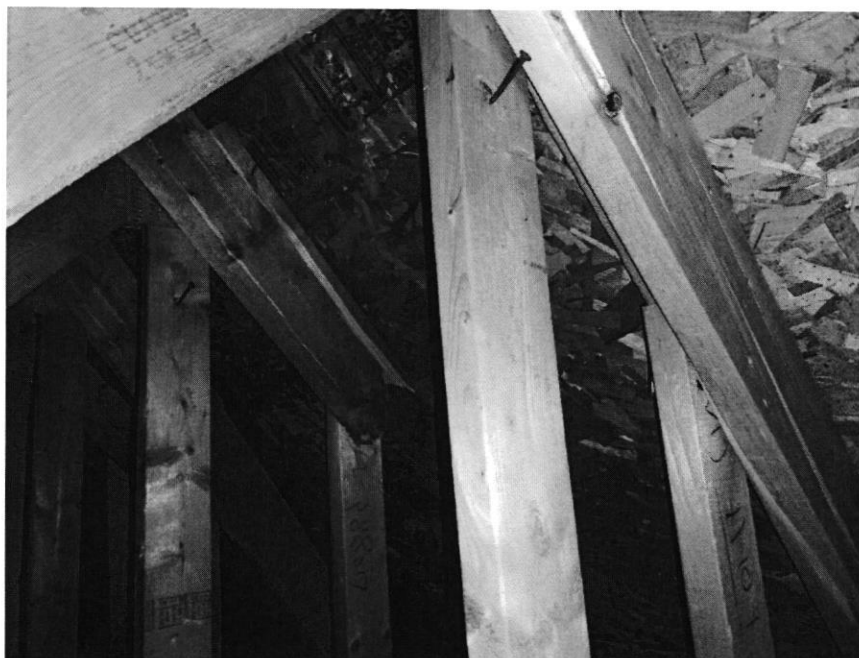
**Photograph 10 - View of fractured 2x6 roof rafters.**

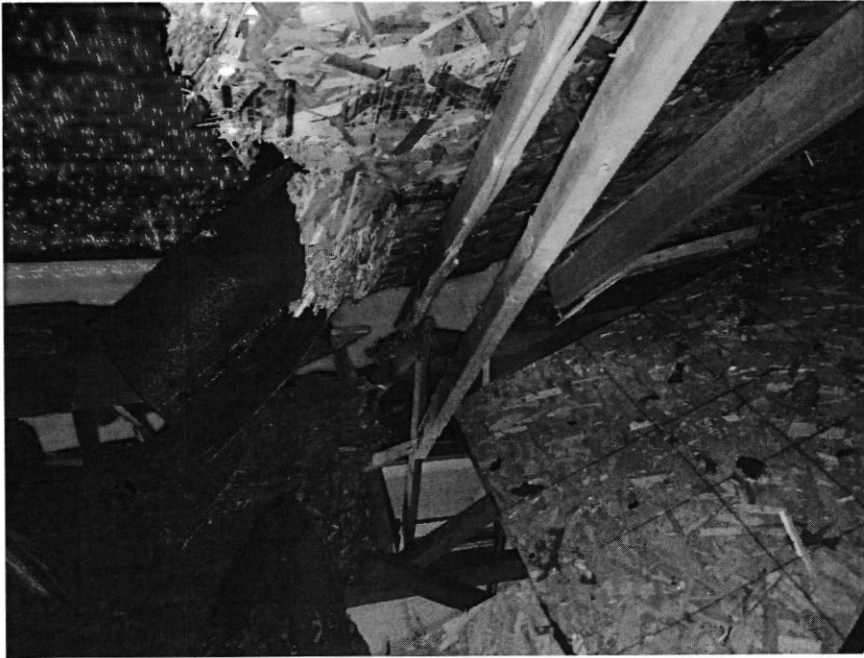
Photograph 11 - View of damaged roof sheathing and displaced roof rafter

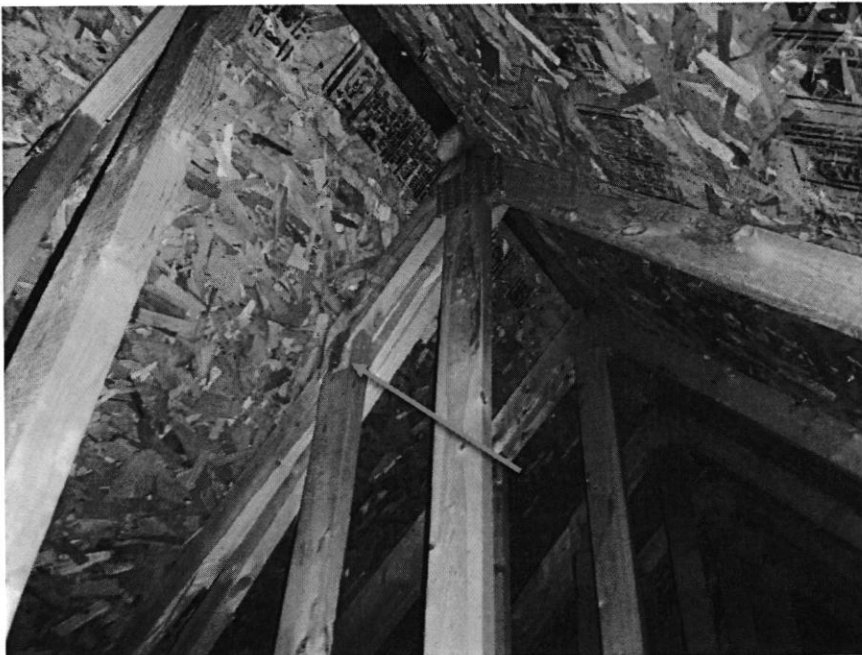
6. Several metal plates were found displaced on the overbuild wood roof trusses that make up the front reverse gable overbuild. See *Photograph 12*.
7. A branch puncture was noted near the ridge of the front. See *Photograph 13*.

Photograph 12 - View of displaced metal plate on front overbuild truss.

10. Repair the overbuild trusses with the installation of plywood gussets plates near the ridge of each truss.
11. Provide a 2x4 ledger board along the left-side bottom chord of the girder truss. Provide 2 rows of 16D common nails 8" o.c. Provide a Simpson H2.5a hurricane strap at each jack truss bearing.

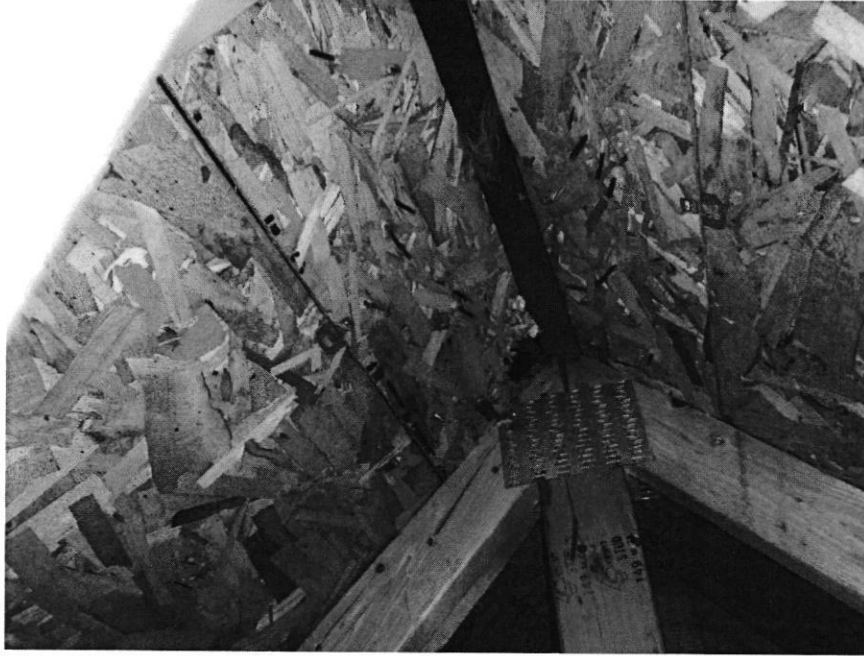
**Photograph 13 - View of branch puncture.**

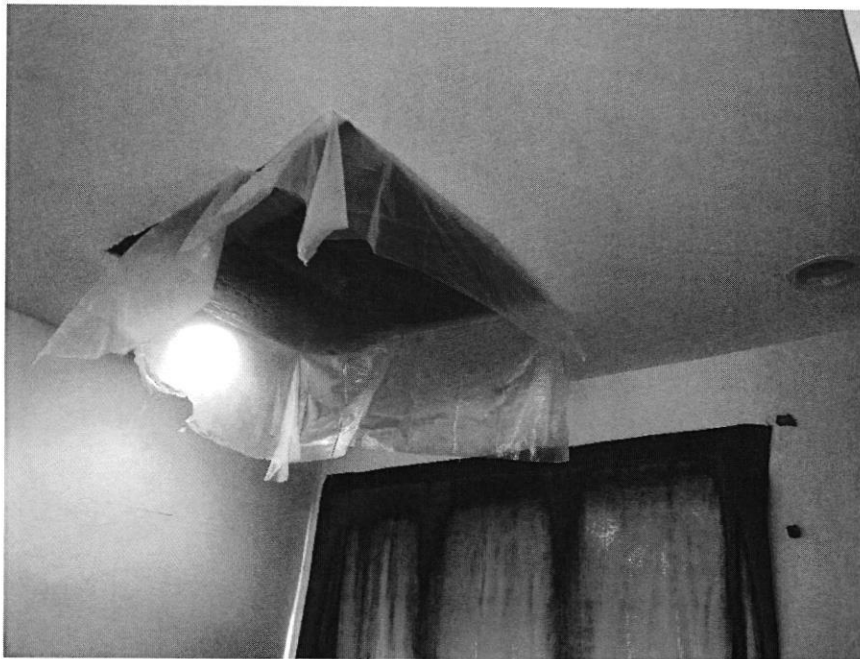
10. Drywall cracks were noted on the vaulted ceiling of the master bedroom near the left-side wall. The bottom chord of the 2-ply girder truss changes elevation at this location to form the vaulted ceiling. Additional cracks were noted on the bathroom wall that divided the garage and master bedroom. See *Photographs 14 to 16*.

**Photograph 14 - View of access hole cut in left-side bathroom ceiling.**

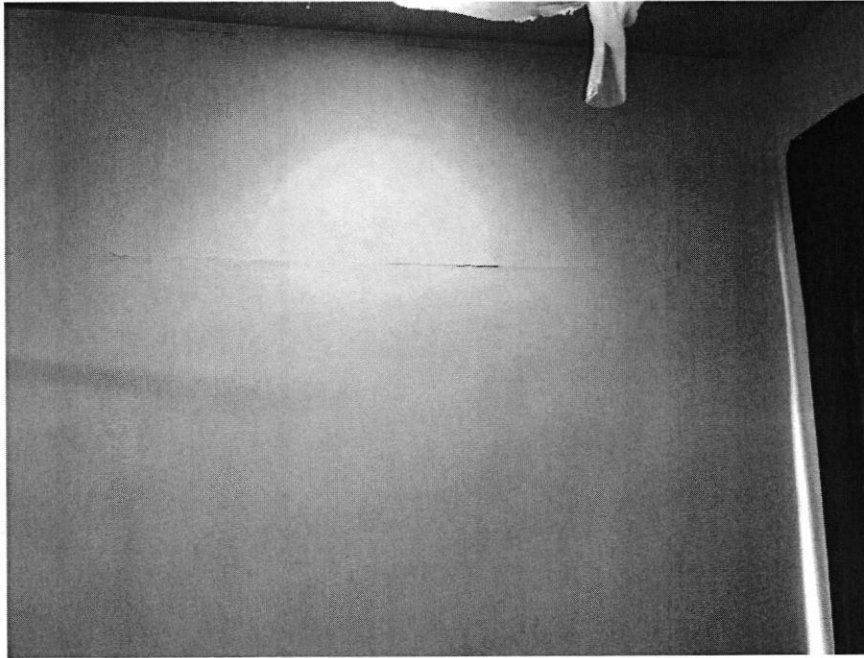
**Photograph 15 - View of stressed drywall in left-side bathroom.**

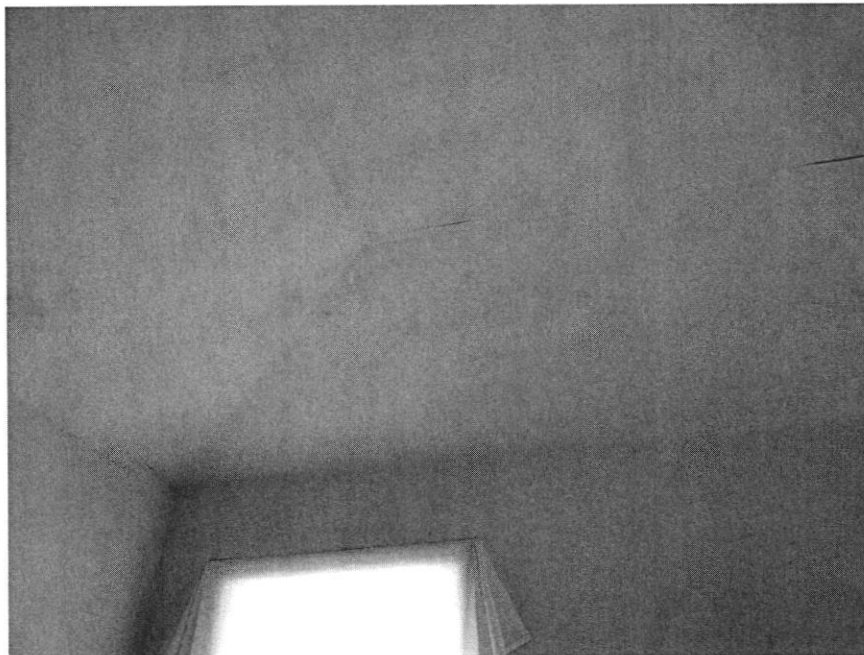
**Photograph 16 - View of damaged drywall seam in left-rear bedroom.**

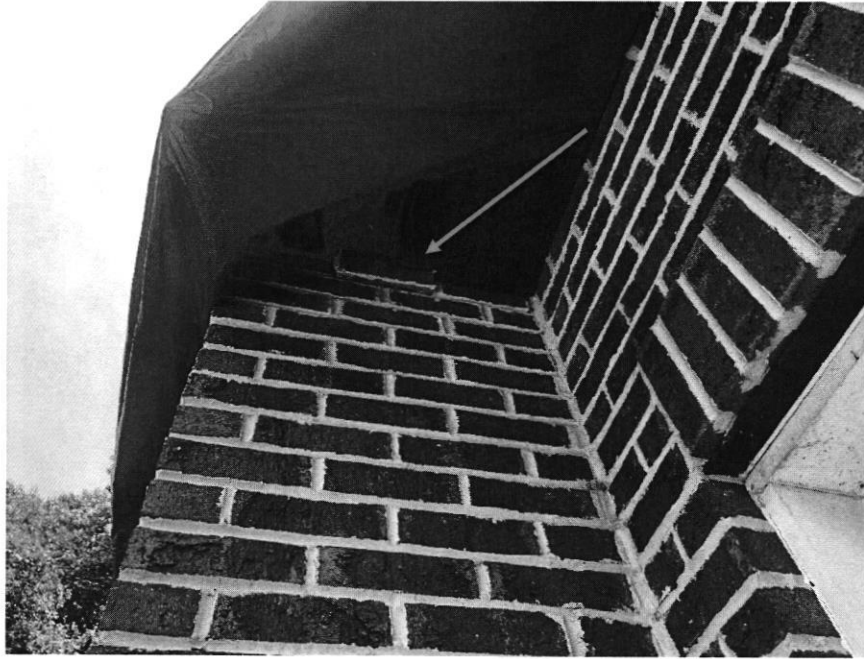
11. Displaced brick was observed at the top of the front wall of the bump-out near the rearmost garage door. See *Photograph 17*.

**Photograph 17 - View of damaged brick.**
