ONSITE SEWAGE DISPOSAL SYSTEM

PROPERTY ADDRESS: 3100 Roxbury Mill Road

Date: 10/2/2018 Name of Evaluator: Drew Henderson Time: 10:00 Property Address: 3100 MD-97 Glenwood, MD 21738 Recent Weather Conditions: Normal		Ordered By: Lodestar Inspections Buyers: David Rezendes Homeowner Interview: The homeowner interview was not received prior to the evaluation.		Occupied: <input type="checkbox"/> Yes <input checked="" type="checkbox"/> No Length of Time Vacant: ~ 1 Year # of People Living in Home: N/A # of People moving in: 14 + Property Age: 1830 System Age: 1985 & 2000 Last Date of Cleaning: Unknown Recomm'd Pumping Freq: Annually	
Liquid level in tank is: <input type="checkbox"/> Above Normal <input checked="" type="checkbox"/> Normal <input type="checkbox"/> Below Normal		Bottom Solids Depth: 10 Inches			
Depth of tank: 34 Inches		Type of Tank Access: Riser		Depth of tank access: At Grade	
Maintenance appears: <input type="checkbox"/> Good <input checked="" type="checkbox"/> Fair <input type="checkbox"/> Poor		Depth to Distribution Box: ~40 Inches

Camera Septic Inspection

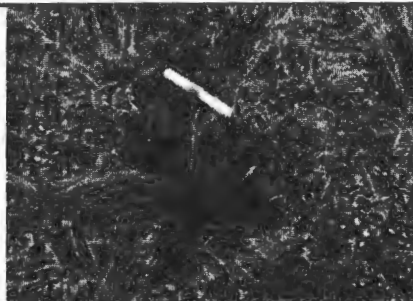
Picture 3:

Absorption System		<input checked="" type="checkbox"/> Acceptable <input type="checkbox"/> Unacceptable <input type="checkbox"/> Needs Further Evaluation		Per the county records there are 2 drainfields, the second drainfield was installed in 2000. During the inspection 2 drainfields were located. Both drainfields were probed and found to be dry to a depth of at least 12 inches from the top of the stone. Approximately 500 gallons of water were introduced into the system with no sign of a backup. The older drainfield has some soil settling over the drainfield (see picture addendum).

Showing the soil settling over the older drainfield

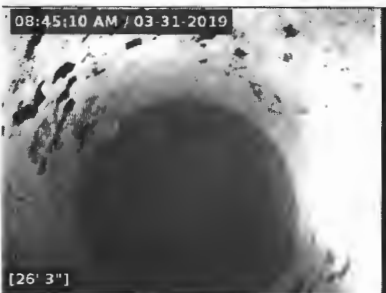
26' 4"

Break in drainfield pipe. The break in the drainfield pipe needs to be repaired by a licensed septic contractor. The point of the break was marked with pink spray paint and a white flag. Contractor onsite was shown where the break is.

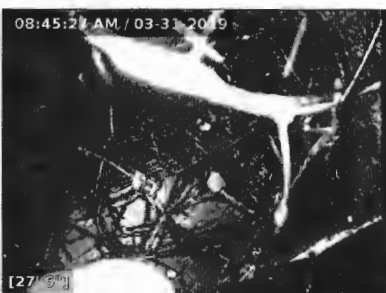
27' 7"

Break in drainfield pipe

- right at start of perf. pipe in stone
