SEWAGE DISPOSAL SYSTEM

Re: Failing Septic System Notice  
7250 Meadow Wood Way  
Simpson Woods, Lot 5

Re: Site Inspection Results  
7250 Meadow Wood Way  
Simpson Woods, Lot 5

# SITE INSPECTION SHEET

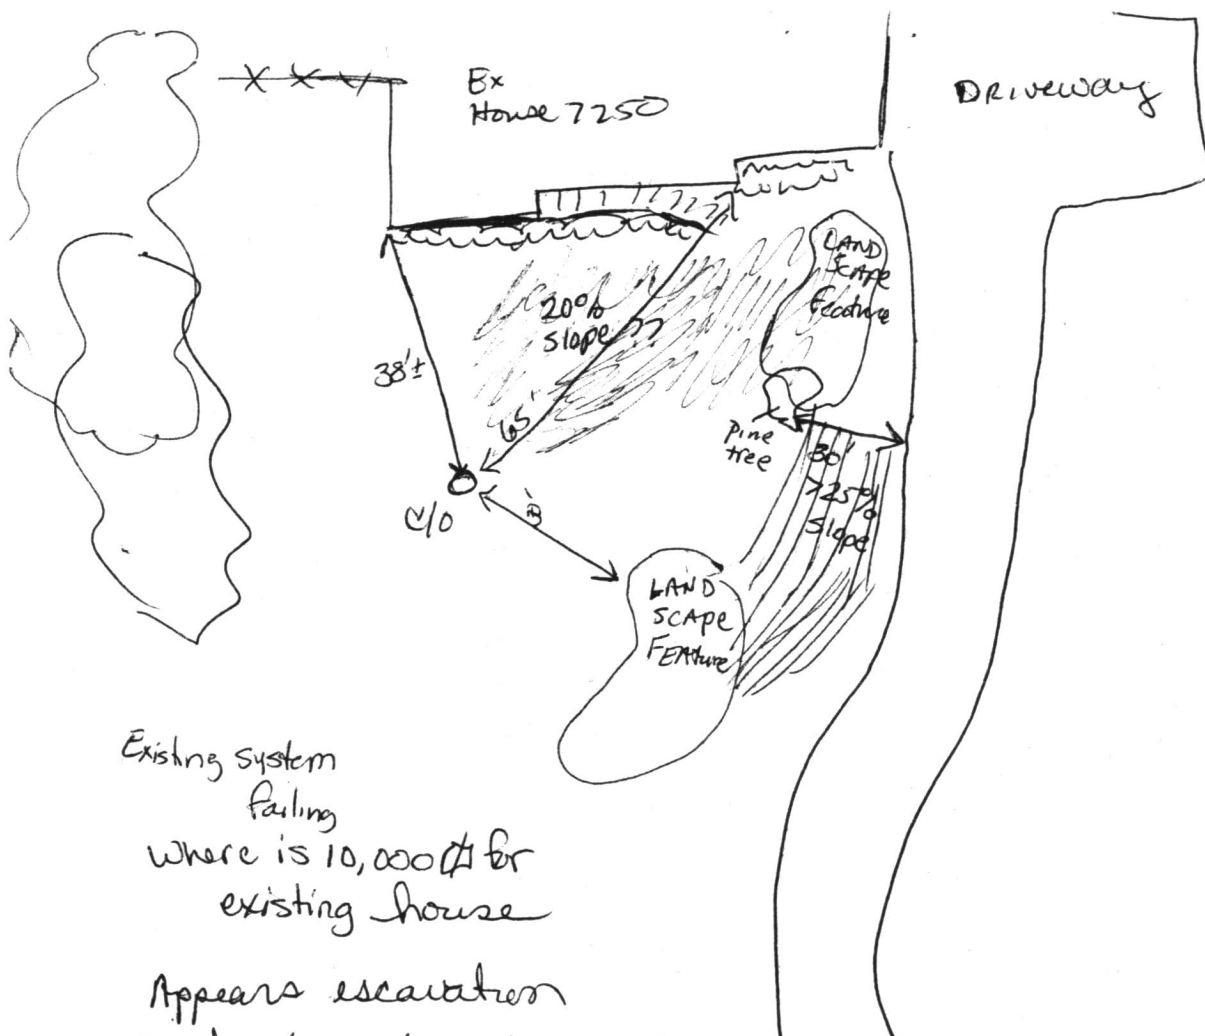
A25718  
P 31439

Existing system  
failing  
where is 10,000 \$ for  
existing house

Appears excavation  
in backyard - soils  
placed on existing SDA,  
Cable @ end of SDA / slightly  
in / driveway over SDA??

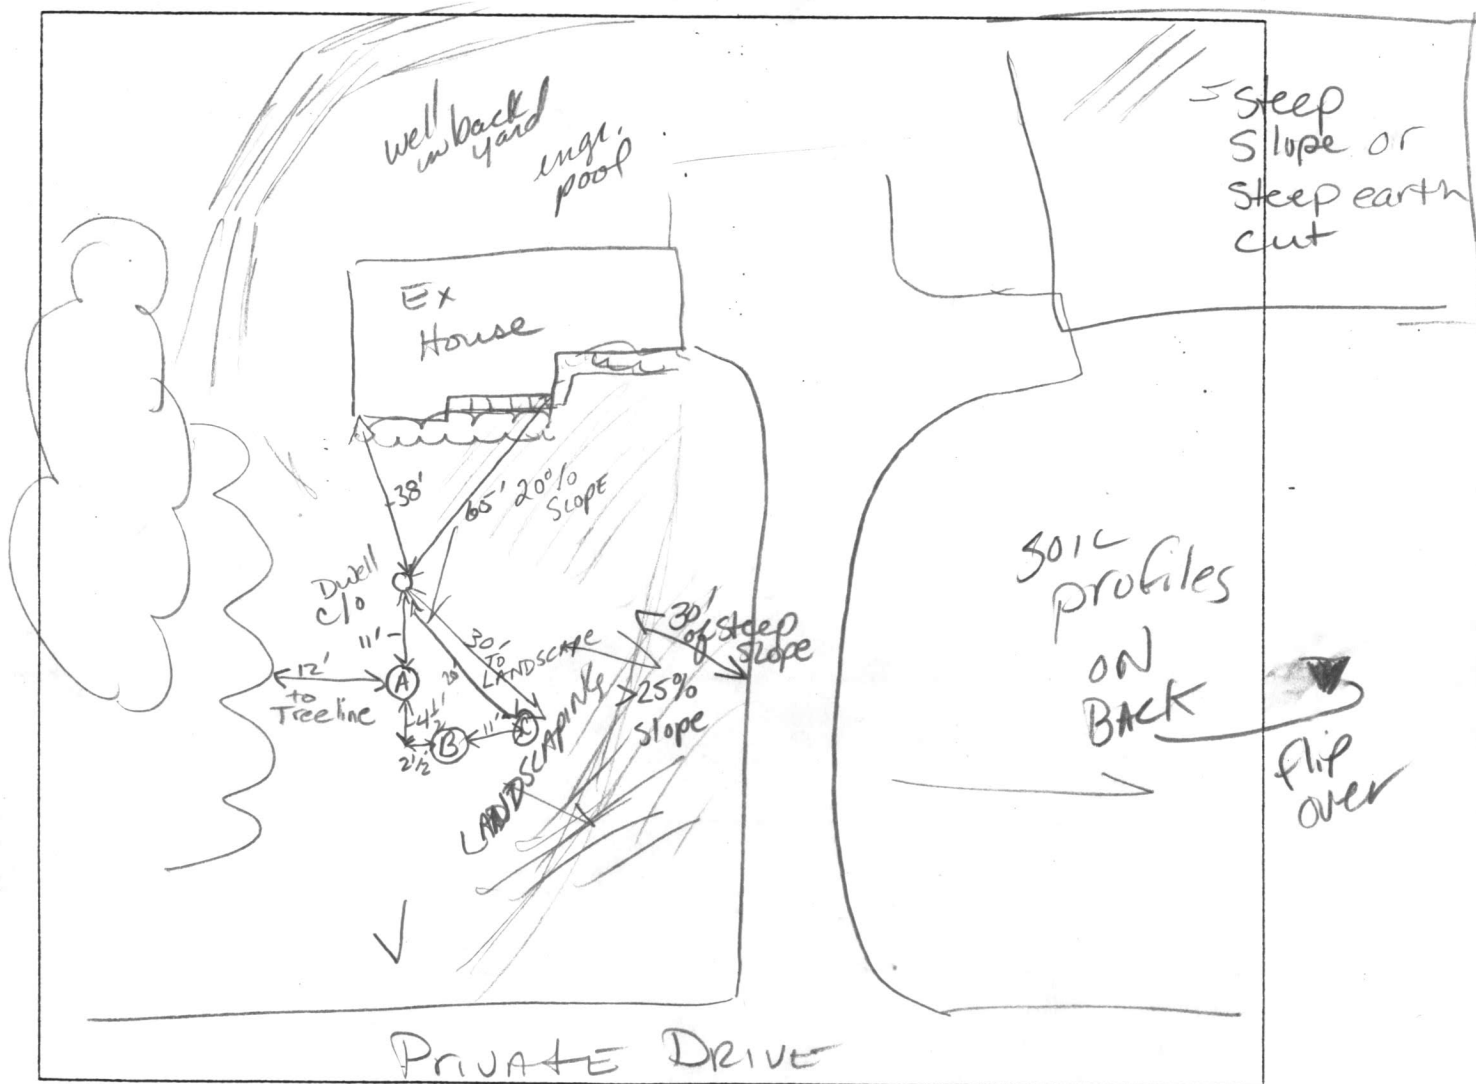
### LOCATION DIAGRAM

COMMENTS: 12-20-04 Percolation test holes in 1980 established septic area. However, due to excavation for driveway creating hillside w/ slopes  $>25\%$  at least 4,500 ft<sup>2</sup> has been compromised. Augered test holes today encountered shallow depths to 28" due to

DATE: 12-20-04 INSPECTOR: KN  
rock or pvc pipe? SEE SOIL DESCRIPTIONS EFFluent in dry well @ low level  
EST 26'

Angered in area  
of visible surface  
B / (A)

Frozen 3"  
brn  
wk rdbn  
micaceous  
granular  
Loam  
12"  
rd brn  
micae  $\approx 40\%$   
SL  
↓  
22"  
grey black  
dk brn  
rock  
frag  
organic  
in appearance  
No roots in  
this layer  
2mm thick +  
size of silver  
dollar  
LOAM  
26"  
tan  
wk rdbn  
moist  
Loam  
28"  
refusal -  
pvc pipe??  
hit hard surface  
sounds hollow

Angered hole out of wall ...  
20' from dry well c/o  
11' from hole (B)  
(C)

brn, tan,  
wk rdbn, 30-  
v. micae 40%  
Loam  
23"  
tan rdbn  
SL  
mica 45%±  
1 stone frag  
encountered  
28"  
Hard Rock?  
Sounded hollow,  
though.

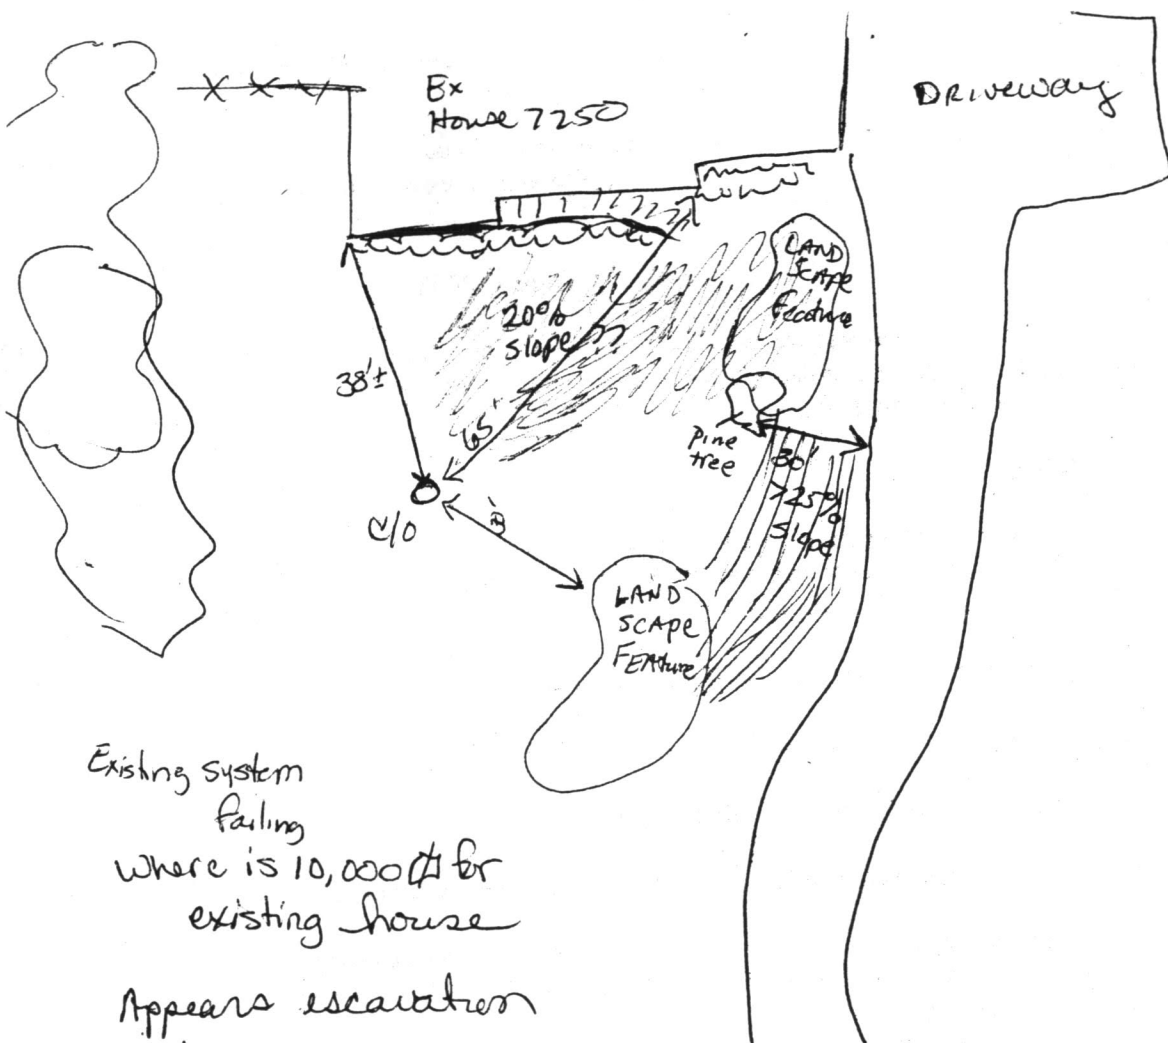
A25718  
P 31439

Existing system  
failing  
where is 10,000 \$ for  
existing house

Appears excavation  
in backyard - soils  
placed on existing SDA,  
Cable @ end of SDA / slightly  
in / driveway over SDA??
