SITE INSPECTION SHEET

PROPOSAL: Convert BR#2 into full bathroom and add a BR.

Site Visit 11.27.18
7413 Meadow View Court
Clarksville, MD

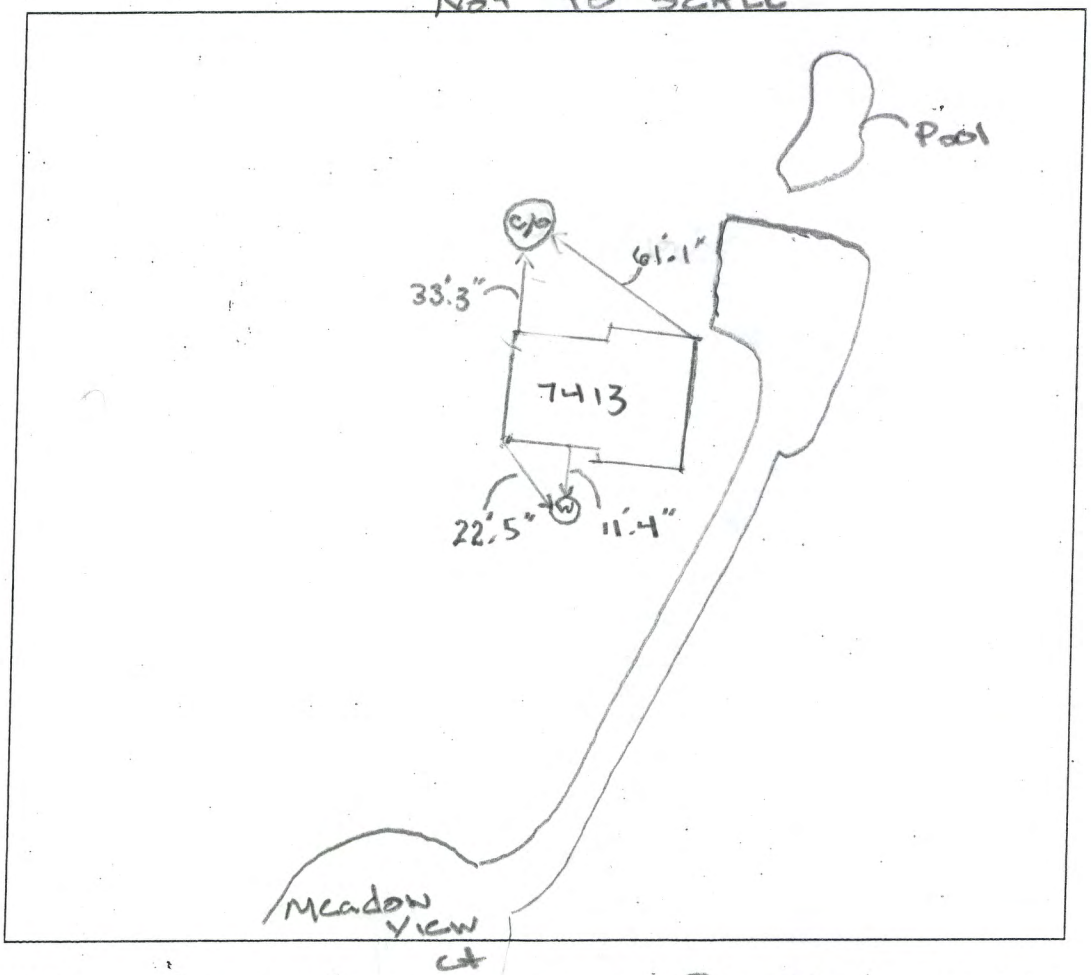
LOCATION DIAGRAM

COMMENTS: 1 pc well cap secure. Pvc flush w/ cap. Well pump rope observed. No well tag. Well has been GPS'd. Septic tank c/o pvc w/ cap. No septic issue observed
