# Howard County Health Department

## ONSITE SEWAGE DISPOSAL SYSTEM

**REPAIR**

PROPERTY ADDRESS: 3100 Roxbury Road Mill Rd (Rt 97)

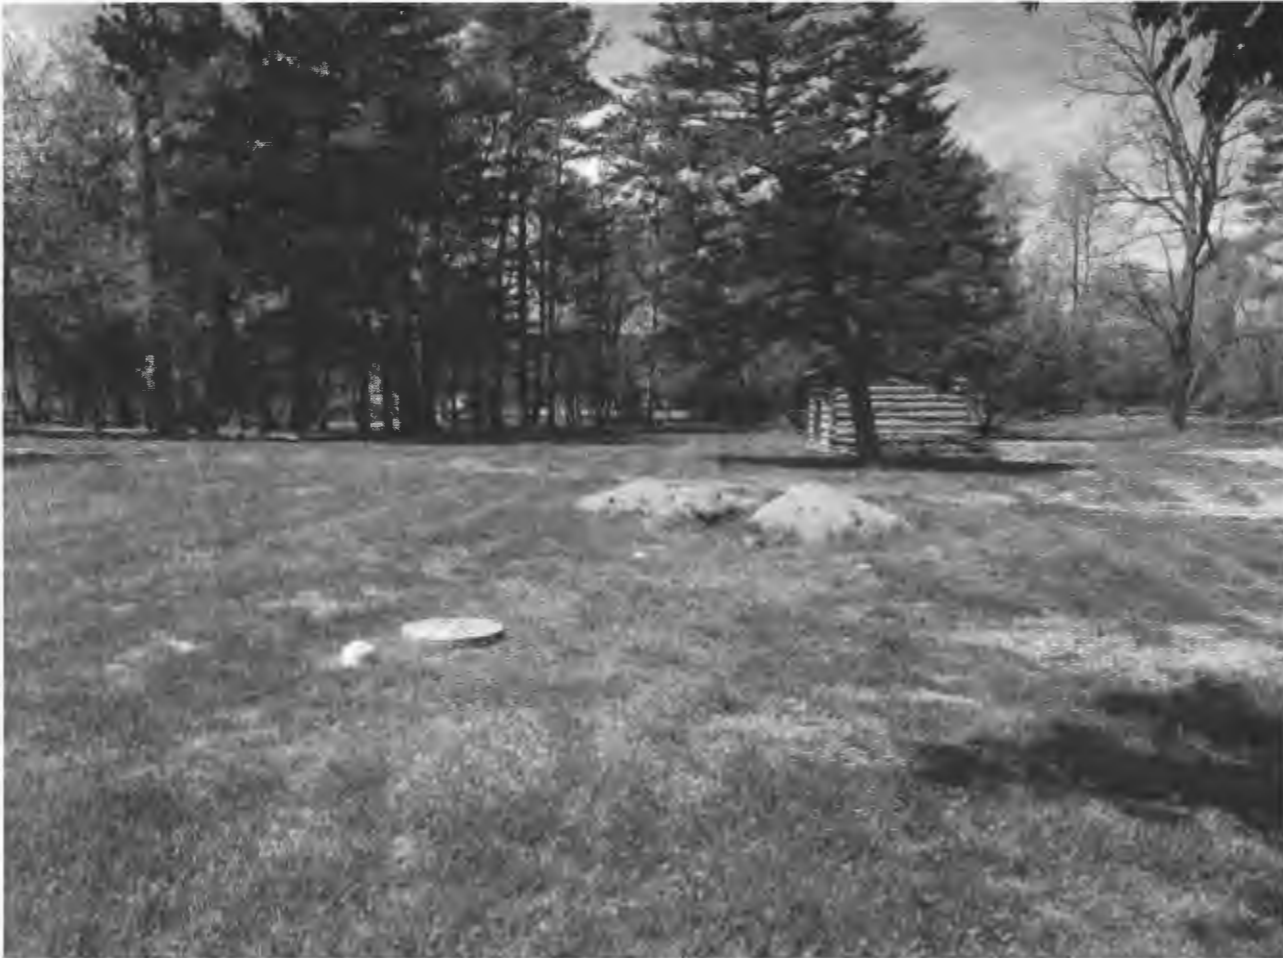
4/30/19-pic

INSTALLATION: 4/30/19 - site inspection for repair, contractor not onsite. (R) 5/1/19 - site inspection  
contractor rep onsite to operate back hoe, the repair was to a break in the  
pipe running to the trench to the North, SCH 40 PVC 4" line repaired, ok to backfill. (R)

Contractor pic  
of break in  
pipe to what's  
listed on the 12/6/2000  
as built as the  
"Old trench"  
for the repair at  
the time.
