SITE INSPECTION SHEET

OWNER: Tierney Ahearn PHONE #: \_\_\_\_\_  
ADDRESS: 15280 Sweetbay St CONTRACTOR: \_\_\_\_\_  
Woodbine MD WELL TAG #: HO-95-0633  
SUBDIVISION: Belle Haven LOT: 25 COUNTY #: 13  
PROPOSAL: Sinking patches continue to appear in yard especially  
after heavy rains

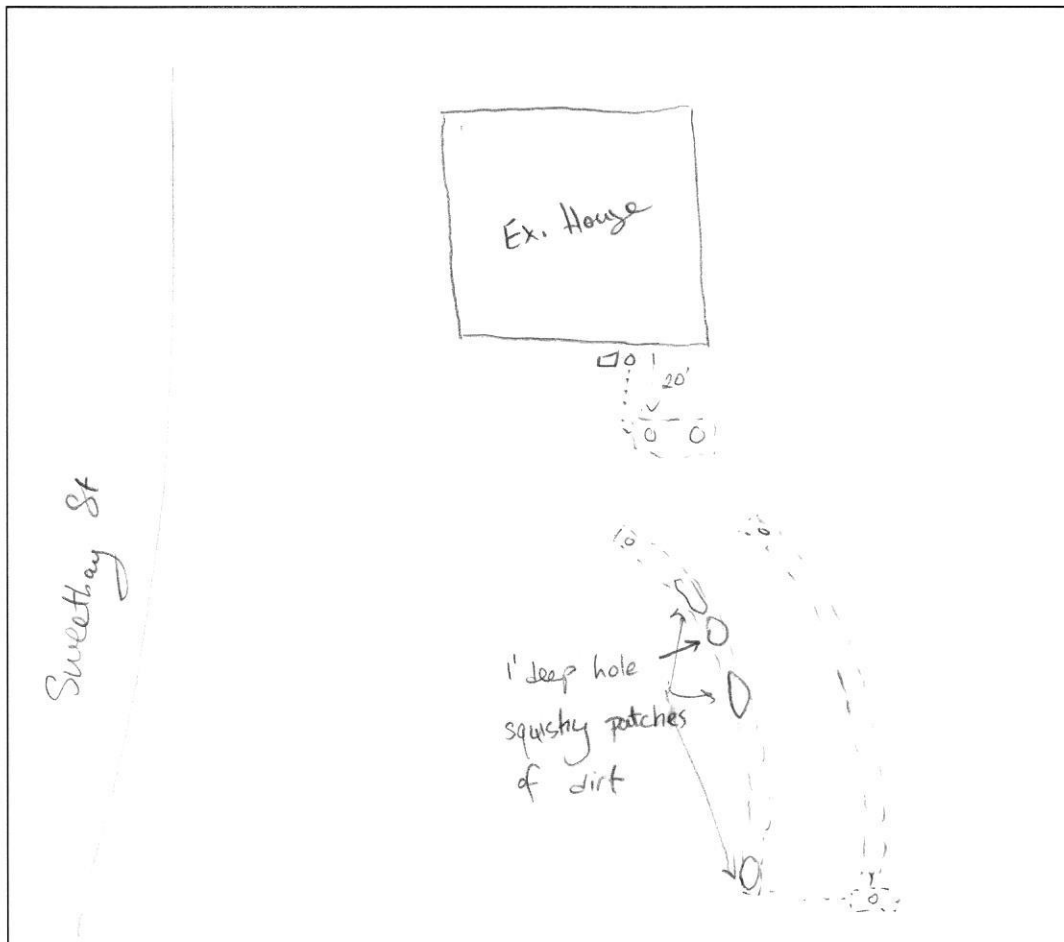
LOCATION DIAGRAM

COMMENTS: Large patches of squishy soil along end of second trench. One  
patch has 1'x1'x0.5' hole. Observation pipe of second trench has water  
at the very bottom, first trench obs. pipe was dry. Lid of tank broken -  
water level normal, HOOT observed to function. Mike Sample reports  
HOOT last inspected on 4/16/21.

9/2/21 spoke with owner and advised that patches are most  
likely result of landscaping. No sign of system failure (SR)
