# Howard County Health Department

### ONSITE SEWAGE DISPOSAL SYSTEM

PROPERTY ADDRESS: 3654 Sharp Road

<b>Date:</b> 3/9/2023 <b>Name of Evaluator:</b> Drew Henderson <b>Time:</b> 09:00 <b>Property Address:</b> 3654 Sharp Road Glenwood, MD 21738 <b>Recent Weather Conditions:</b> Normal		<b>Ordered By:</b> Angie Graboski  <b>Homeowner Interview:</b> The homeowner interview was sent conducted during the evaluation.	<b>Occupied:</b> <input checked="" type="checkbox"/> Yes <input type="checkbox"/> No <b>Length of Time Vacant:</b> N/A <b># of People Living in Home:</b> 6 <b>Property Age:</b> 1986 <b>System Age:</b> 1986 <b>Last Date of Cleaning:</b> ~1 Month Ago <b>Recomm'd Pumping Freq:</b> Annually
<b>Liquid level in tank is:</b> <input checked="" type="checkbox"/> Above Normal <input type="checkbox"/> Normal <input type="checkbox"/> Below Normal		<b>Bottom Solids Depth:</b> 4 Inches	
<b>Depth of tank:</b> 42 inches		<b>Type of Tank Access:</b> Cleanout	
<b>Maintenance appears:</b> <input type="checkbox"/> Good <input checked="" type="checkbox"/> Fair <input type="checkbox"/> Poor		<b># of Bedrooms:</b> 3

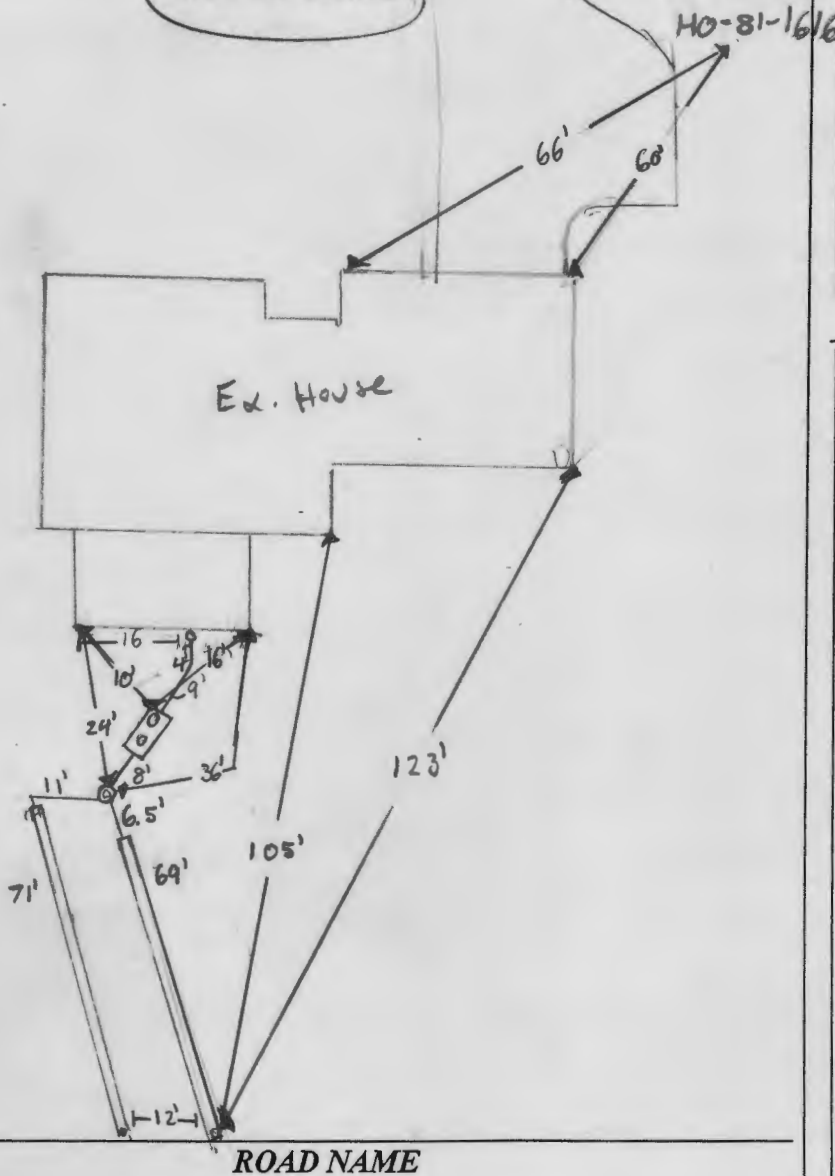
NOT TO SCALE

WIDTH 2' INLET 3.5-4' BOTTOM 8'  
NUMBER OF TRENCHES 2  
TOTAL LENGTH 140  
ABSORPTION AREA 280 ft<sup>2</sup>  
DISTRIBUTION BOX LEVEL yes  
DISTRIBUTION BOX BAFFLE NO  
DISTRIBUTION BOX PORT Manhole

SEPTIC TANK 1 LEVEL ys  
MANUFACTURER MO. Concrete  
CAPACITY 1000 GAL  
SEAM LOC Top  
TANK LID DEPTH 4'  
BAFFLES 6" Front & 4" back  
BAFFLE FILTER back  
MANHOLE LOC Front & back  
6" PORT LOC \_\_\_\_\_  
WATERTIGHT TEST —  
SLOTTED yes  
DATE ON LID 3/31/2023

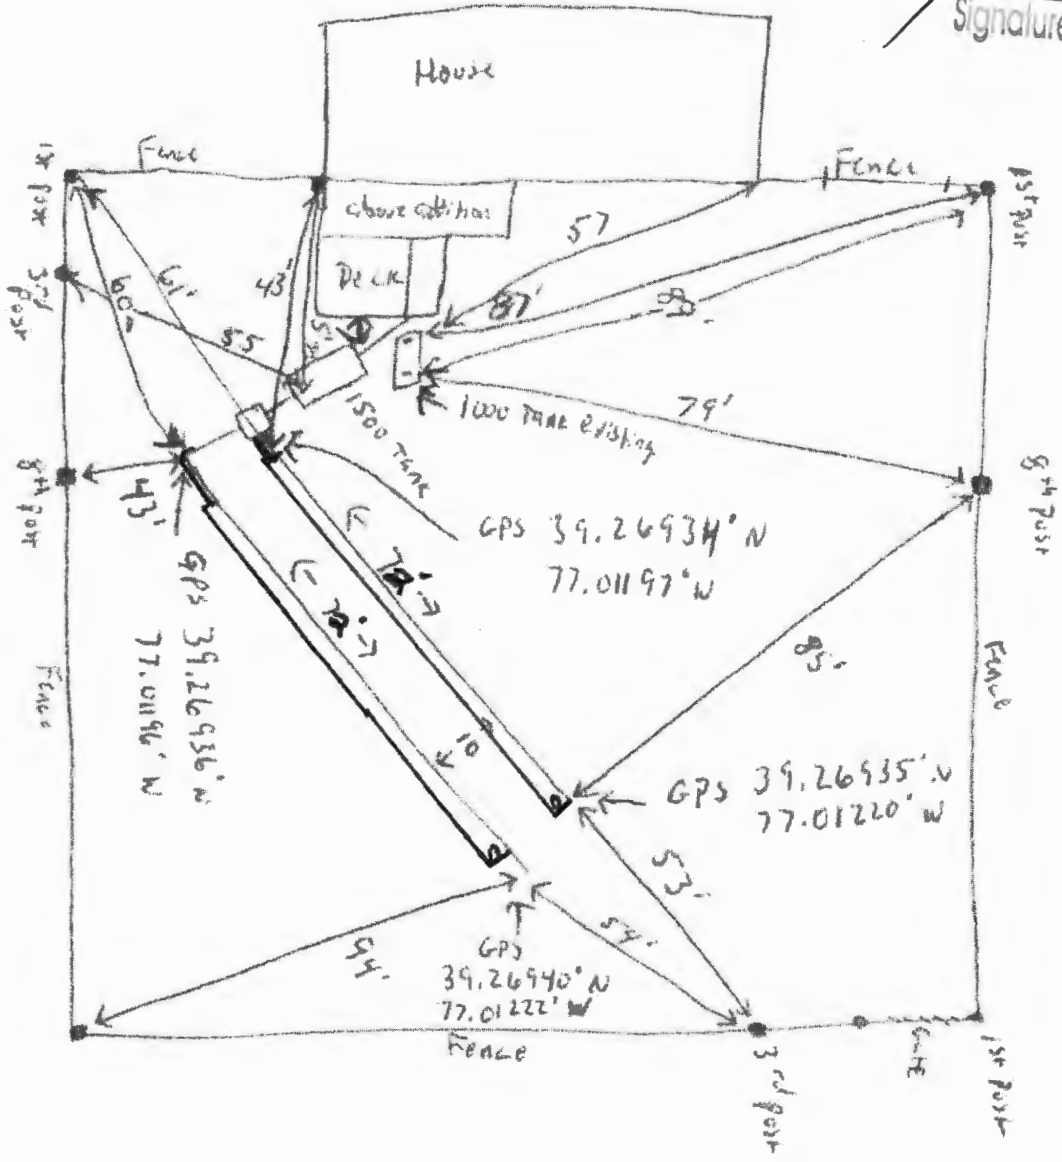
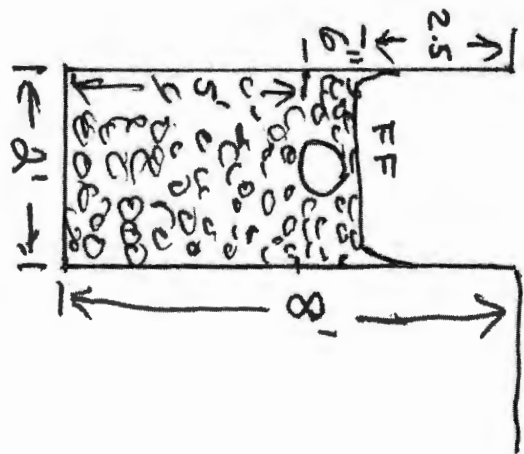
Approved Septic System Plan  
Howard County Health Department

TRENCH INLET 3'  
TRENCH LENGTH TOTAL 143'  
TRENCH DEPTH 8'  
NEW SEPTIC TANK  
TOPSEAM  
20000.  
1500 GAL
