| SFD/REPAIR & REPLACE SUNROOM FROM TREE AND WATER DAMAGE: TRUSSES, SHEATHING, ROOFING, GAURDRAILS, INSULATION, INTERIOR FINISHES, MECHANICAL, ELECTRICAL AND MISC.**REPAIR PER ENGINEER'S REPORT, SUBJECT TO FIELD INSPECTION** | | |

CHENG RESIDENCE  
TREE IMPACT DAMAGE REPAIR  
14820 VIEW WAY COURT  
GLENELG, MD 21737

## OBSERVATIONS AND FINDINGS

Re: *Insured:* Jeffrey & Bethany Cheng  
*Location:* 14820 View Way Court  
Glenelg, MD 21737  
*Claim:* Tree Impact Damage  
*TEG No.:* T260-009

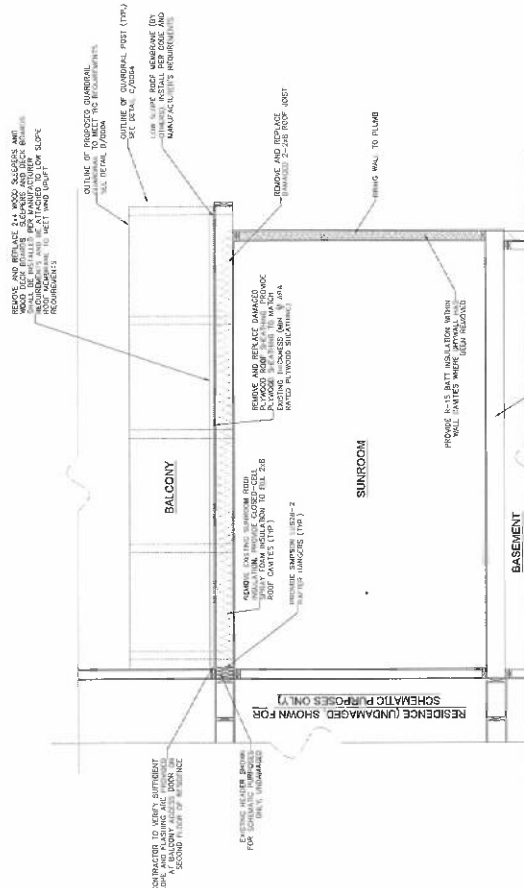
A CROSS SECTION  
0004  
SCALE 1/2" = 1'

NOTE: 1. GUARDRAIL SYSTEM SHALL BE INSTALLED PER CODE AND MANUFACTURER REQUIREMENTS. 2. CONTRACTOR TO VERIFY SUFFICIENT SLOPE AND FLASHING ARE PROVIDED AT BALCONY ACCESS DOOR ON SECOND FLOOR OF RESIDENCE.

- REMOVE STEEL POST AND DRILL 3/4" HOLE IN ALL FOUR MARKS THROUGH THE DECK BOARD AND BLOOMING.
- ATTACHING POST:
  - PROVIDE 3/4" DIAMETER HOT-DIPPED GALVANIZED (OR STAINLESS STEEL) BOLTS AND NUTS APPROXIMATELY 1" LONGER THAN THE DISTANCE BETWEEN STEEL MOUNTING PLATES (MINIMUM 5").
