SEWAGE DISPOSAL SYSTEM

Re: Failing Septic System Notice  
7250 Meadow Wood Way  
Simpson Woods, Lot 5

Re: Site Inspection Results  
7250 Meadow Wood Way  
Simpson Woods, Lot 5

# SITE INSPECTION SHEET

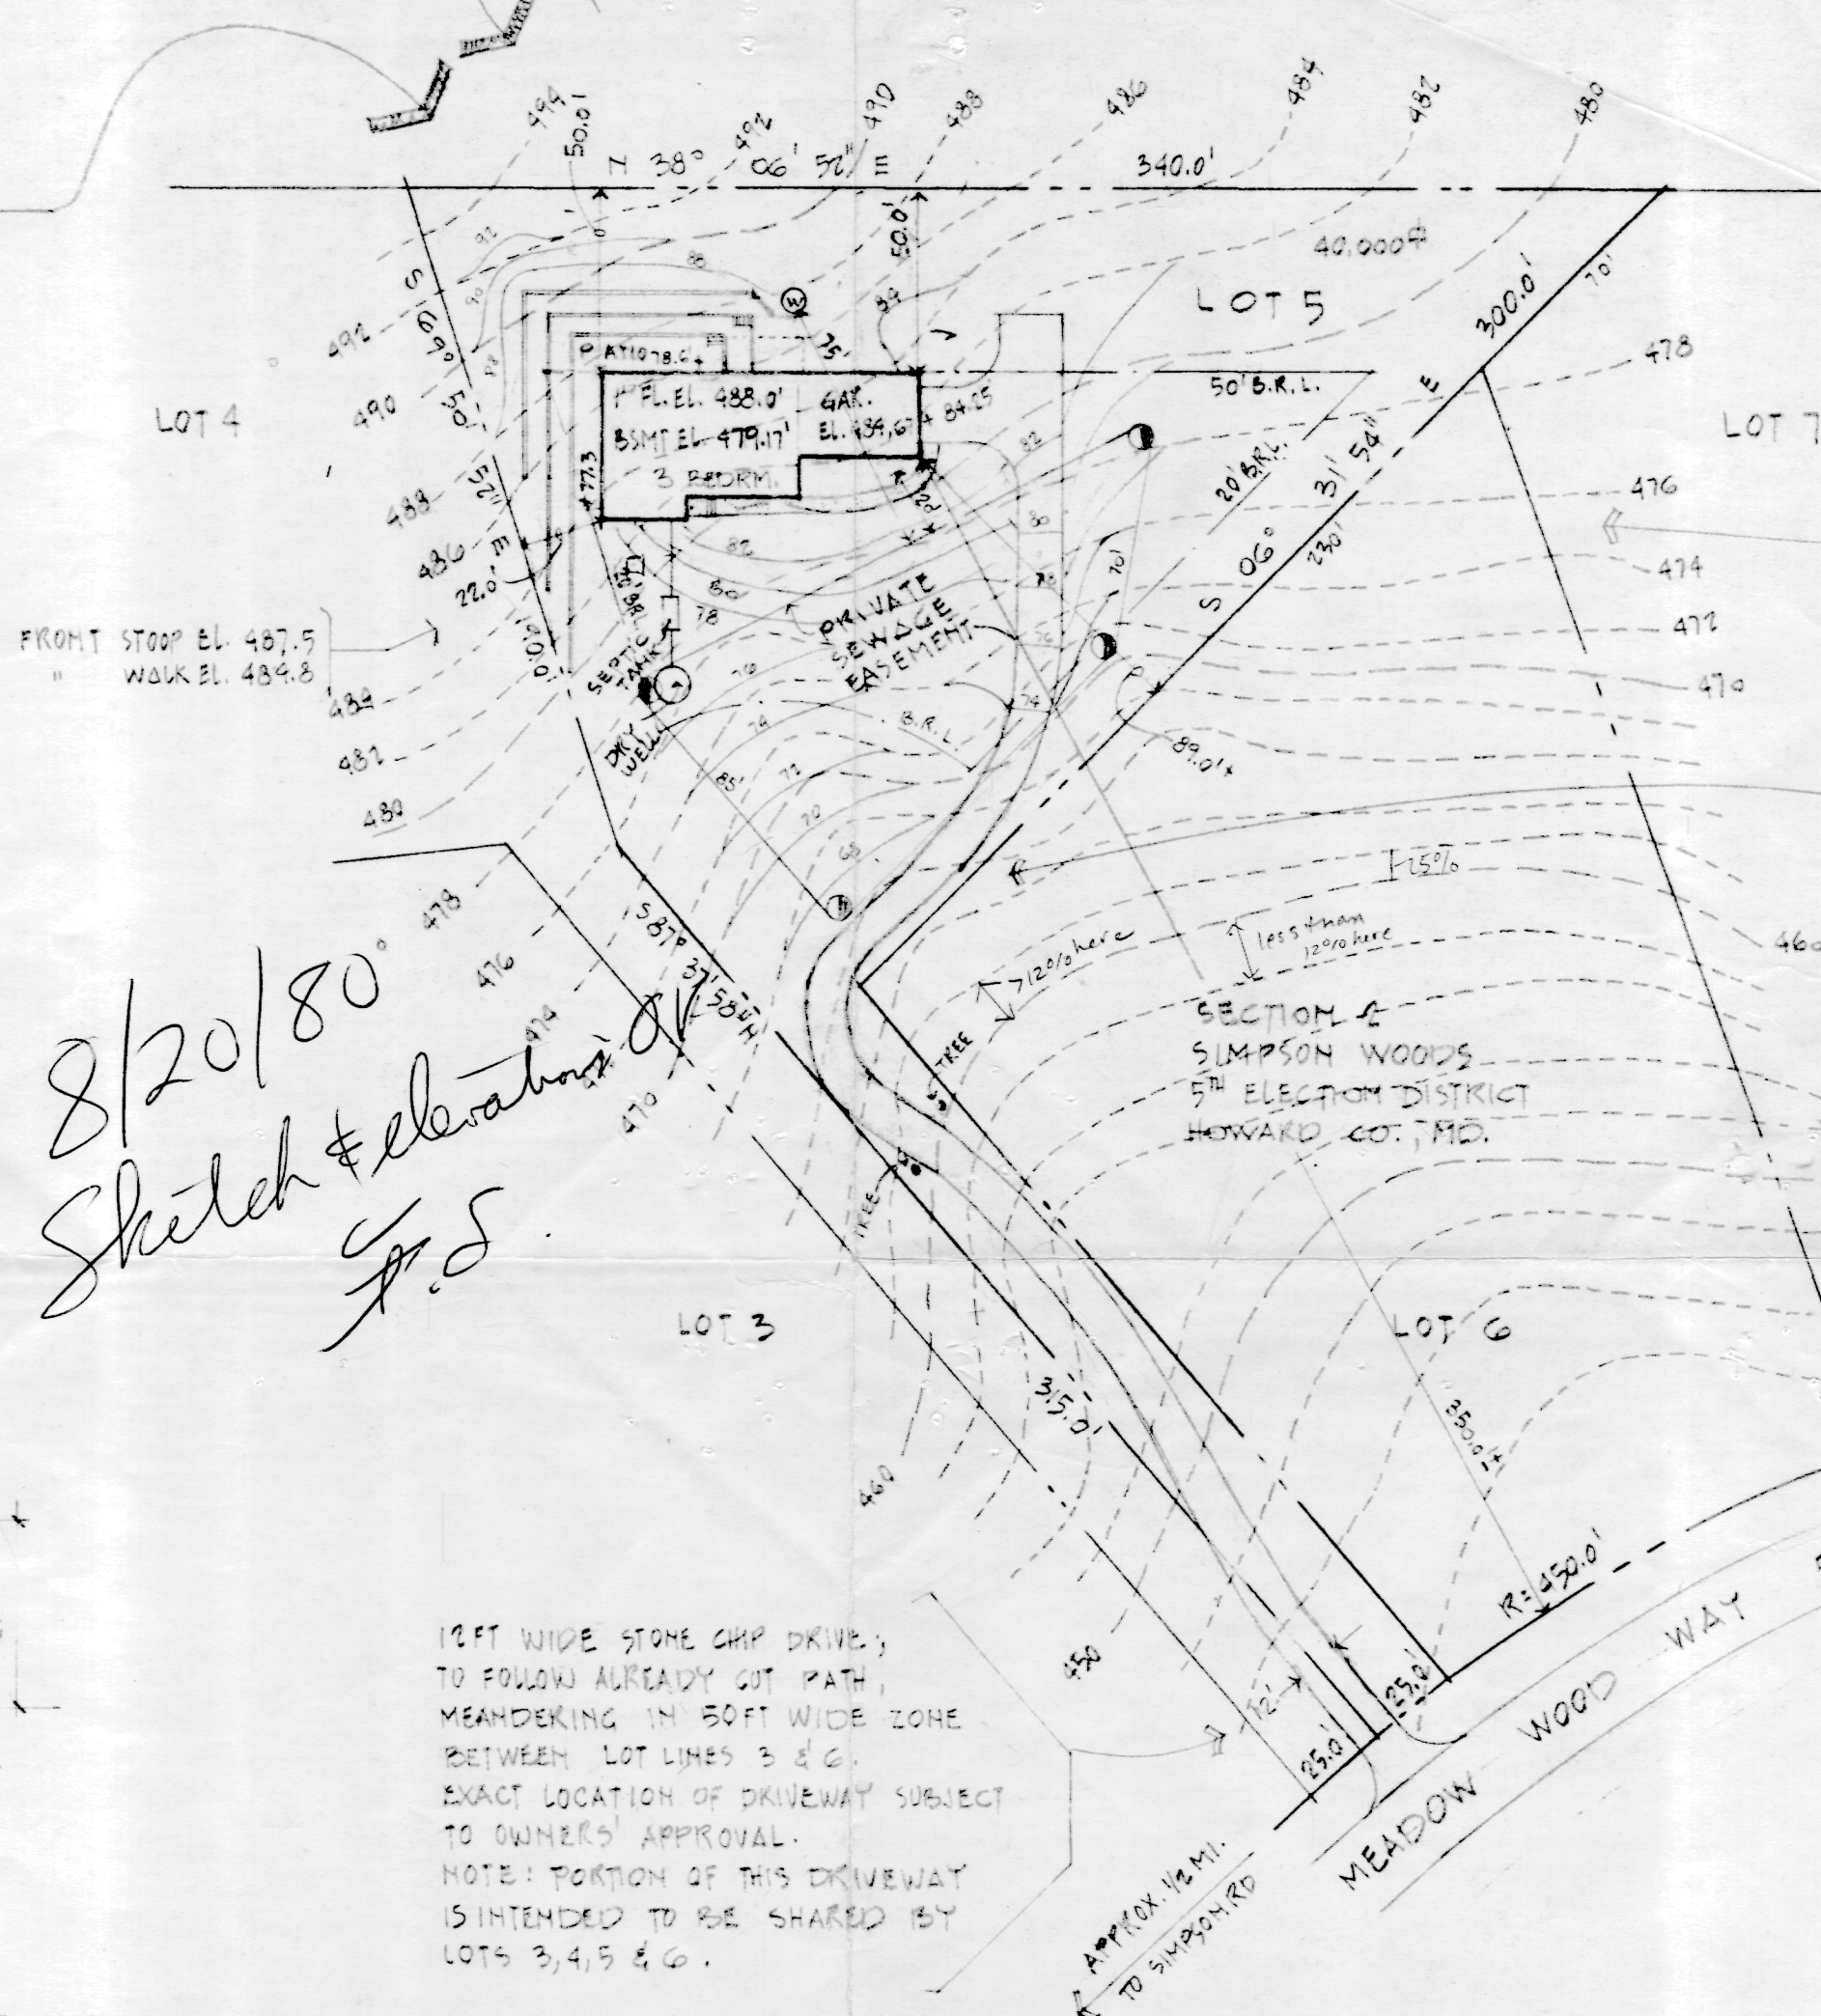
# SITE PLAN 1" = 30'

Appears excavation  
in backyard - soils  
placed on existing SDA,  
Cable @ end of SDA / slightly  
in / driveway over SDA??
