## INFORMATION FORM – SEPTIC SYSTEM REPAIR/UPGRADE

Property Address: 2445 THOMPSON DRIVE County file: 286606

<b>Date:</b> February 15, 2021 <b>Name of Evaluator:</b> Nicholas Riehl <b>Time:</b> 9:00 AM <b>Property Address:</b> 2445 Thompson Drive Marriottsville, MD 21104 <b>Recent Weather Conditions:</b> Normal		<b>Ordered By:</b> Jeff Berman  <b>Buyers:</b> Jayre Reaves  <b>Homeowner Interview:</b> The homeowner interview was sent and was received prior to the evaluation.		<b>Occupied:</b> <input type="checkbox"/> Yes <input checked="" type="checkbox"/> No <b>Length of Time Vacant:</b> 3 Months <b># of People Living in Home:</b> N/A <b># of People moving in:</b> Unknown <b>Property Age:</b> 1950 <b>System Age:</b> Unknown <b>Last Date of Cleaning:</b> 9/2020 <b>Recomm'd Pumping Freq:</b> 2-3 Years	
<b>Liquid level in tank is:</b> <input checked="" type="checkbox"/> Above Normal <input type="checkbox"/> Normal <input type="checkbox"/> Below Normal			<b>Bottom Solids Depth:</b> 10 Inches		
<b>Depth of tank:</b> 20 Inches		<b>Type of Tank Access:</b> Cleanout		<b>Depth of tank access:</b> At Grade

# SITE INSPECTION SHEET

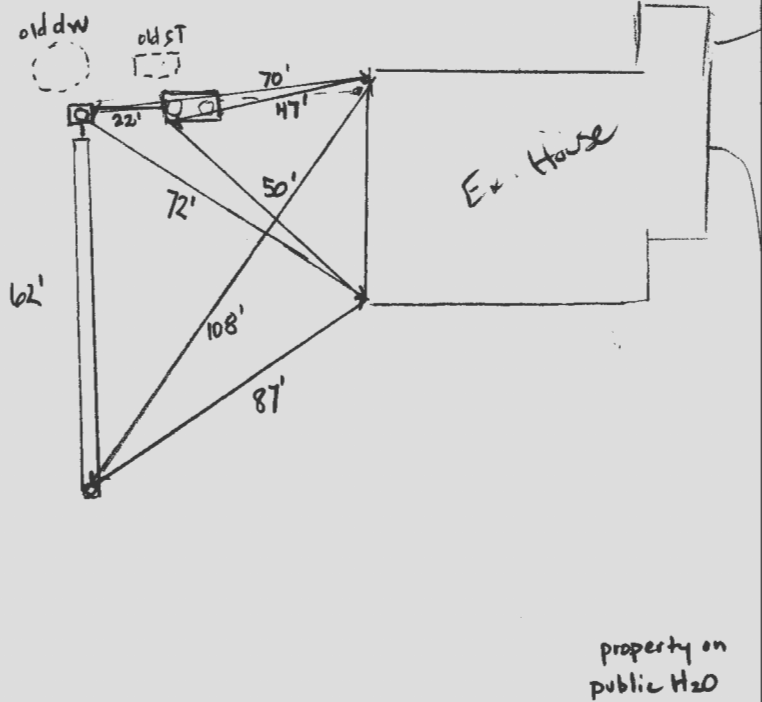
WIDTH	INLET	BOTTOM
3'	2'	6'
NUMBER OF TRENCHES		1
TOTAL LENGTH		62'
ABSORPTION AREA		186 sq feet + sidewall
DISTRIBUTION BOX LEVEL		yes
DISTRIBUTION BOX BAFFLE		yes
DISTRIBUTION BOX PORT		yes

SEPTIC TANK 1 LEVEL	yes
MANUFACTURER	Back River
CAPACITY	1500 GAL
SEAM LOC	top
TANK LID DEPTH	3'
BAFFLES	6" front / 4" back
BAFFLE FILTER	-
MANHOLE LOC	front / back
6" PORT LOC	-
WATERTIGHT TEST	-
SLOTTED	yes
DATE ON LID	2/23/21

4/6/21 Install 1 x 62' trench running on contour running towards road. Ex. Drywell pumped and collapsed. (1x man)

INSTALLATION: 4/8/21 - contractor on-site, old tank & drywell pumped crushed & filled in w/ clean dirt & stone, new tank in place & mostly covered, d box installed & one trench @ 62', stone looks good, geotextile fabric in place, ok to backfill & continue (20)
