# HOWARD COUNTY HEALTH DEPARTMENT

RECEIPT DATE: 2/21/2024 **ONSITE SEWAGE DISPOSAL SYSTEM** P 575795

APPROVAL DATE: 3/13/2024 **PERMIT: MINOR REPAIR** A \_\_\_\_\_

PROPERTY ADDRESS: 11717 Wayneridge Court

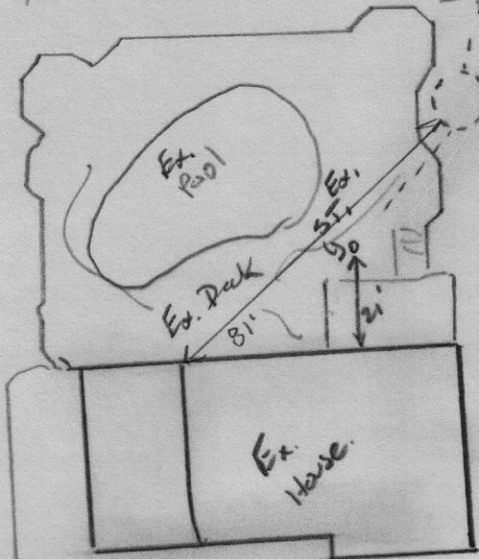
New sch 40 piping installed 3/13/2024

New obs. pipe

Ex. Trench per As-Built from 1983 (P32722)  
Ex. Septic Pit? (see Insp. report)

Ex. Trench per As-Built from 1983 (P32722)

3/13/2024 Inspector confirmed sch 40 piping replaced w/ new fitting @ surface of backline where old ball-run valve was connected. line ran into ex. trench w/ new obs pipe installed @ beginning. stone under pipe was clear, little to no blockage no sign of water (perm)

TRENCHES:	LINEAR FEET REQUIRED: <u>n/a</u>	INLET DEPTH: _____
	TRENCH WIDTH: _____	MAXIMUM BOTTOM DEPTH: _____
	MINIMUM SPACE BETWEEN TRENCHES: _____	EFFECTIVE AREA BEGINNING DEPTH: _____
LOCATION:	_____	
NOTES:	Contractor to replace backline piping with new sch 40 connecting into ex. Trench.

3/12/2024 To replace old piping and ball-run valve /connections w/ new sch 40 pipe per contractor and buyer/seller's request. (perm)

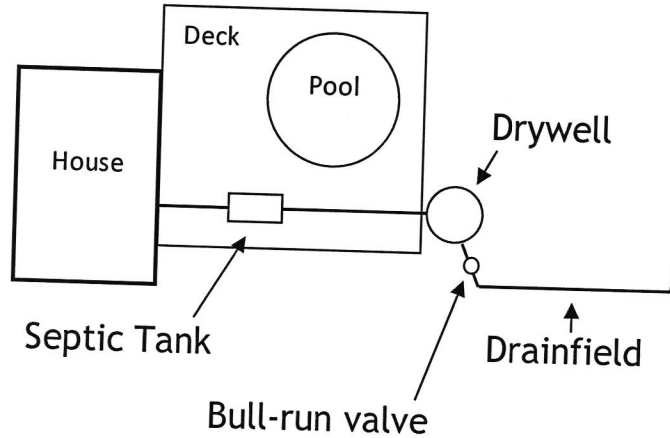
### Sketch of System

**Explain:** The front line and septic tank must be replaced. The front line appears to be composed of orangeburg and the septic tank appears to be composed of block and is not water-tight.

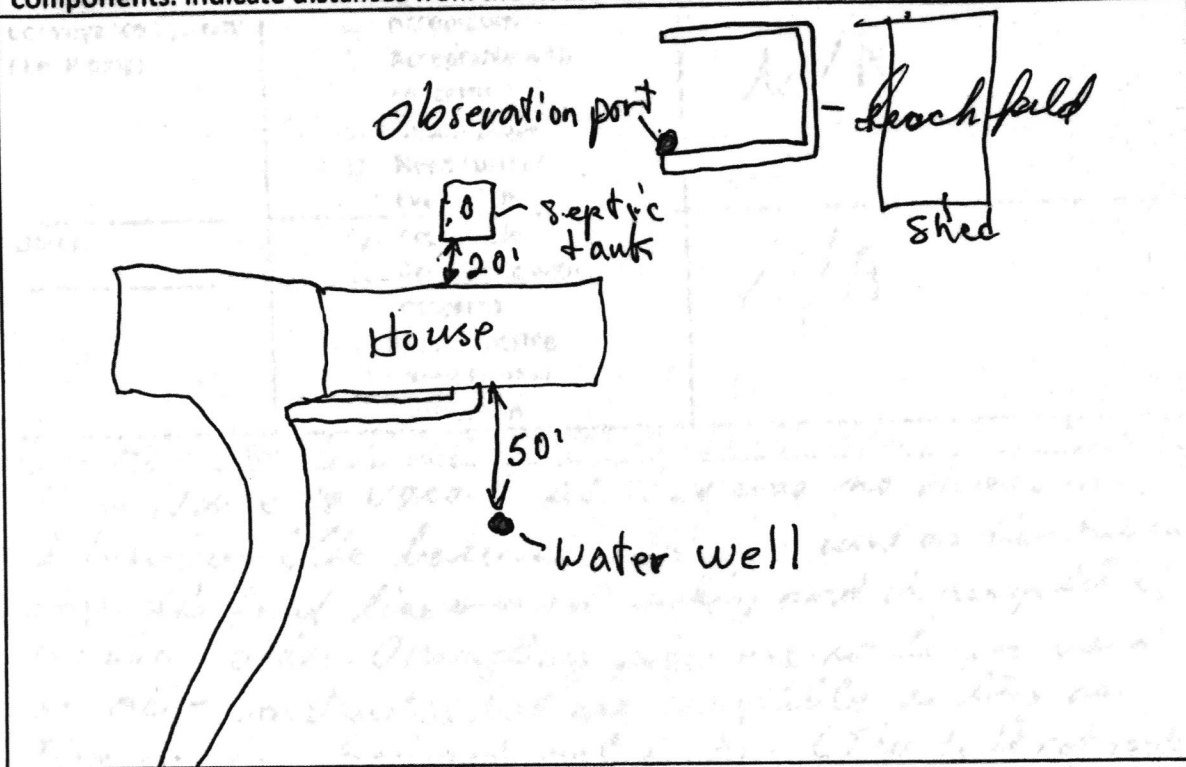
### OSDS Layout

System Component	Condition	Comments
Septic Tank / Pre-Treatment Unit	<input checked="" type="checkbox"/> Acceptable <input type="checkbox"/> Acceptable with concerns <input type="checkbox"/> Unacceptable <input type="checkbox"/> Needs Further Evaluation	
Pump Tank	<input type="checkbox"/> Acceptable <input type="checkbox"/> Acceptable with concerns	N/A
