RECEIPT DATE: 3/20/2026 **ONSITE SEWAGE DISPOSAL SYSTEM** P 5-90382

APPROVAL DATE: 3/31/26 **PERMIT:** REPAIR A _____

PROPERTY ADDRESS: 3611 Scheel Dr, Ellicott City, MD 21042

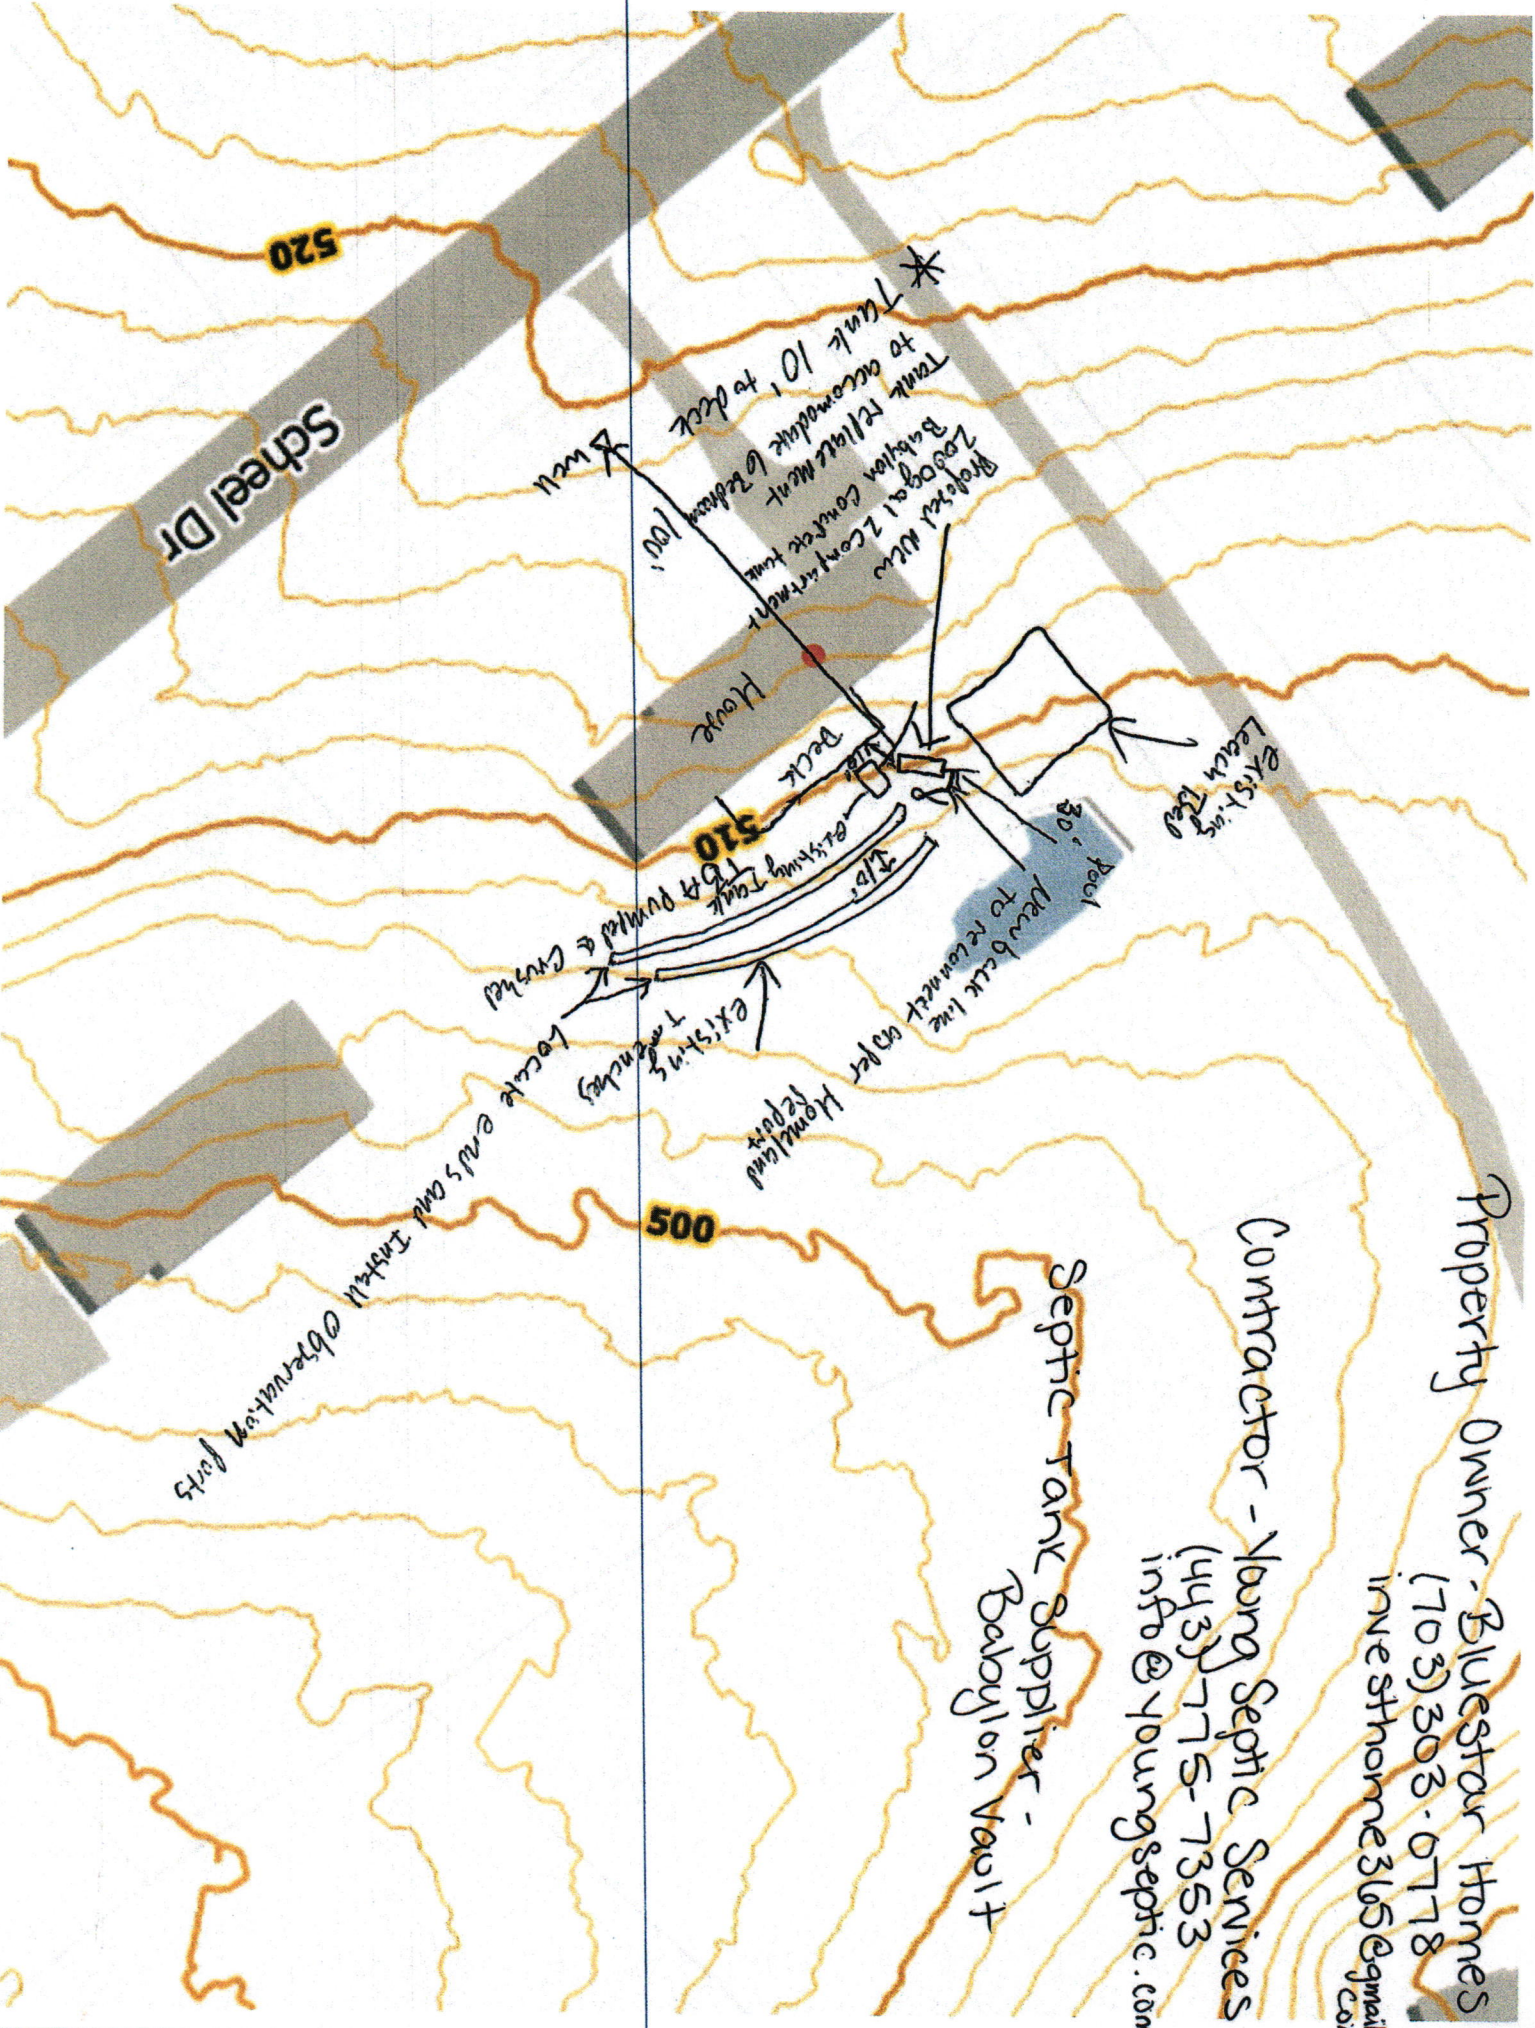
3/27/26	<p>Contractor has bottom trench dig, sand, and geotextile fabric added. Confirmed to bottom by placing tape measure down the observation port 2' from top of stone to grade. When starting upper trench, contractor encountered a third trench that was not permitted. Trench was dry but full of biomat. Trench ran perpendicular to the trench the contractor was digging, approximately 10' from start of trench. Contractor continued to dig trench and we discovered that the trench had a 4" inlet and ran alongside the trench for about 4'. OK to continue trench. Slight curving at this area as well. Contractor continued upper trench with 6' bottom and 2.5' inlet.</p>
3/27/26	<p>Back on site, Contractor completed trench, installed observation port and geotextile fabric. 2' from top of stone to grade. Distance between trenches on stone marginal, but OK. (L) void d-box, observed 6" front baffle and 4" back baffle with effluent filter. OK to backfill. (MB)</p>
