RECEIPT DATE: 4/15/2026 **ONSITE SEWAGE DISPOSAL SYSTEM** P 591016

APPROVAL DATE: 4/22/2026 **PERMIT: REPAIR - Minor** A Repair  
*Kmw*  
**Repair**

PROPERTY ADDRESS: 925 Sunset Valley Drive

<b>Date:</b> March 31, 2026 <b>Name of Evaluator:</b> Tyler Young <b>Time:</b> 8:00 AM <b>Property Address:</b> 925 Sunset Valley Drive Sykesville, MD 21784 <b>Recent Weather Conditions:</b> Normal	<b>Ordered By:</b> Lucy Renehan  <b>Buyers:</b> Patrick Mullinex  <b>Homeowner Interview:</b> The homeowner interview was sent and received prior to the evaluation.	<b>Occupied:</b> <input checked="" type="checkbox"/> Yes <input type="checkbox"/> No <b>Length of Time Vacant:</b> N/A <b># of People Living in Home:</b> 4 <b># of People moving in:</b> 2 <b>Property Age:</b> 1990 <b>System Age:</b> 1990 <b>Last Date of Cleaning:</b> Unknown <b>Recomm'd Pumping Freq:</b> 3-4 Years
<b>Liquid level in tank is:</b> <input type="checkbox"/> Above Normal <input checked="" type="checkbox"/> Normal <input type="checkbox"/> Below Normal		<b>Bottom Solids Depth:</b> >24 Inches
<b>Depth of tank:</b> 17 Inches	<b>Type of Tank Access:</b> Cleanout	<b>Depth of tank access:</b> At Grade

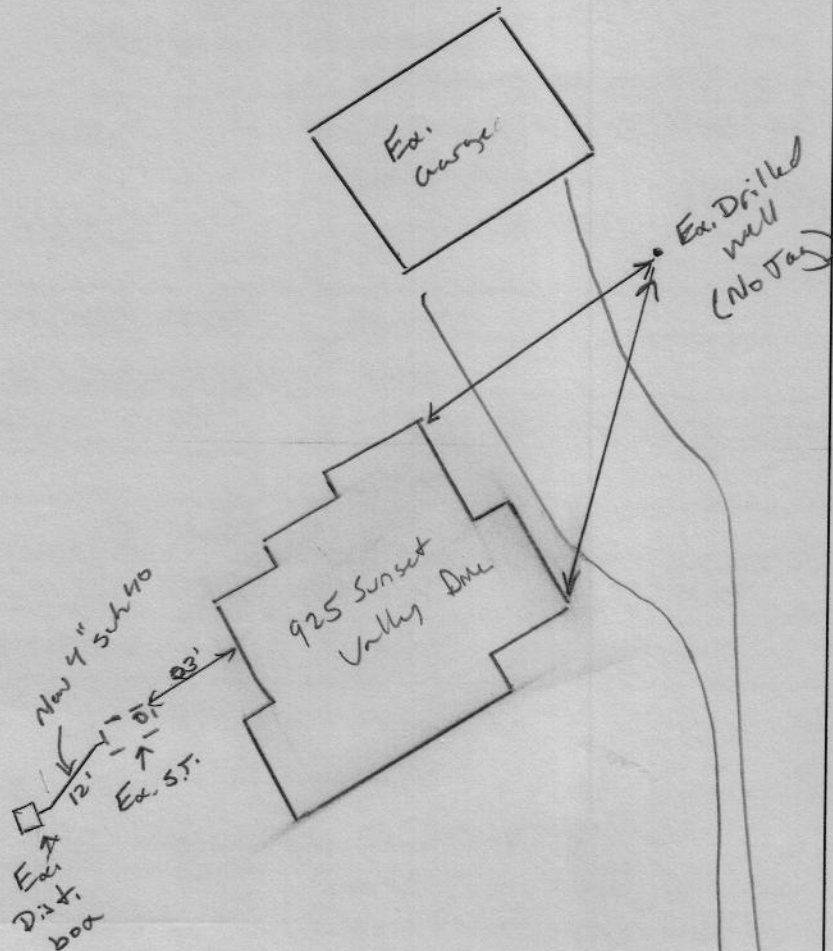
NOTES: Replace existing sewer line from existing septic tank with new sch40 pipe. Install new distribution box in same location.
