SITE INSPECTION SHEET

OWNER: \_\_\_\_\_ PHONE #: 410-419-3273  
ADDRESS: 10981 Scaggsville Rd. CONTRACTOR: Paul Arnold  
\_\_\_\_\_ WELL TAG #: \_\_\_\_\_  
SUBDIVISION: \_\_\_\_\_ LOT: \_\_\_\_\_ COUNTY #: \_\_\_\_\_  
PROPOSAL: Refinish basement after water damage.

(10981 Scaggsville Rd.)

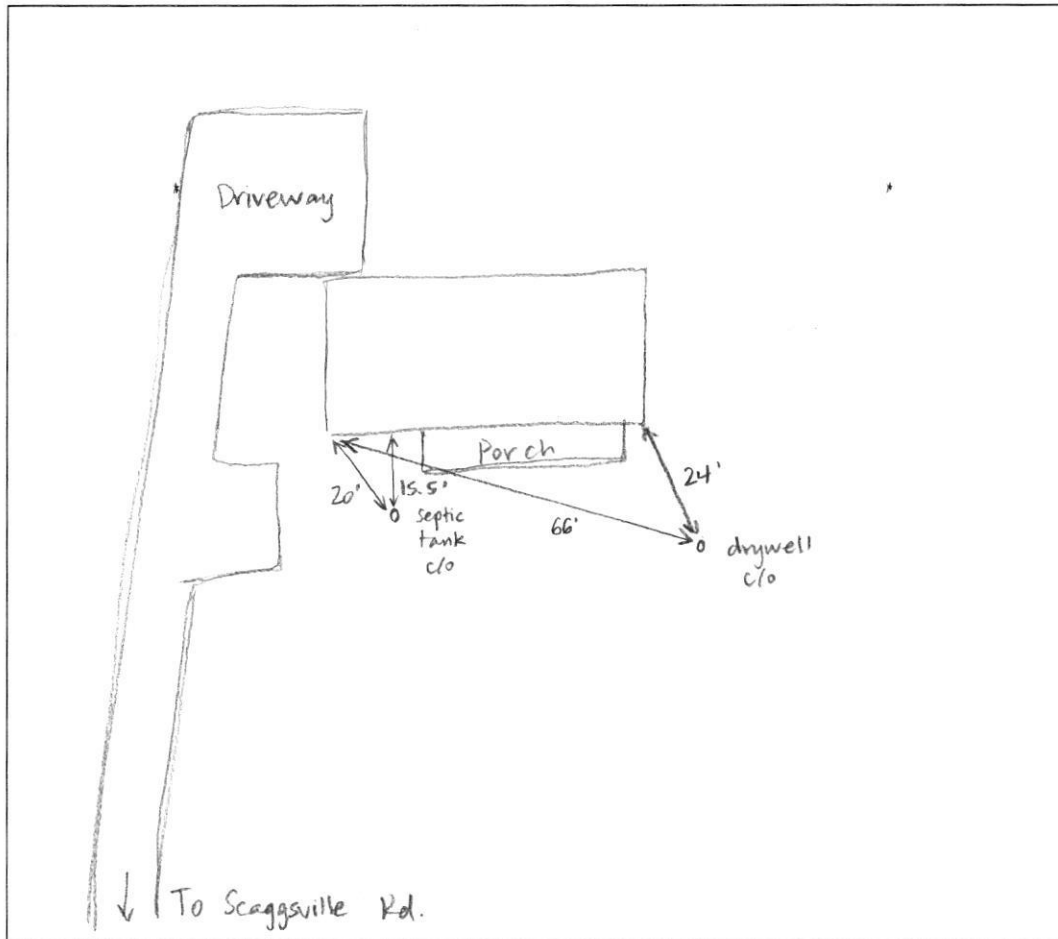
LOCATION DIAGRAM

COMMENTS: Drywell measured - 11' to bottom. 32" to liquid from  
grade. Septic tank is 29" to scum/liquid from grade.
